PARSC 017

Enbridge Line 3 Abandoned Pipeline
Segment Subsurface Field Study

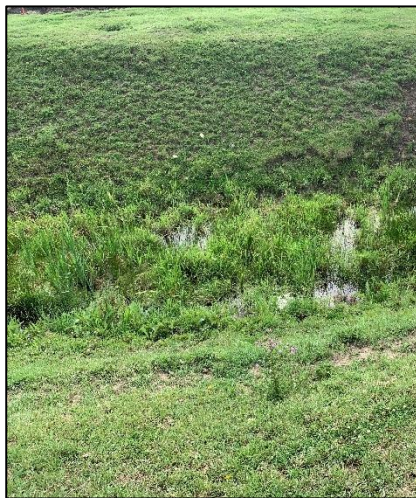
The material at both sites MP 27.5276 and MP 29.52 was found to be primarily clay soils. This classifies the material as “badly” or “unusually corrosive” due to its high moisture content and low permeability as discussed in Section 2.2. Both excavations had standing water and required frequent dewatering. MP 27.5276 is in close proximity to the landowner’s drainage trench, while MP 29.52 is near a highway ditch. This is shown in Figure 3-1 and Figure 3-2 respectively.

Figure 3-1: Standing water site conditions, MP 27.5276

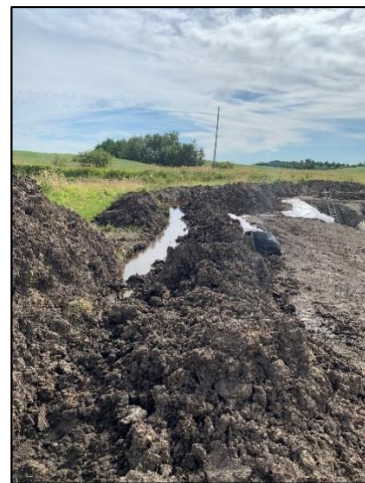
Figure 3-2: Standing water site conditions, MP 29.52

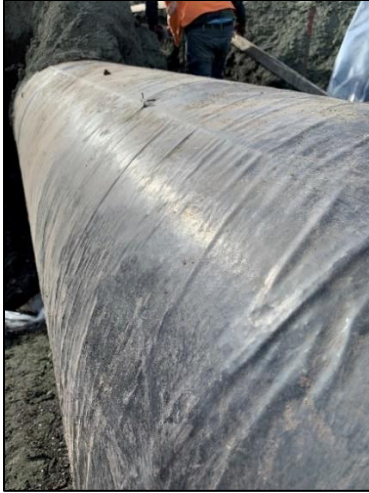
At MP 27.5276, moderate circumferential wrinkling as well as tenting along the long seam were observed along the pipe section as seen in Figure 3-3 and Figure 3-4. Note that the circumferential orientation and generalized nature of the wrinkling is atypical for PE tape wrap, the cause of which is likely related to the application of the coating. Overall, the condition of the PE tape was fair considering the vintage of the line, as no major indications of damage were observed.

Figure 3-3: Minor tenting along pipe seam, MP 27.5276.

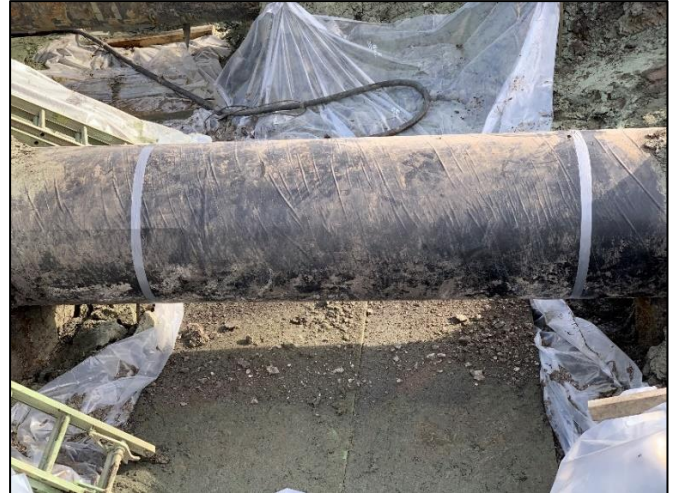
Figure 3-4: General circumferential wrinkling of coating, MP 27.5276.

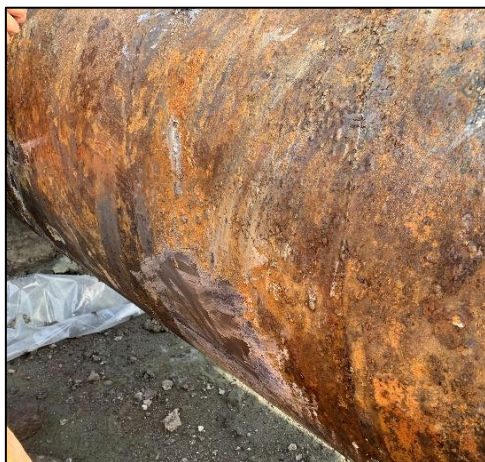
The coating was easily removable with little adhesive remaining, which may be an indicator of additional disbondment not observed initially on the exterior of the tape wrap. Moisture was trapped on the underside of the pipe, including a mud-like substance as seen in Figure 3-5 and Figure 3-6.

Figure 3-5: Mud trapped beneath coating, MP 27.5276.

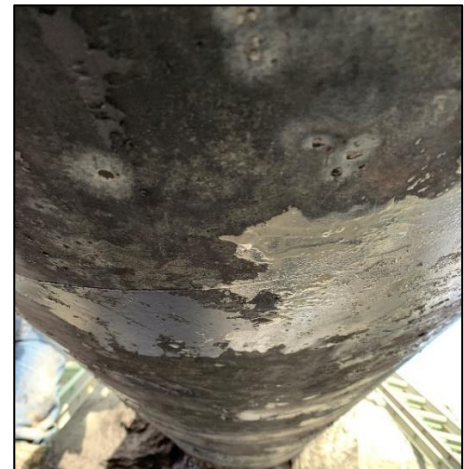
Figure 3-6: Moisture trapped on underside of pipe, MP 27.5276.

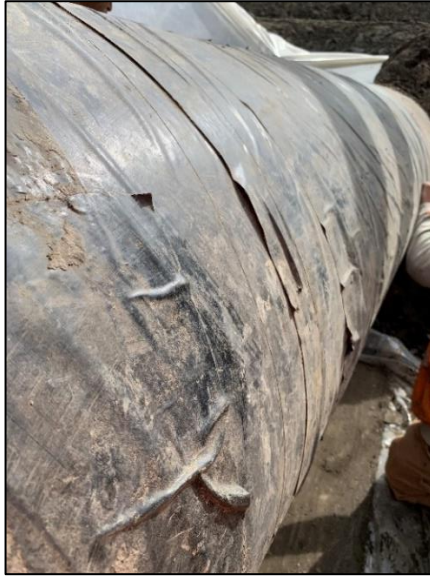
Moderate disbondment and wrinkling was observed at MP 29.52, localized primarily on the sides of the pipe at the 3 o'clock and 9 o'clock positions as seen in Figure 3-7 and Figure 3-8. As stated in Section 3.2, this is typically attributed to the friction and weight of the soil "pulling" the coating down upon backfill of the pipeline.

Figure 3-7: Moderate coating disbondment, MP 29.52

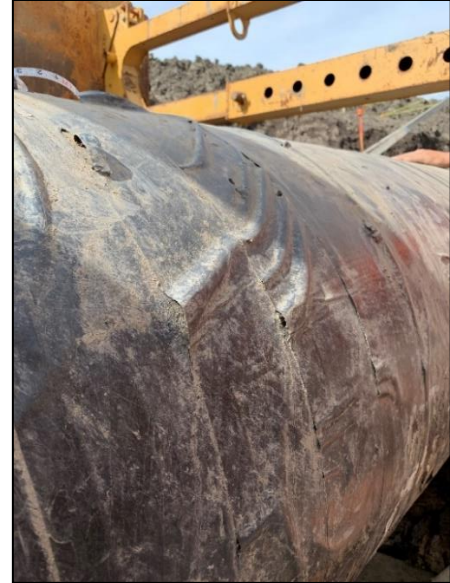
Figure 3-8: wrinkling disbondment at 9 o'clock position, MP 29.52.

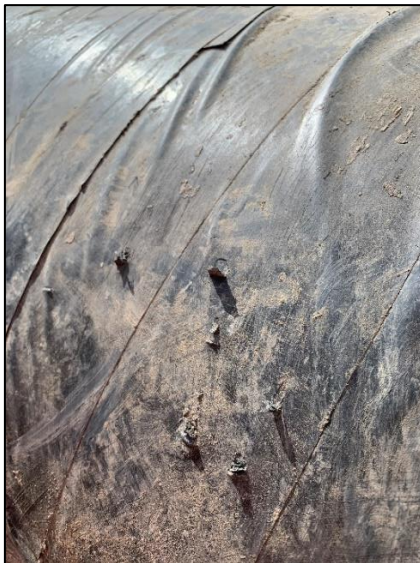
Minor lacerations were observed on the exposed section of pipeline coating, and minor tenting disbondment was noted along the long seam as seen in Figure 3-9 and Figure 3-10 respectively. Much like at MP 27.5276, moisture was trapped along the bottom of the pipe due to water ingress between the pipe steel and coating at disbondment locations.

Figure 3-9: Minor lacerations in coating, MP 29.52

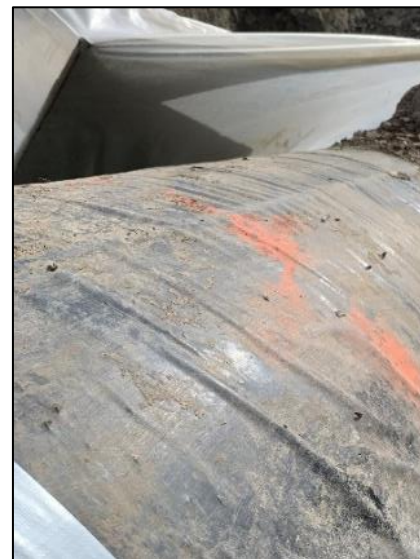
Figure 3-10: Tenting along pipe seam, MP 29.52

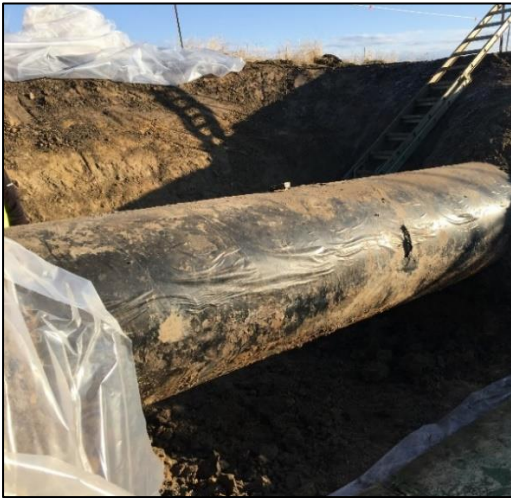
Similar to MP 27.5276 and MP 29.2, the coating at MP 80.4655 was in fair condition, considering its age. However, a gash was observed at the 9 o'clock position (Figure 3-11 and Figure 3-12) and a large disbonded patch was observed at the 1 o'clock position (Figure 3-13 and Figure 3-14), both of which resulted in bare steel being exposed to the soil. Tenting was visible along the longitudinal pipe joint seam (Figure 3-13), and there was significant axial wrinkling observed at the 3 o'clock and 9 o'clock positions (Figure 3-11), typically attributed to the friction and weight of the soil upon backfill. This is commonly observed on PE wrapped pipelines of this vintage. Upon coating removal, no through wall defects were observed, and some moisture was found trapped on the underside of the pipe.

Figure 3-11: Axial wrinkling pattern along the 9 o'clock position, MP 80.4655.

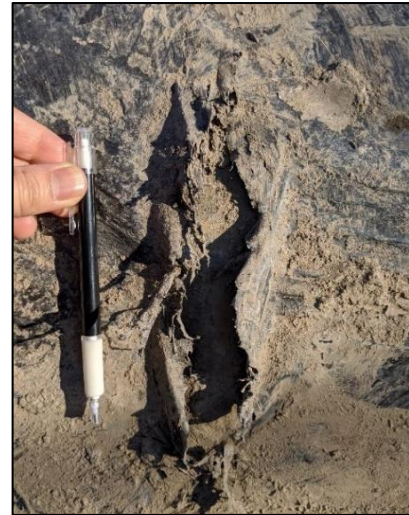
Figure 3-12: Coating damage at 9 o'clock position, MP 80.4655.

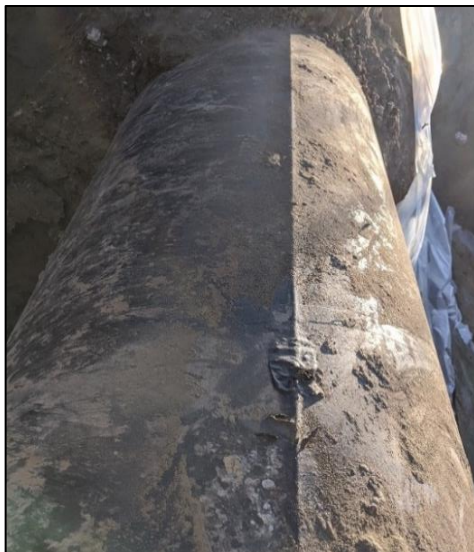
Figure 3-13: Tenting disbondment along pipe seam, MP 80.4655.

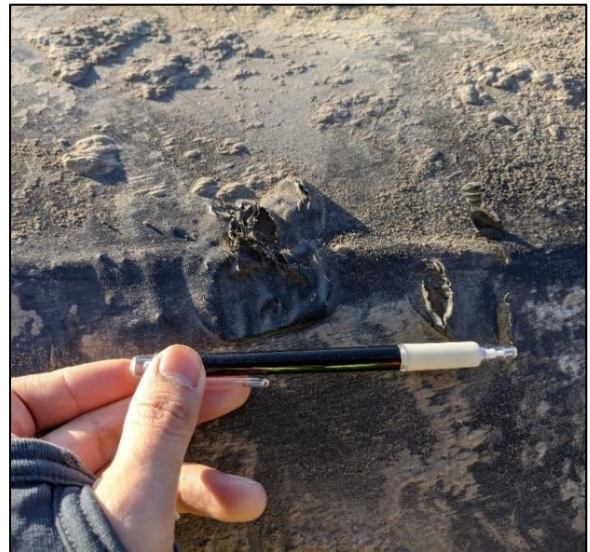
Figure 3-14: Disbonded coating at 1 o'clock position, MP 80.4655.

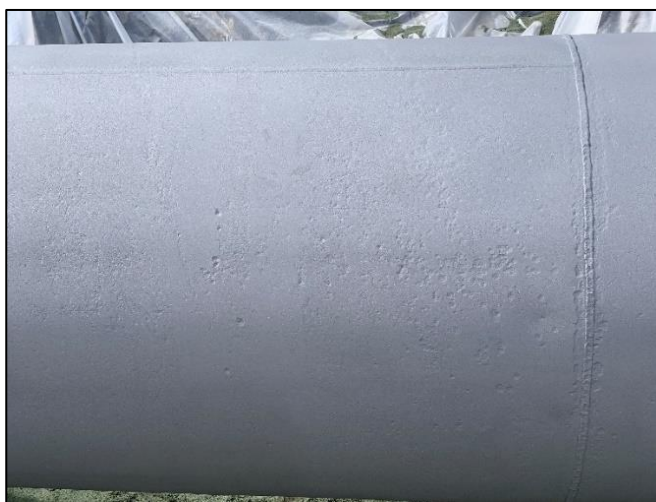
Upon visual inspection of the pipe surface, pitting corrosion was observed along the sides of the pipeline near the 3 o'clock and 9 o'clock positions (see Figure 3-14), however was not limited to those locations. The most severe corrosion was found to be along the exposed girth weld as seen in Figure 3-15, matching the location of the mud-like substance uncovered beneath the coating.

Figure 3-14: Clustered pitting corrosion and wall loss along girth weld, MP 27.5276

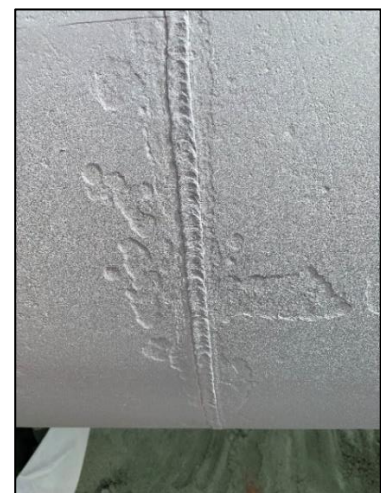
Figure 3-15: Wall loss near girth weld at 9 o'clock position, MP 27.5276

A total of 84 features were identified for MP 27.5276. From Table 3.3, it can be seen that the greatest maximum pit depth was found to be 2.32 mm (CLS13) near the girth weld, corresponding to 69.1% RWT. The types of features observed at MP 27.5276 ranged from clustered features with larger areas of wall loss, and 'pinole' features with higher depth-to-surface area ratios. The concentration of features of high surface area along the girth weld may be an indication of corrosion by a mechanism other than pitting alone, such as microbiologically-influenced corrosion (MIC). Figure 3-16 shows clusters of features along the girth weld, along the sides of the pipeline, and other dispersed locations on the surface.

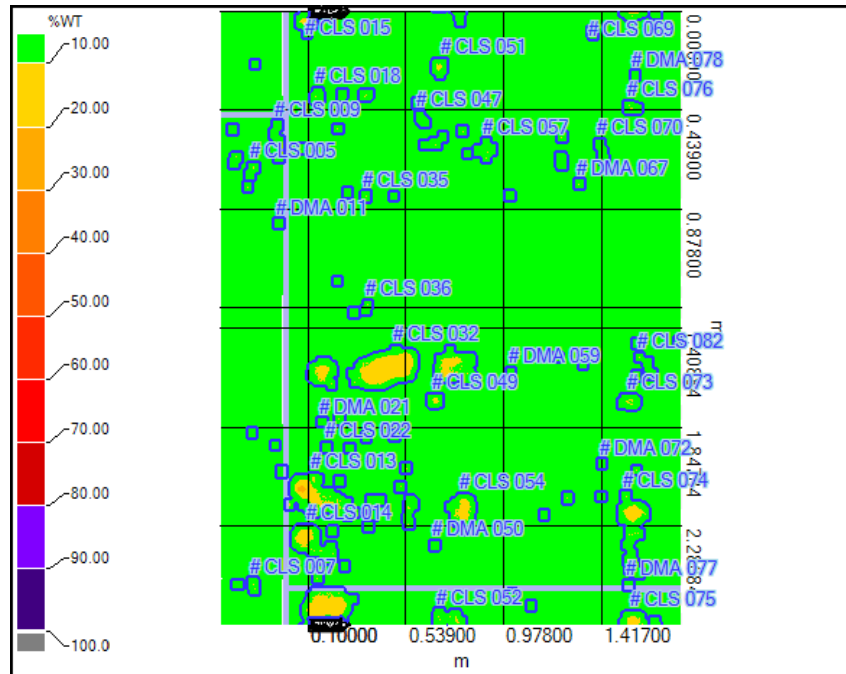
Figure 3-16: Overview of laser scan results, MP 27.5276.

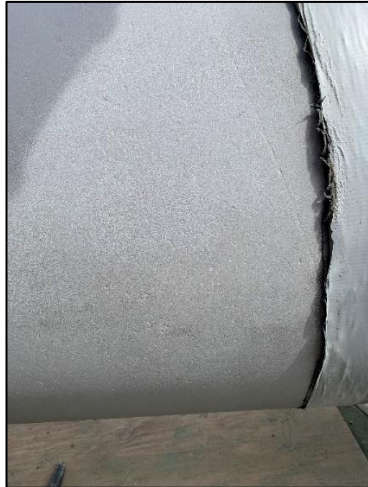
Corrosion was observed visually to a lesser degree at MP 29.52 as compared to MP 27.5276. Some pitting was dispersed along the sides of the pipeline as seen in Figure 3-17, however did not register on the laser scan as the depth at no point exceeded the critical factor threshold of 10% wall loss. Some shallow pitting corrosion was observed near the seam at the 12 o'clock position as seen in Figure 3-18.

Figure 3-17: Pipe surface, 9 o'clock position, MP 29.52.

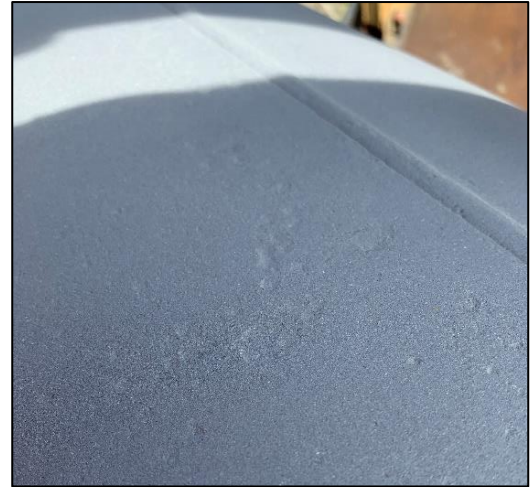
Figure 3-18: Corrosion features at 12 o'clock position, MP 29.52

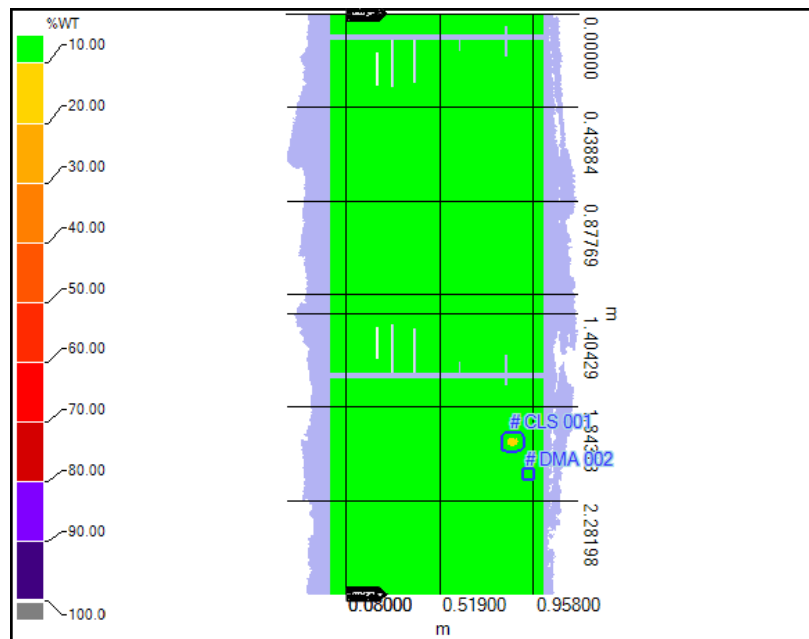
Negligible corrosion was observed along the bottom of the pipeline, despite water entrapment beneath coating on the underside of the pipe. Two features were measured near the seam at the 12 o'clock position in Figure 3-19. Negligible general wall loss was observed visually, and the nominal wall thickness was measured as 8.0 mm.

Figure 3-19: Overview of laser scan results, MP 29.52.

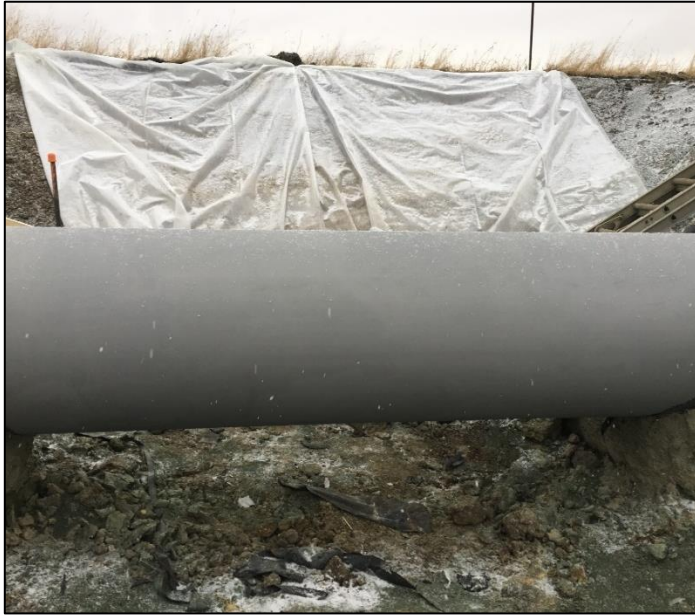
After sandblasting, little evidence of corrosion was detected visually. A minor grouping of pits were noted along the 9 o'clock position, corresponding with the coating disbondment location.

Figure 3-20: Pipe surface at 9 o'clock position, MP 80.4655.

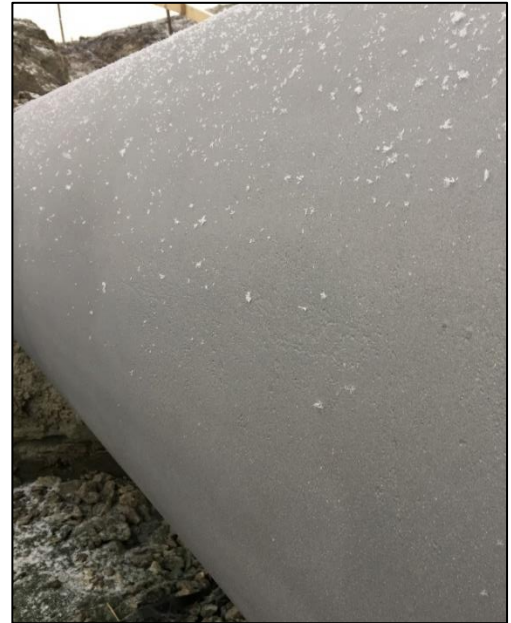
Figure 3-21: Minor pitting at 9 o'clock position, MP 80.4655.

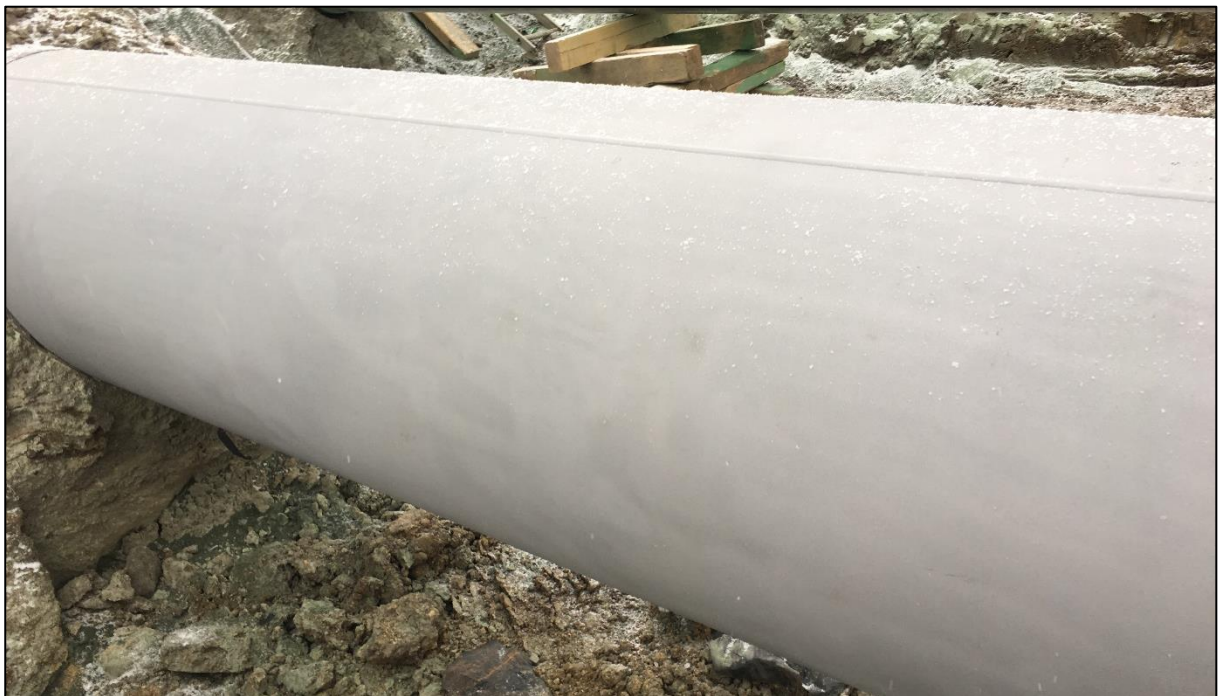
Figure 3-22: Pipe Surface at 3 O'clock Position

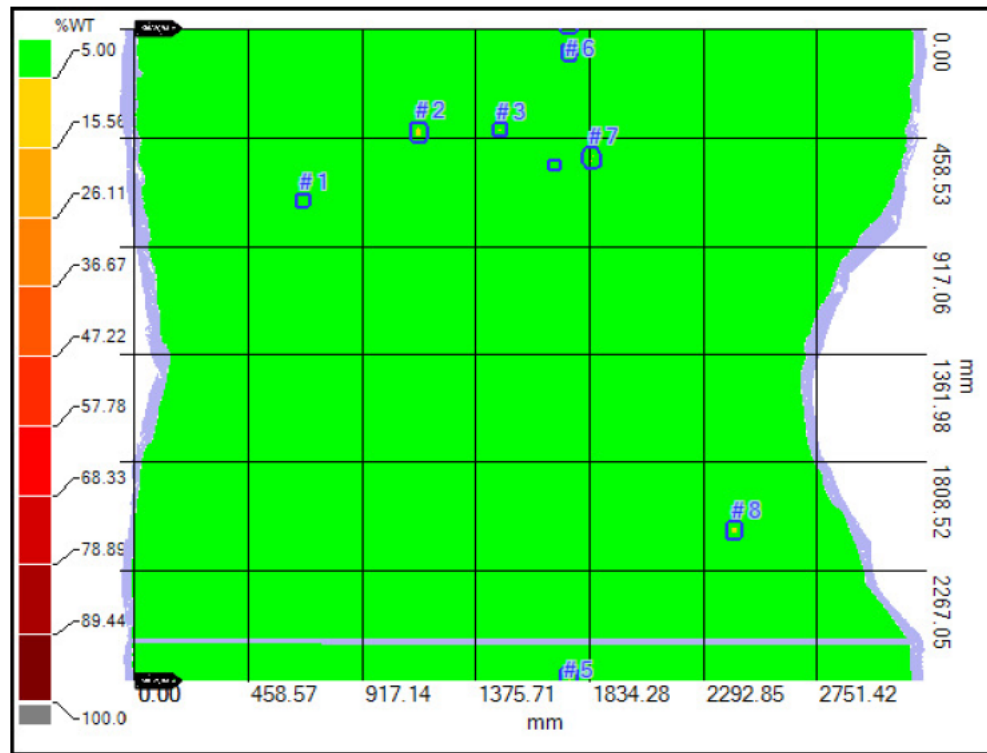
The nominal wall thickness was measured to be 7.4mm. A total of 8 features were identified for MP 80.4655. From Table 3.3, the greatest maximum pit depth was found to be 0.61 mm (Feature #5), corresponding to 91.7% RWT. Figure 3-23 confirmed the cluster of minor pitting along the 9 o'clock position.

Figure 3-23: Overview of laser scan results, MP 80.4655.
