# Review of Previous Pipeline Abandonment Program – TransCanada Peace River Mainline

Pipeline  
Abandonment  
Research Steering  
Committee

February 2018

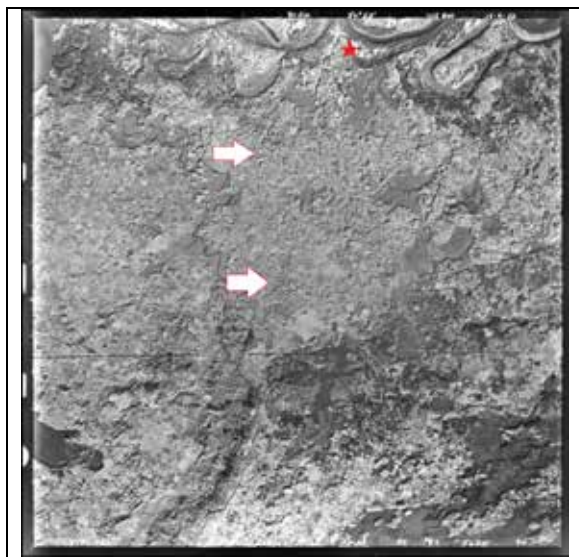
Plate C-1. White arrows show approximate beginning/end point locations on Segment 1 prior to pipeline construction at SE 19 and SE 18-91-1 W6M (September 1952). Red star provides landscape reference point.

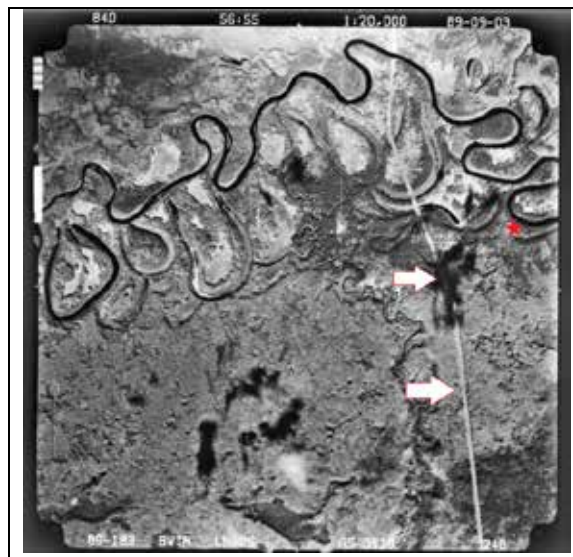
Plate C-2. White arrows show approximate beginning/end point locations on Segment 1 after abandonment at SE 19 and SE 18-91-1 W6M; forest type and hydrology are similar (September 1989). Red star provides landscape reference point.

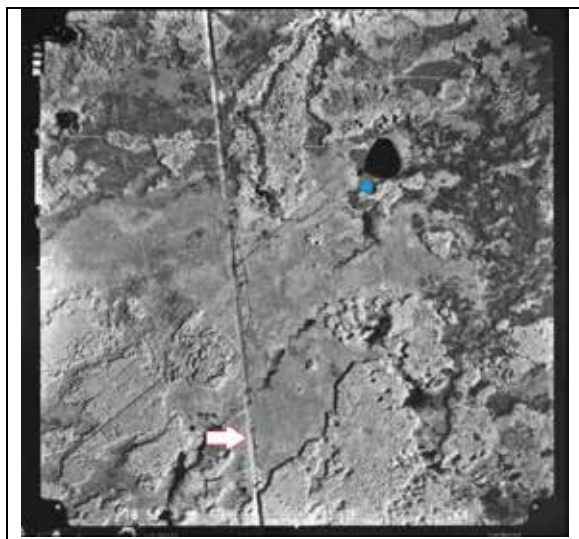
Plate C-3. White arrow shows the approximate screw anchor weight location on Segment 2 at SW 17-90-1 W6M, immediately following pipeline abandonment (June 1978). Blue star provides landscape reference point.

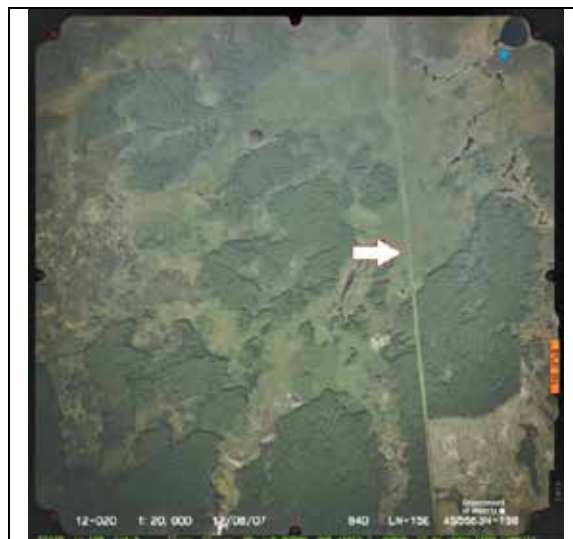
Plate C-4. White arrow shows the approximate screw anchor weight location on Segment 2 at SW 17-90-1 W6M, decades following pipeline abandonment; hydrology is similar in this location (August 2012). Blue star provides landscape reference point.

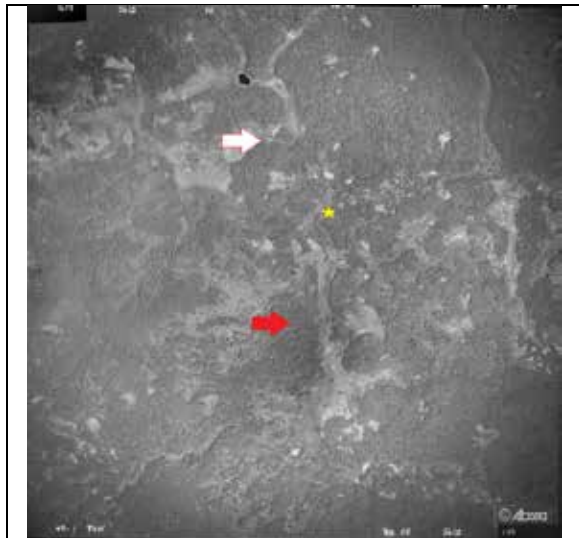
*Plate C-5. White arrow shows the approximate screw anchor weight location on Segment 3 at NE 29-89-1 W6M, and yellow arrow shows the approximate beginning/end point at NW 16-89-1 W6M, prepipeline construction (September 1950). Yellow star provides landscape reference point.*

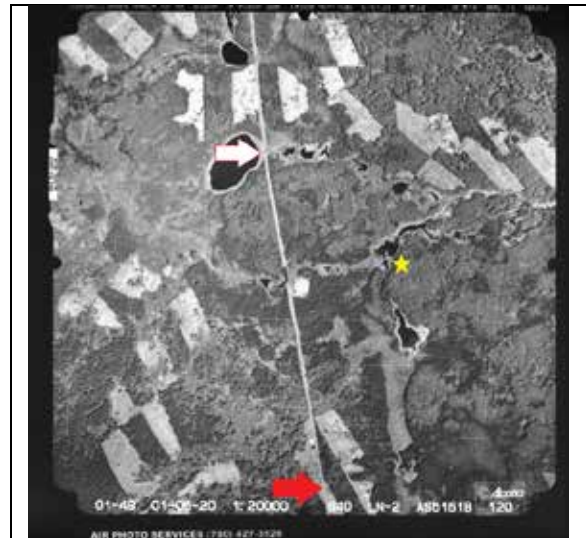
*Plate C-6. A white arrow shows the approximate screw anchor weight location on Segment 3 at NE 29-89-1 W6M, and red arrow shows the approximate beginning/end point at NW 16-89-1 W6M; hydrology is similar before and after pipeline abandonment; forest is cleared in the approximate area of beginning/end point in 2001 (June 2001). Yellow star provides landscape reference point.*

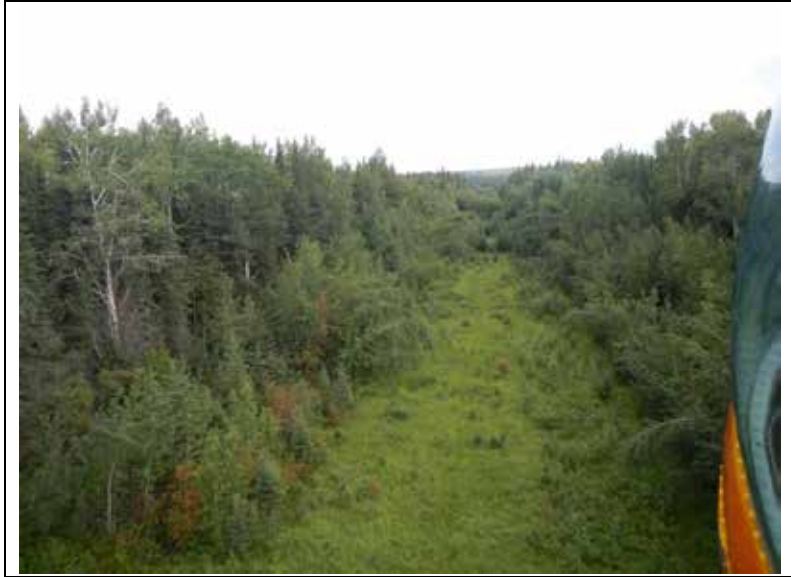
*Plate D-1. View south along the abandoned pipeline Segment 1 showing the well-vegetated right-of-way (ROW) near the end point of the segment at SE 18-91-1 W6M (Unique ID 1-1).*

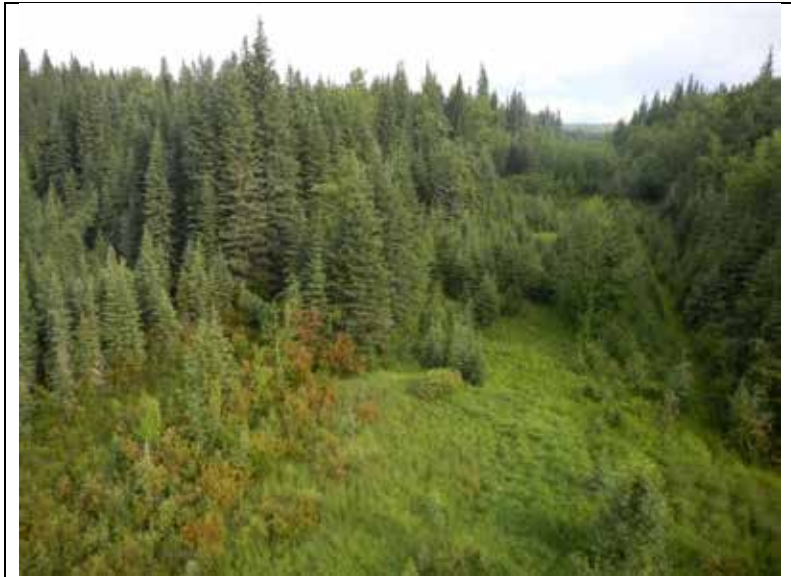
*Plate D-2. View south along the abandoned pipeline Segment 1 showing the well-vegetated ROW near the start point of the segment at SE 19-91-1 W6M (Unique ID 1-1).*

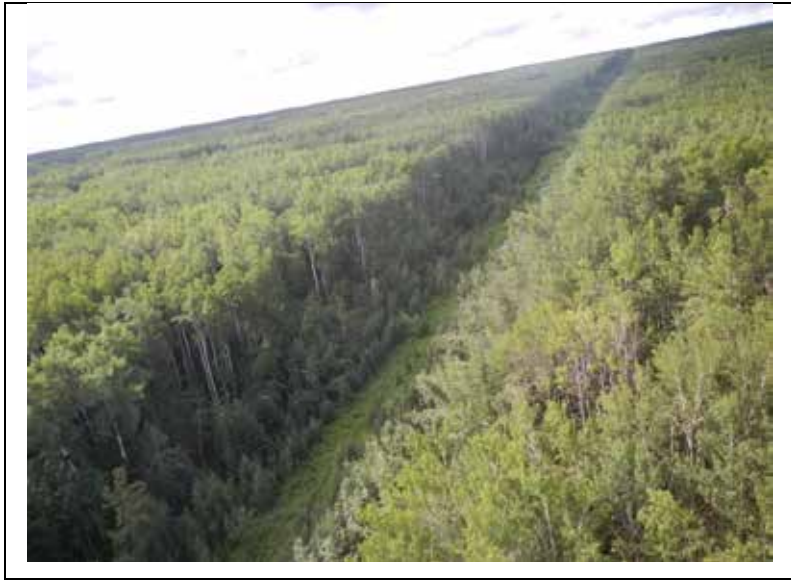
There was no evidence of subsidence, which may indicate water conduit effect, corrosion, or pipeline collapse observed along the abandoned pipeline sections. Unnatural ponded water or sunken areas along the abandoned pipeline segments were not apparent during the field survey. Plates D-2 and D-11 in Appendix D show appropriate vegetation cover of native vegetation (such as, trembling aspen and white spruce) along the abandoned pipeline segments. No concerns were noted at 18-91-1 W6M (Unique ID 1-2) in relation to the heavy-wall carrier pipe.

*Plate D-3. View south at the approximate heavy-wall carry site along the abandoned pipeline Segment 1 at NW 18-91-1 W6M (Unique ID 1-2).*

Heavy-wall pipe (Unique ID 1-2)	18-91-1 W6M (430379E 6306148N)	<ul style="list-style-type: none"> <li>Excavate and assess the condition of the heavy-wall pipe and compare it to the condition of nonheavy-wall pipe.</li> </ul>
Access road (Unique ID 3-4)	SW 21-89-1 W6M (432364E 6287593N)	<ul style="list-style-type: none"> <li>Excavate abandoned pipe under a small portion of the road and assess it for evidence of corrosion, to determine if access over the abandoned pipe has caused it to deaerate and become anodic, as described in DNV's Understanding the Mechanisms of Corrosion and their Effects on Abandoned Pipelines (2015).</li> </ul>
Watercourse crossings (Unique IDs 2-5 and 2-6)	NE 31-90-1 W6M (430801E 6302058N) SW 17-90-1 W6M (431330E 6296436N)	<ul style="list-style-type: none"> <li>Excavate the pipe outside of the riparian area of the watercourse and assess it for through-wall corrosion.</li> <li>If through-wall corrosion is noted on the pipeline, assess the surrounding area for evidence of preferential flow of water through the pipe.</li> <li>Assess the area surrounding the pipe for evidence of erosion or preferential flow of water along the outside of the pipe.</li> </ul>

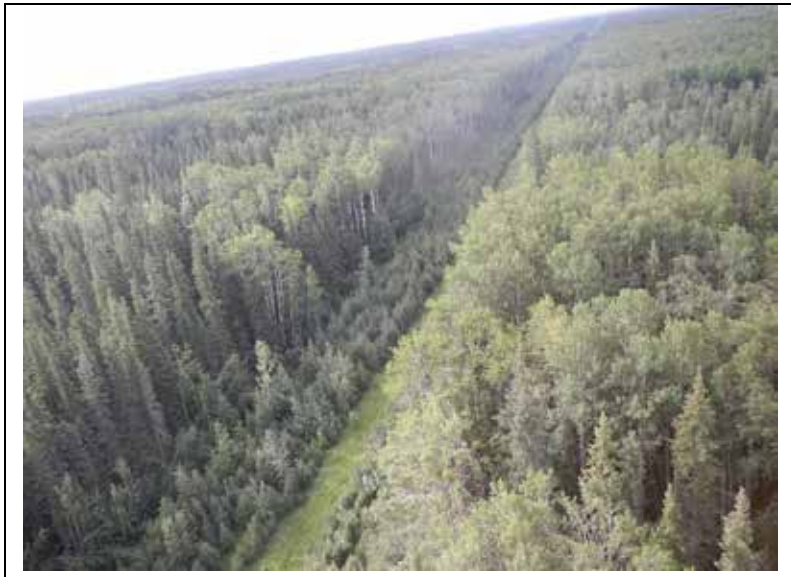
*Plate D-4. View south along the abandoned pipeline Segment 1 showing upland forest at SW 18-91-1 W6M (Unique ID 1-2).*

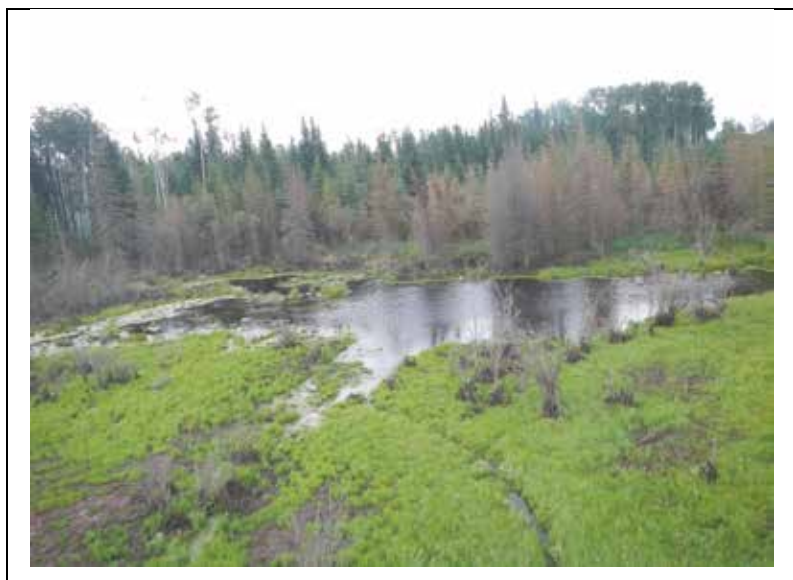
*Plate D-5. View west across the abandoned pipeline Segment 2 showing beaver impoundment at SE 6-91-1 W6M, near the start point (Unique ID 2-1).*

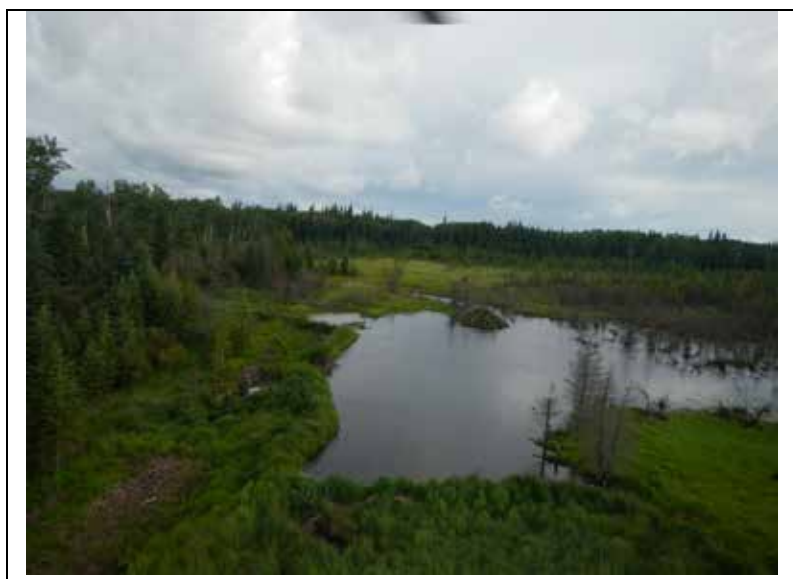
*Plate D-6. View south along the abandoned pipeline Segment 2 showing beaver activity and an area with a screw anchor; no issues with pipe buoyancy at SE 6-91-1 W6M (Unique ID 2-2).*

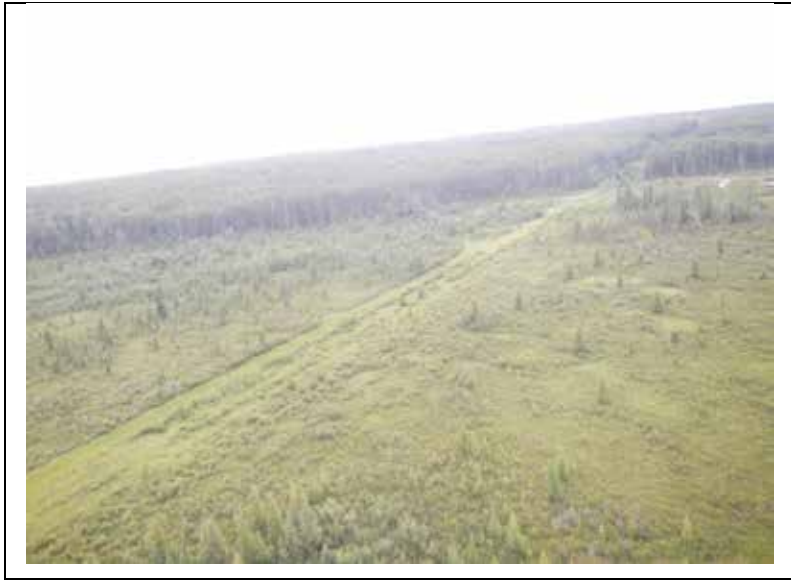
There was no evidence of pipeline exposure at the surface along the abandoned pipeline segments. Approximate screw anchor locations, typically within wetland complexes at SE 6-91-1 W6M (Unique ID 2-2), SW 17-90-1 W6M (Unique ID 2-3), NE 29-89-1 W6M (Unique ID 3-2), and SW 21-89-1 W6M (Unique ID 3-3), were observed as well-vegetated with appropriate hydrology (such as, open water or floating vegetation mats within wetlands). Based on these observations, it is anticipated that subsurface testing would demonstrate that the screw anchors are providing appropriate pipeline weighting at these locations (Plates D-7 and D-14, Appendix D).

*Plate D-7. View south along the abandoned pipeline Segment 2 showing an area with a screw anchor and no issues with pipe buoyancy at SW 17-90-1 W6M (Unique ID 2-3).*

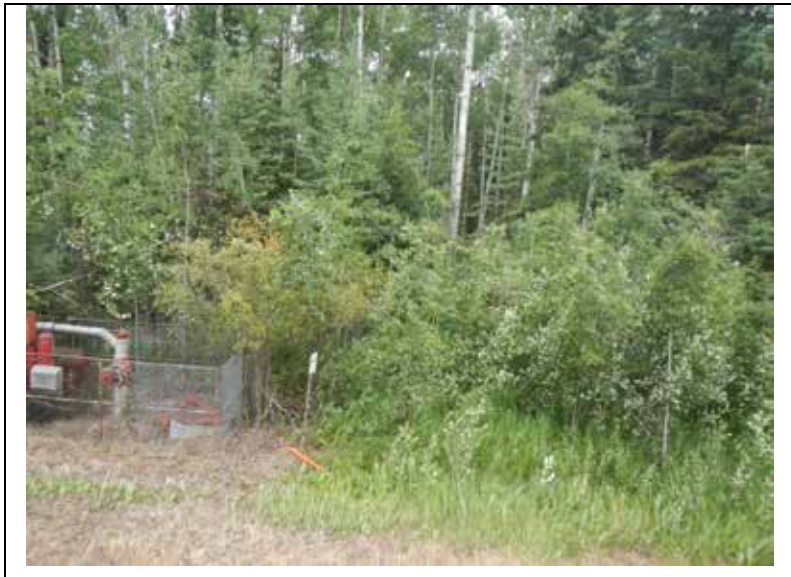
There were no obvious signs that would indicate soil or water contamination along the abandoned pipeline segments, such as a change in vegetation colour or a visible sheen on water or soil, including at the valve assembly at NW 8-90-1 W6M (Unique ID 2-4) (Plate D-8, Appendix D).

*Plate D-8. View west at the valve site showing healthy, woody vegetation growing on the abandoned pipeline Segment 2 ROW at NW 8-90-1 W6M (Unique ID 2-4).*

Site Description	Legal Location (Approximate UTM 11U)	Additional Testing
Valve assembly (Unique ID 2-4)	NW 8-90-1 W6M (431383E 6295615N)	<ul style="list-style-type: none"> <li>Collect soils samples from the area immediately adjacent to the valve assembly and submit for contamination screening (for example, hydrocarbons and benzene, toluene, ethylbenzene, and xylenes).</li> <li>If the valve is associated with the segment of pipe being assessed as part of the Project, then assess it to determine if it has been deactivated/disabled in the closed position and if it is acting as a means of segmenting the pipe. A definitive determination of the state of this valve (that is, is the valve functioning or permanently disabled) was not possible since the site is fenced.</li> </ul>
Screw anchors (Unique IDs 2-2, 2-3, 3-2, and 3-3)	SE 6-91-1 W6M (430767E 6302378N) SW 17-90-1 W6M (431346E 6296251N) NE 29-89-1 W6M (431900E 6290383N) SW 21-89-1 W6M (432335E 6287822N)	<ul style="list-style-type: none"> <li>Excavate select screw anchor sites and assess whether the screw anchors are still in place on the pipeline.</li> <li>Assess the condition of the pipeline and the pipeline coating (if the pipeline is coated).</li> <li>If through-wall corrosion is noted on the pipeline, assess the surrounding area for evidence of preferential flow of water through the pipe (that is, evidence of the formation of water conduits).</li> <li>Assess the area surrounding the pipe for evidence of erosion or preferential flow of water along the outside of the pipe (that is, erosion).</li> </ul>

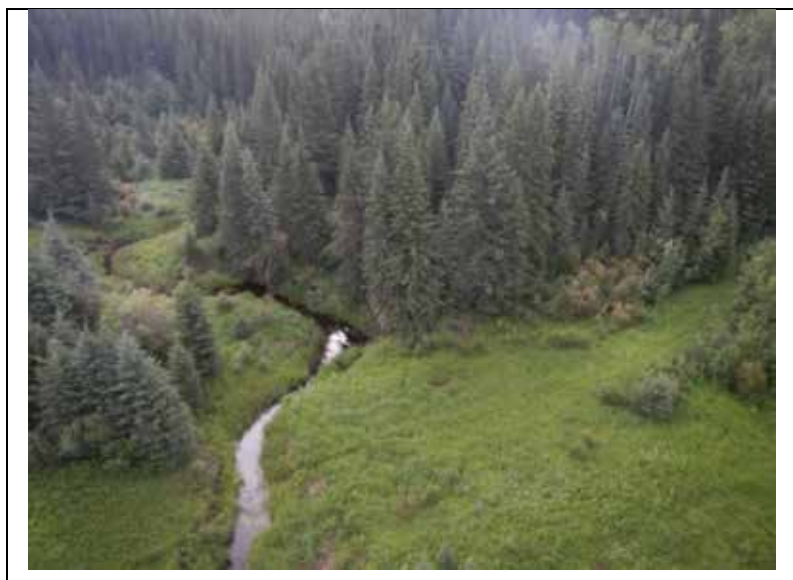
*Plate D-9. View west across the abandoned pipeline Segment 2 showing a watercourse crossing at NE 31-90-1 W6M (Unique ID 2-5).*

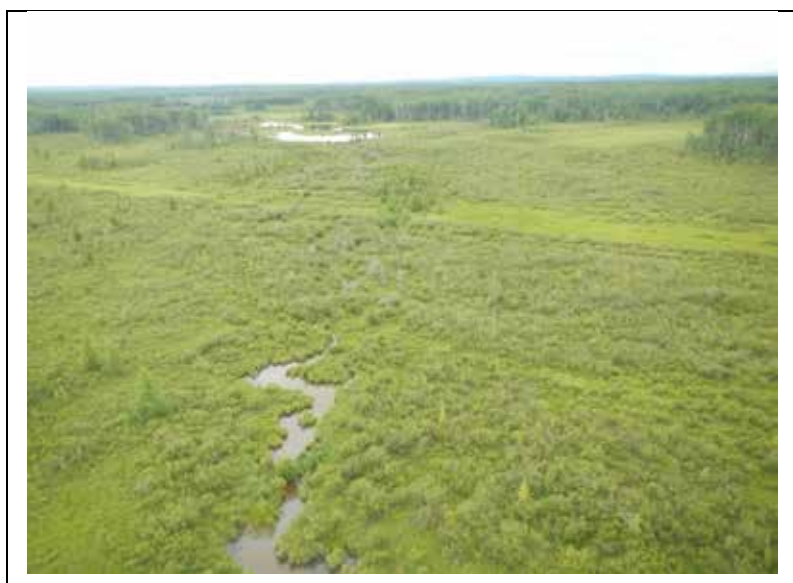
No signs of soil erosion or preferential weathering were observed during the field survey, and the riparian areas and wetland habitat surrounding watercourses were well-vegetated with native vegetation. No evidence of the above-mentioned issues were observed at watercourse crossings at NE 31-90-1 W6M (Unique ID 2-5) and SW 17-90-1 W6M (Unique ID 2-6). The watercourse at NE 31-91-1 W6M is surrounded by upland habitat (Plate D-9, Appendix D). The watercourse at SW 17-90-1 W6M is associated with wetland habitat (Plate D-10, Appendix D).

*Plate D-10. View east across the abandoned pipeline Segment 2 showing a watercourse crossing at SW 17-90-1 W6M (Unique ID 2-6).*

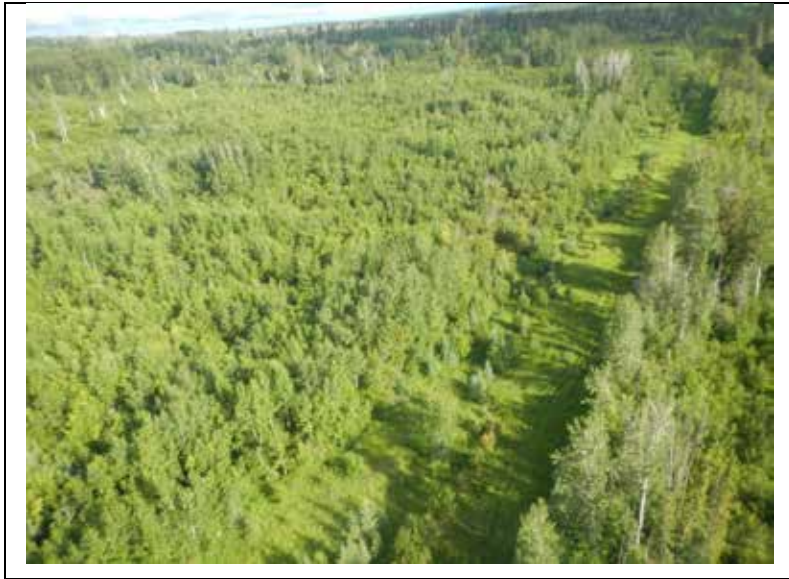
*Plate D-11. View north along the abandoned pipeline Segment 3 showing the well-vegetated ROW near the end point of the segment at NW 16-89-1 W6M (Unique ID 3-1).*

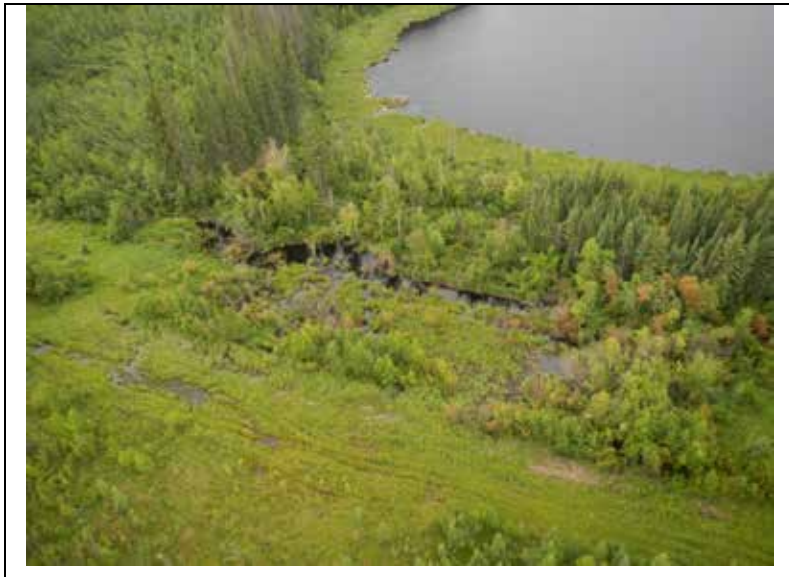
*Plate D-12. View west across the abandoned pipeline Segment 3 showing a beaver impoundment at NE 29-89-1 W6M (Unique ID 3-1).*

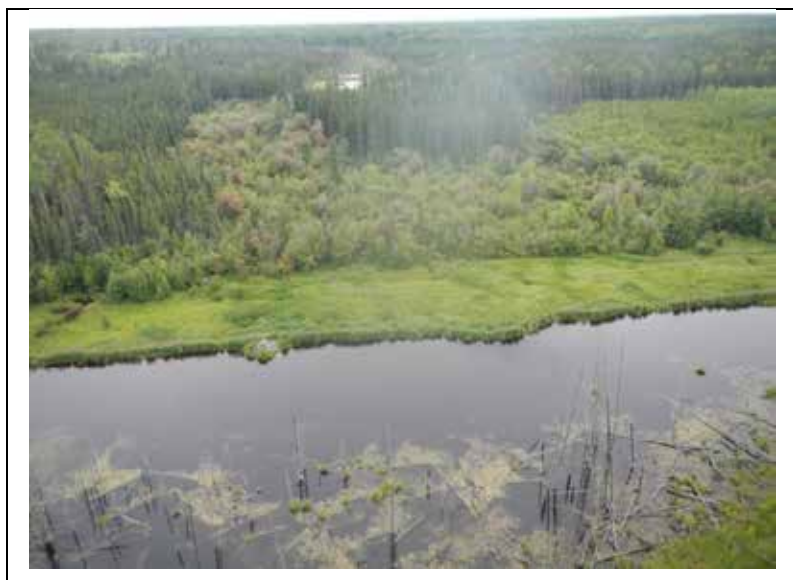
Beaver dams were observed to have altered the hydrology in numerous locations along the abandoned pipeline segments, the PRML ROW, and the surrounding area (Plate D -13, Appendix D). Active beaver dams were noted on and off the pipeline rights-of-way; however, the beavers did not appear to be preferentially attracted to the specific abandoned pipeline segments when compared to the adjacent pipeline ROW.

*Plate D-13. View east across the abandoned pipeline Segment 3 showing a beaver-altered wetland with healthy, emergent vegetation at SE 29-89-1 W6M (Unique ID 3-1).*

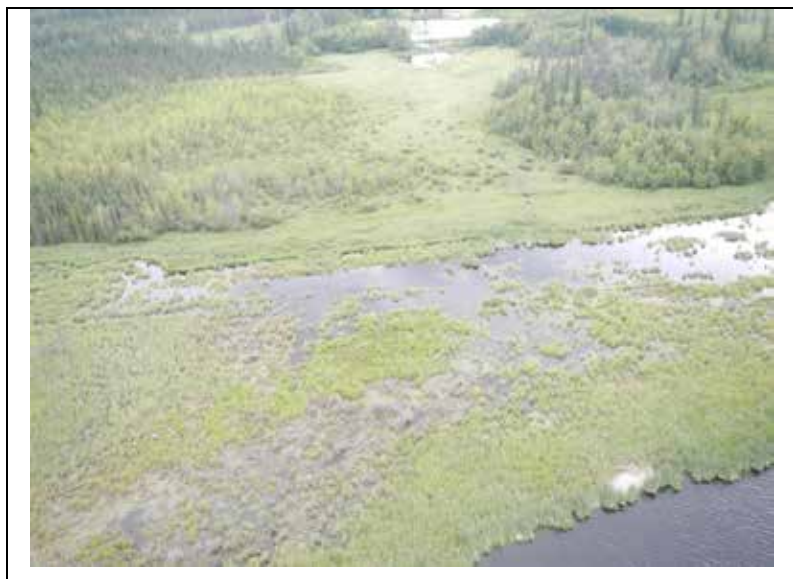
*Plate D-14. View east across the abandoned pipeline Segment 3 showing beaver dams and an area with a screw anchor; no issues with pipe buoyancy at NE 29-89-1 W6M (Unique ID 3-2).*

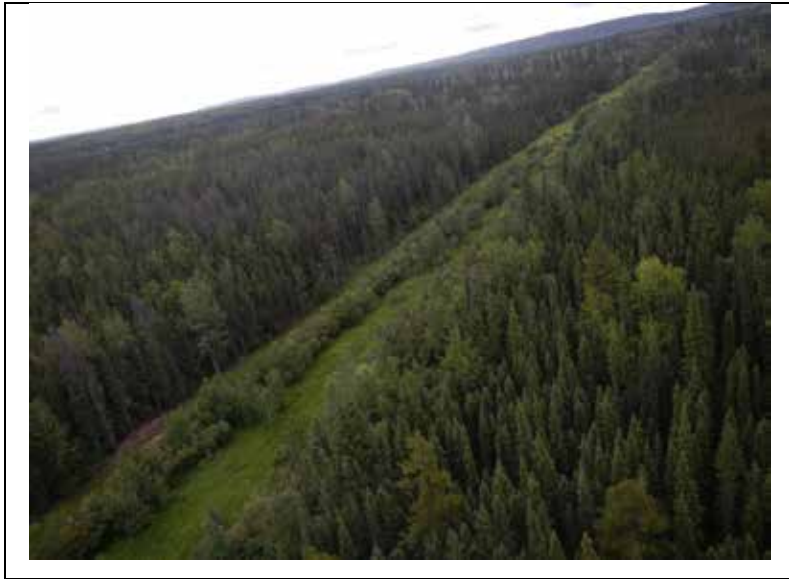
*Plate D-15. View west across the abandoned pipeline Segment 3 showing Peace River Mainline, the abandoned pipeline segment rights-of-way, and the approximate screw anchor location to the south at SW 21-89-1 W6M (Unique ID 3-3).*

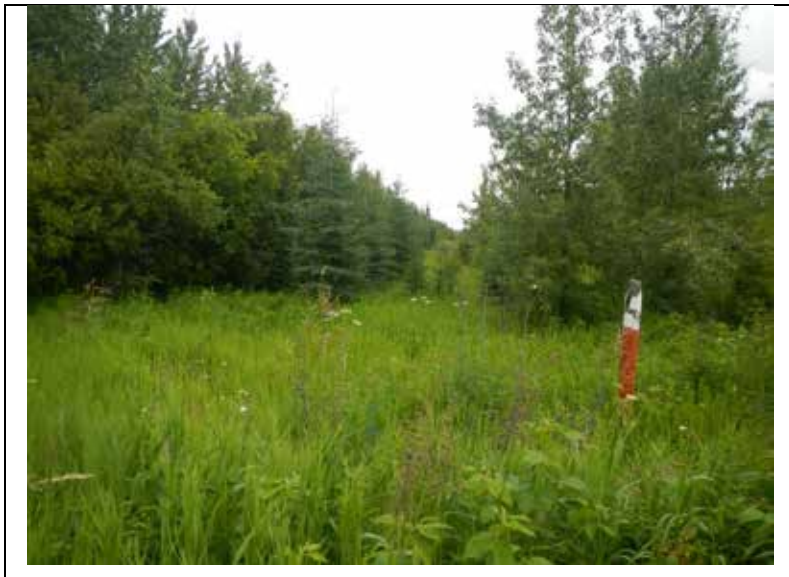
No special concerns were observed at the access road and bell hole location at SW 21-89-1 W6M (Unique ID 3-4). The area surrounding the access road was well-vegetated with appropriate woody vegetation and a graminoid understory. No impounded water was observed along the road crossing (Plate D-16, Appendix D). There are no county regulated or maintained road crossings along any of the abandoned segments, and as such, there are no available records of additional maintenance related to subsidence at road crossings.

*Plate D-16. View west at a road crossing showing vegetation growth at the abandoned pipeline Segment 3 at SW 21-89-1 W4M (Unique ID 3-4).*
