# PARSC 016

## Peace River Mainline Abandoned Pipeline Segment Field Study

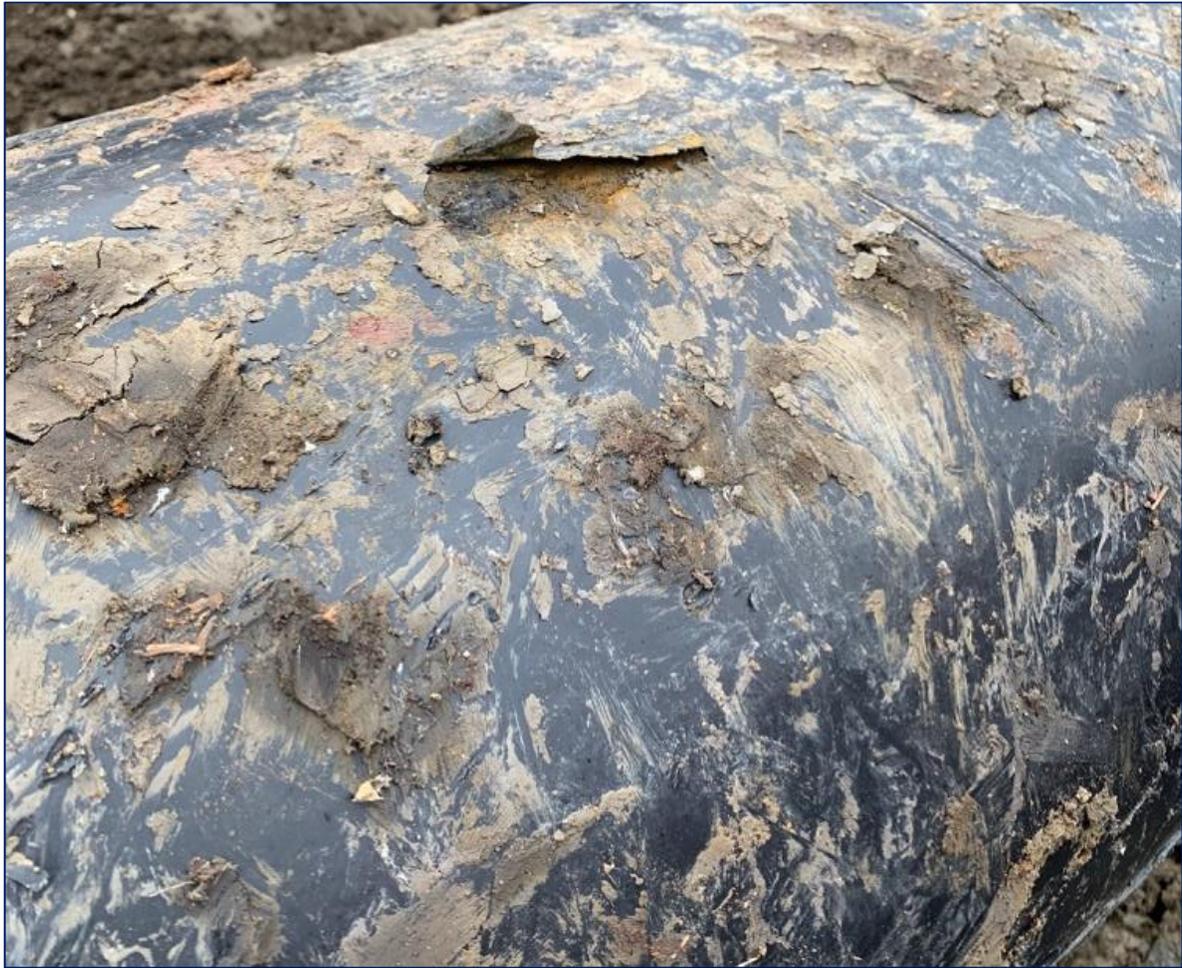
*Figure 3-1: Coating Damage on Abandoned PRML*

The PE coating was in very good condition, considering its age. There were no visual indications that the coating had experienced any significant degradation since abandonment. Minimal coating disbondment was observed, and the only damage appeared to be a small area at the 12 o'clock position, along the pipe seam. The coating appeared to be peeling away, exposing the bare steel, as shown in Figure 3-1.

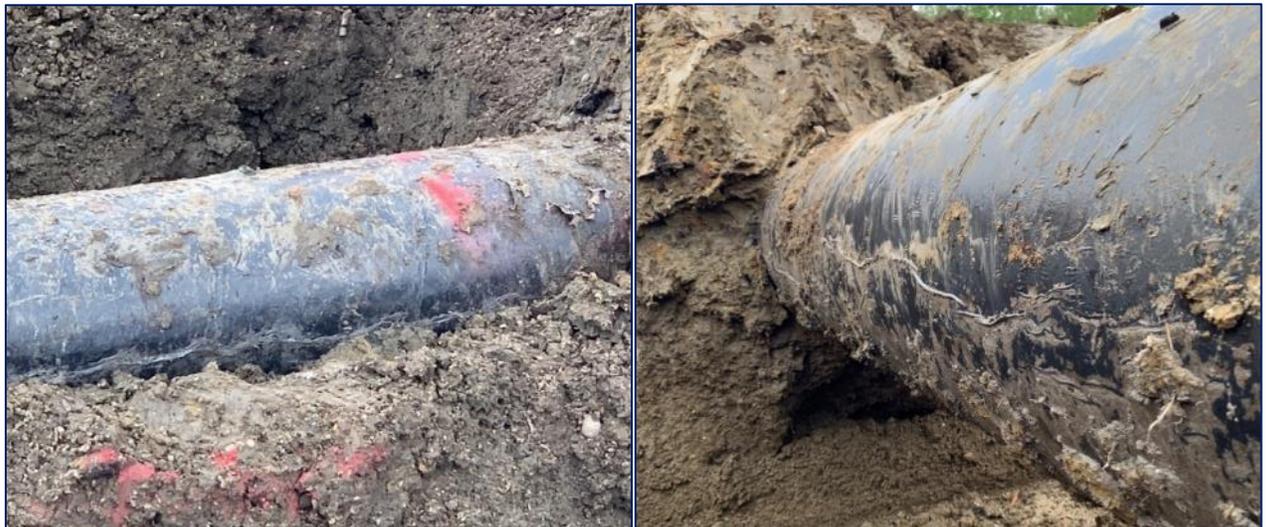
*Figure 3-2: Coating ‘Wrinkling’ Disbondment on Abandoned PRML*

Additionally, coating ‘wrinkling’ disbondment was noted at the 3 and 9 o’clock positions, as shown in Figure 3-2, which is consistent with PE coated pipelines of this vintage. This is typically attributed to the weight and friction of the soil load after backfill.

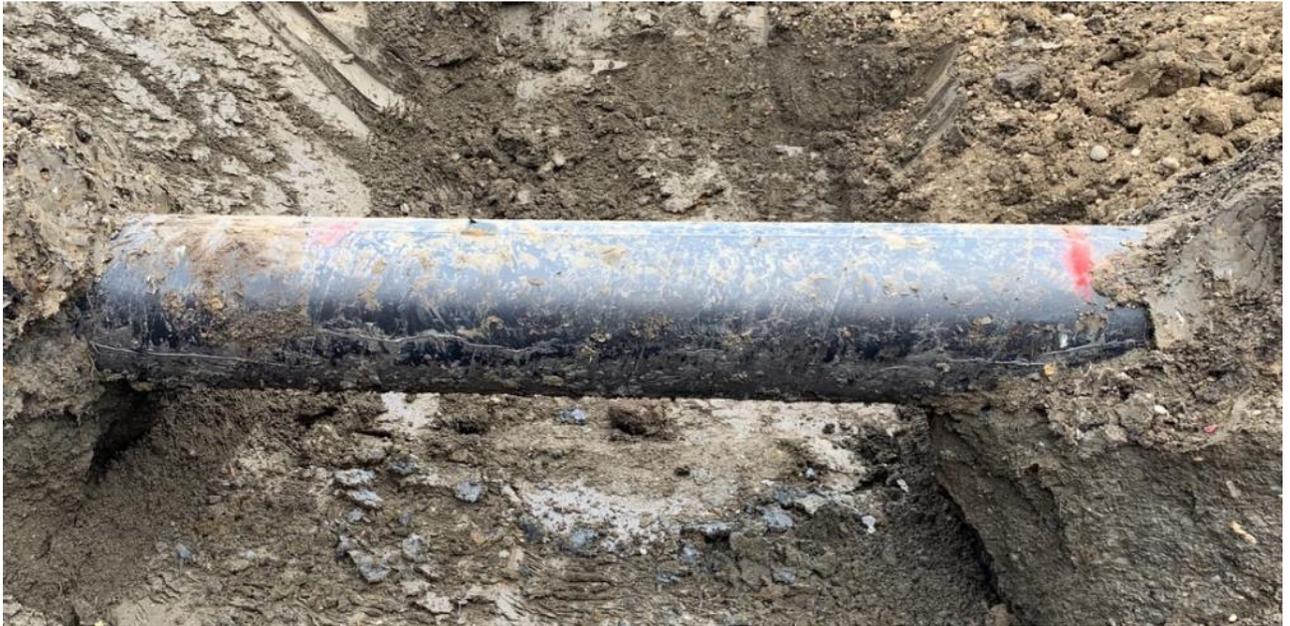
*Figure 3-3: Fully Excavated PRML Segment*

Prior to sandblasting, a visual inspection showed no indication of through-wall defects within the 2 m exposed section, as shown in Figure 3-3.

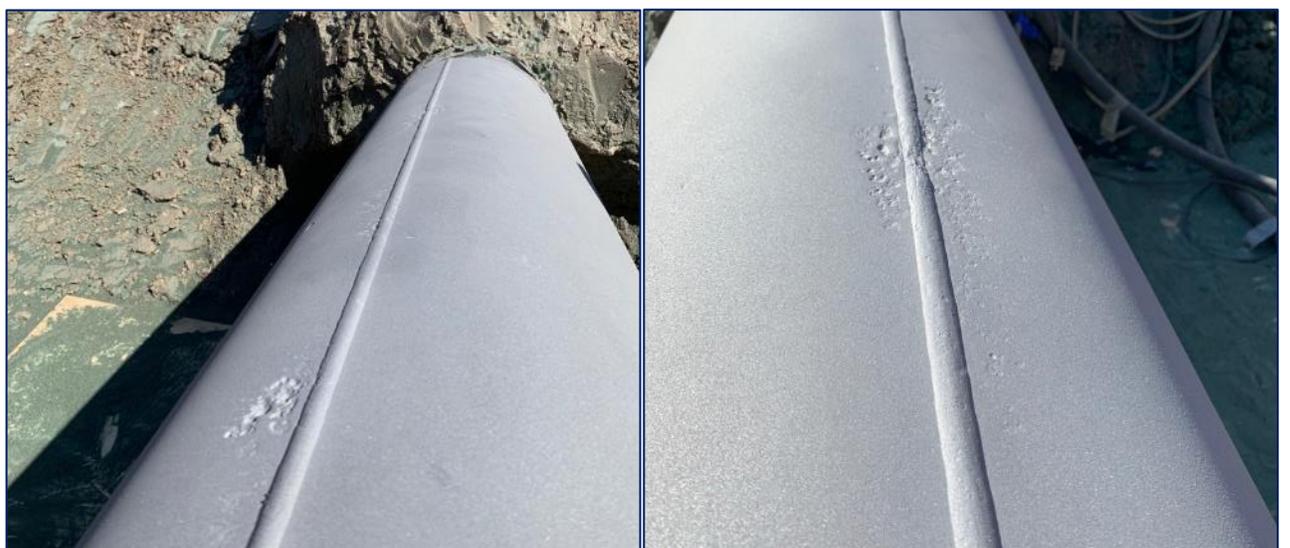
*Figure 3-4: Pitting Corrosion Along Pipeline Seam*

After sandblasting, the most severe corrosion areas were found to be consistent with the coating disbondment locations. Pitting corrosion was found primarily along the pipe seam and at the 3 and 9 o'clock positions, where the coating had disbonded from the pipe surface. Minimal corrosion was observed over where the coating remained intact and well-adhered.

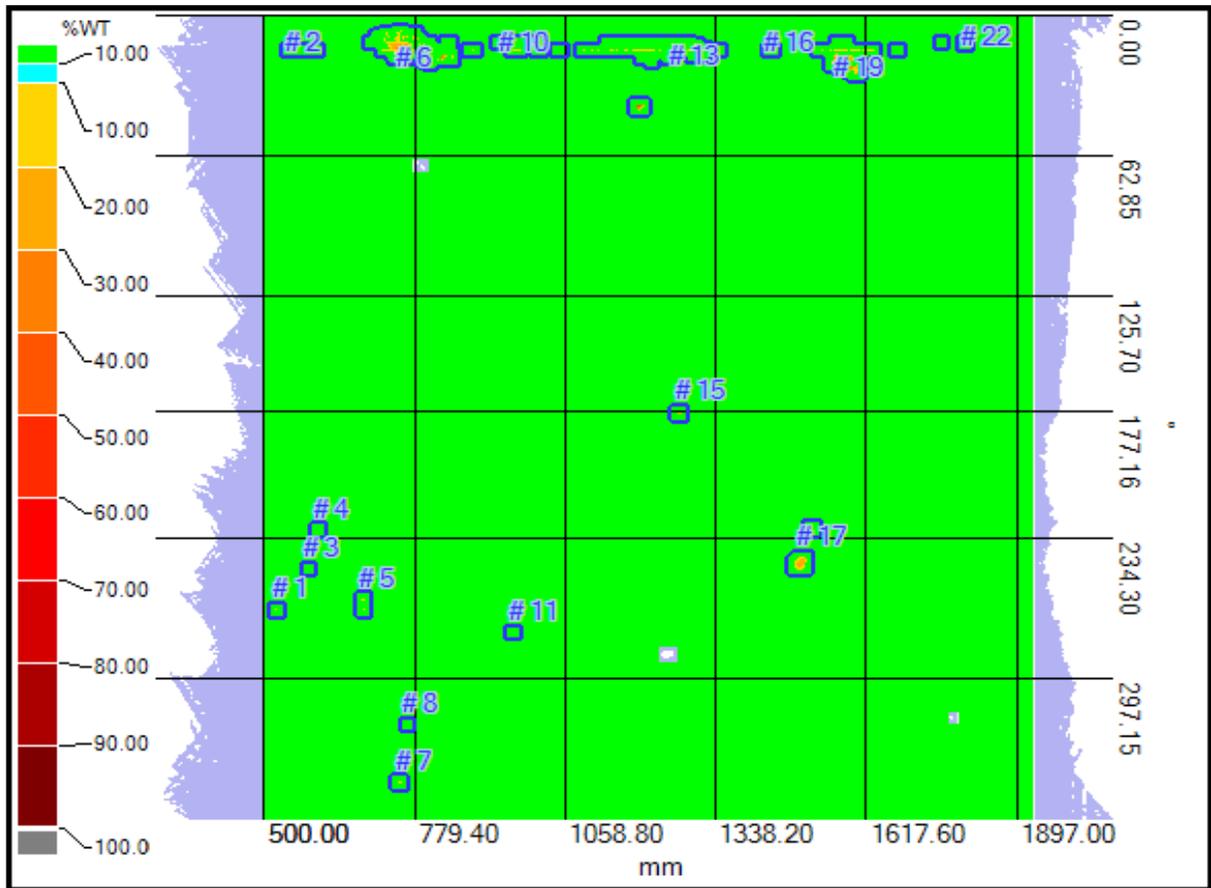
Figure 3-6: Overview of Laser Scan Features

Wall thickness measurements were taken to confirm the nominal wall thickness of the pipeline segment with the records available. From the laser scan data, it was determined that the majority of the pipe wall is still in within the typical mill specification wall thickness tolerances, indicating that negligible uniform wall loss had occurred to the abandoned PRML. An overview of the laser scan features is shown in Figure 3-6.

A total of 22 features were identified, clustering around the 12 and 9 o'clock positions. The maximum depths of the pitting ranged from 0.73 mm (Feature #12) to 4.46 mm (Feature #19), corresponding to remaining wall thicknesses of 89.9% and 37.5%, respectively.

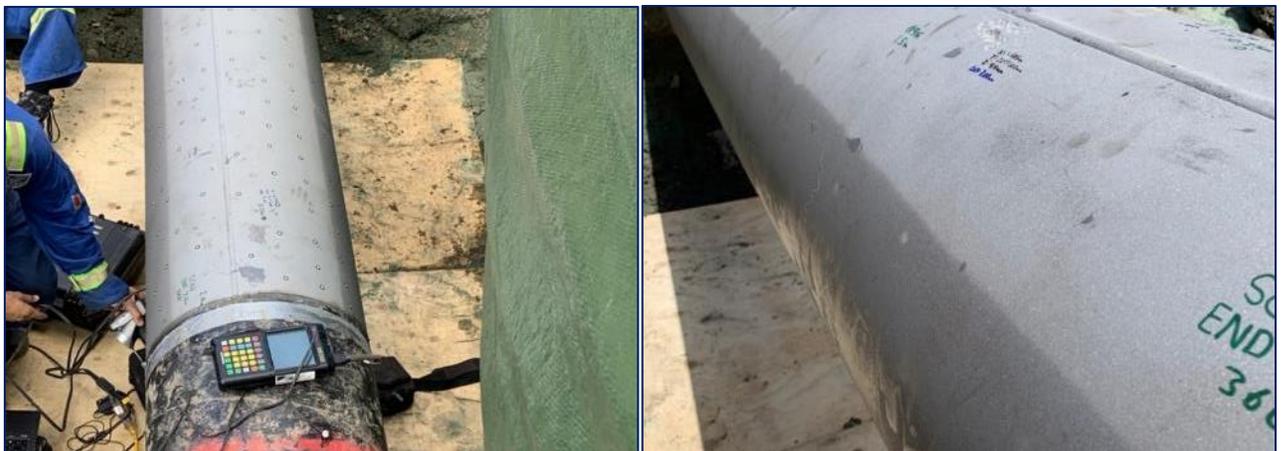
Figure 3-7: Exterior Condensation Lines on Exposed Pipe

Although no through-wall defects were observed during inspection, evidence of a possible ingress source elsewhere along the right of way was noted. Once the abandoned segment had been excavated, sandblasted, and exposed to the ambient temperature, exterior condensation lines were observed at the 10 and 2 o'clock positions, as shown in Figure 3-7 below.

This observation provides an indication that liquid has entered and accumulated in the abandoned PRML. Currently, there is insufficient evidence to ascertain whether this is due to through-wall corrosion penetration or a defect in cap installation. Based on the indicated end points of the abandoned PRML segment, and proximity to wetlands, no adverse environmental effects are expected due to water movement within the abandoned PRML.

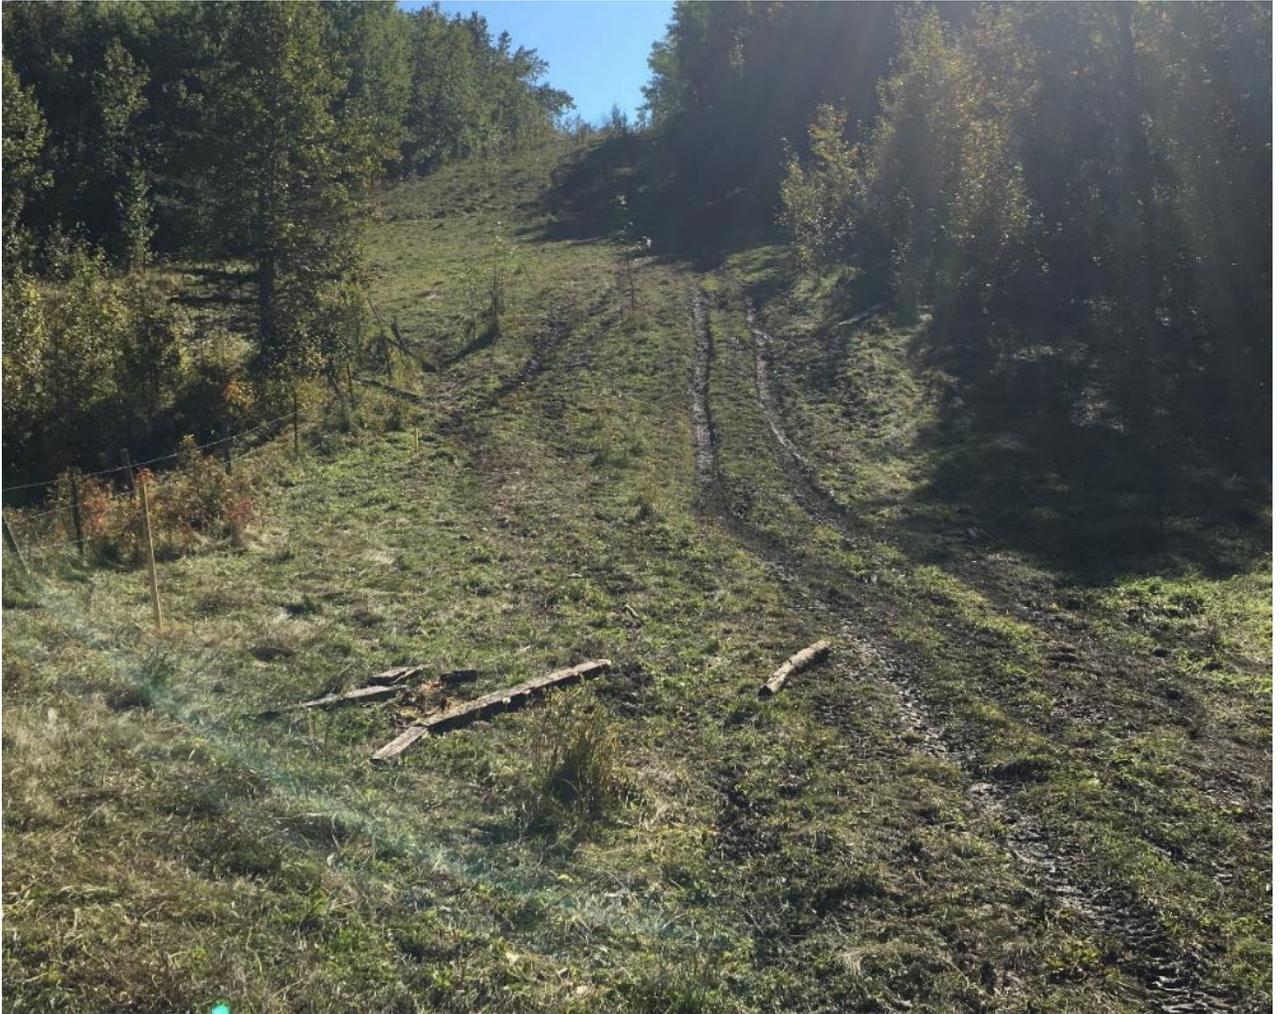
*Figure 3-8: Four Mile Creek Crossing - Pre-Disturbance*

Photographs at the creek crossing were provided by NGTL. A visual inspection of the site showed no indications of soil subsidence as a result of the abandoned PRML. Additionally, no pipeline exposure was observed as a result of the abandoned PRML. A sample photograph of the site is shown in Figure 3-8.

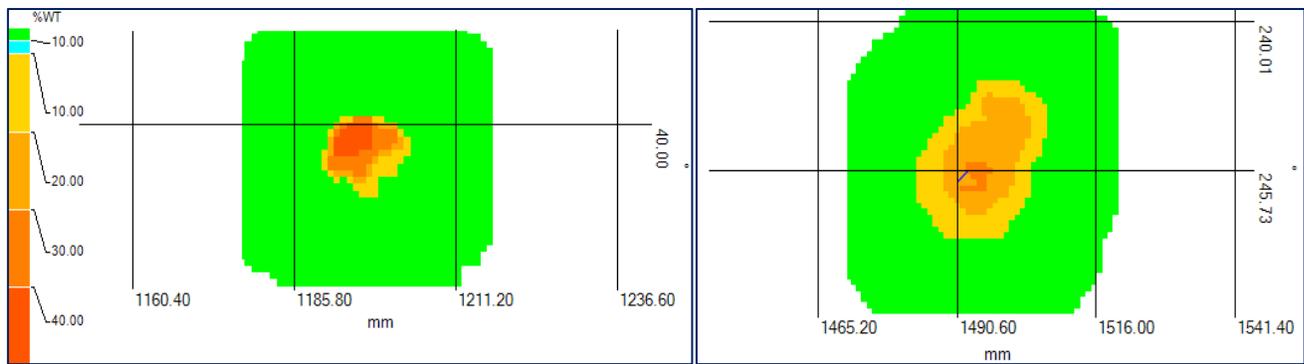
Figure 4-2: Plot of ‘Regular’ Features – Feature #14 (left) and Feature #17 (right)

It should be noted that the ellipse area approach overestimates the surface area for certain feature geometries. While it is effective at approximating ‘regular’ features (e.g., Feature #14 and #17), ‘irregular’ or clustered features (e.g., Feature #10) are not accurately estimated. Figure 4-2 and Figure 4-3 illustrate this limitation.

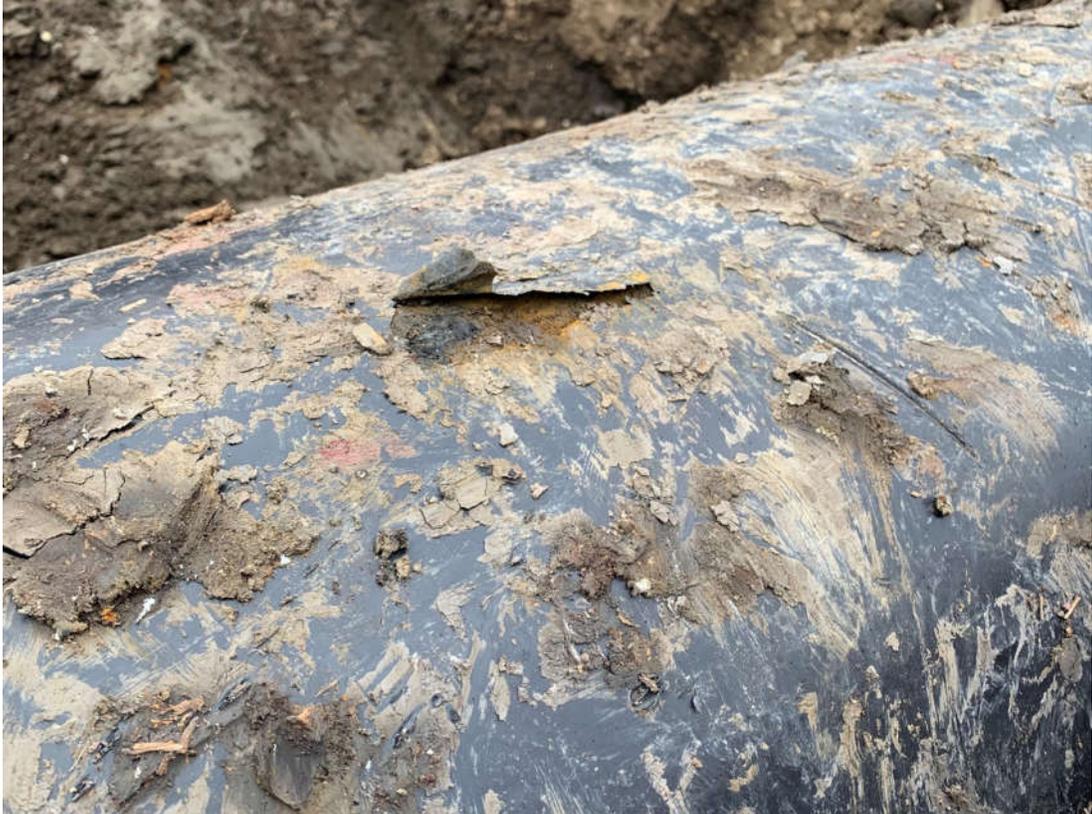
*Figure D: Coating Damage at 12 O'clock Position*

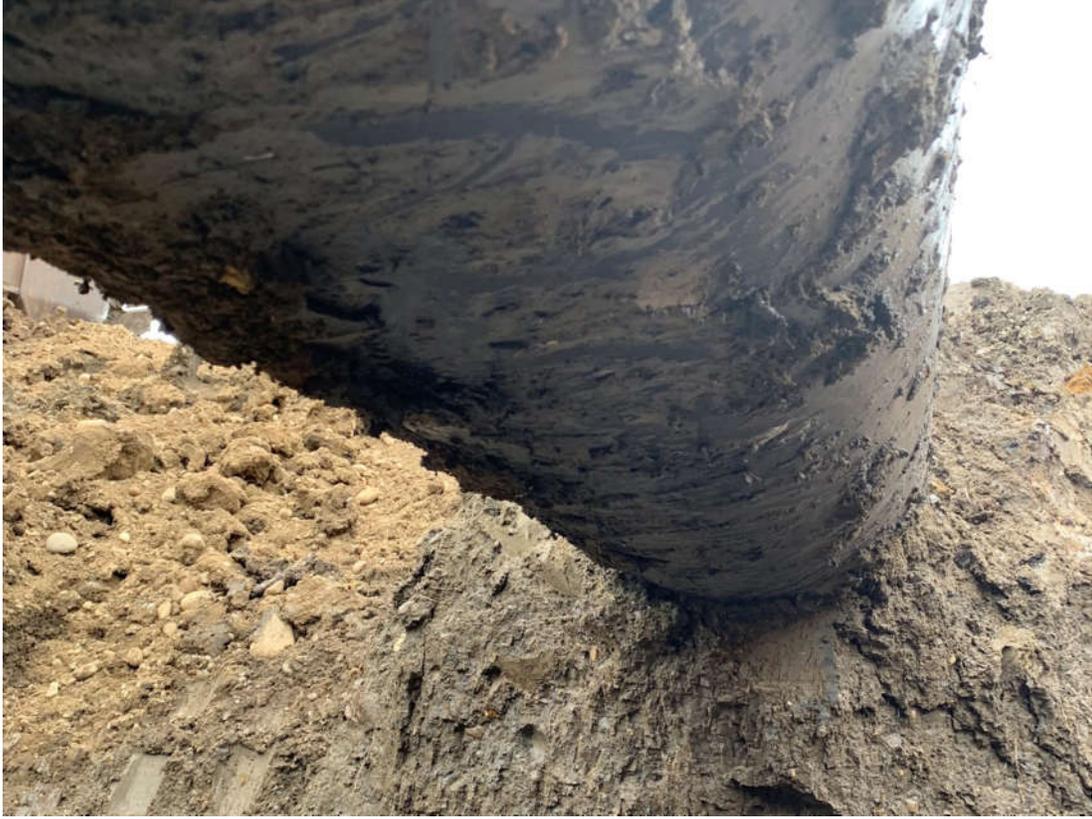
*Figure E: 6 O'clock Position – Full Excavation*

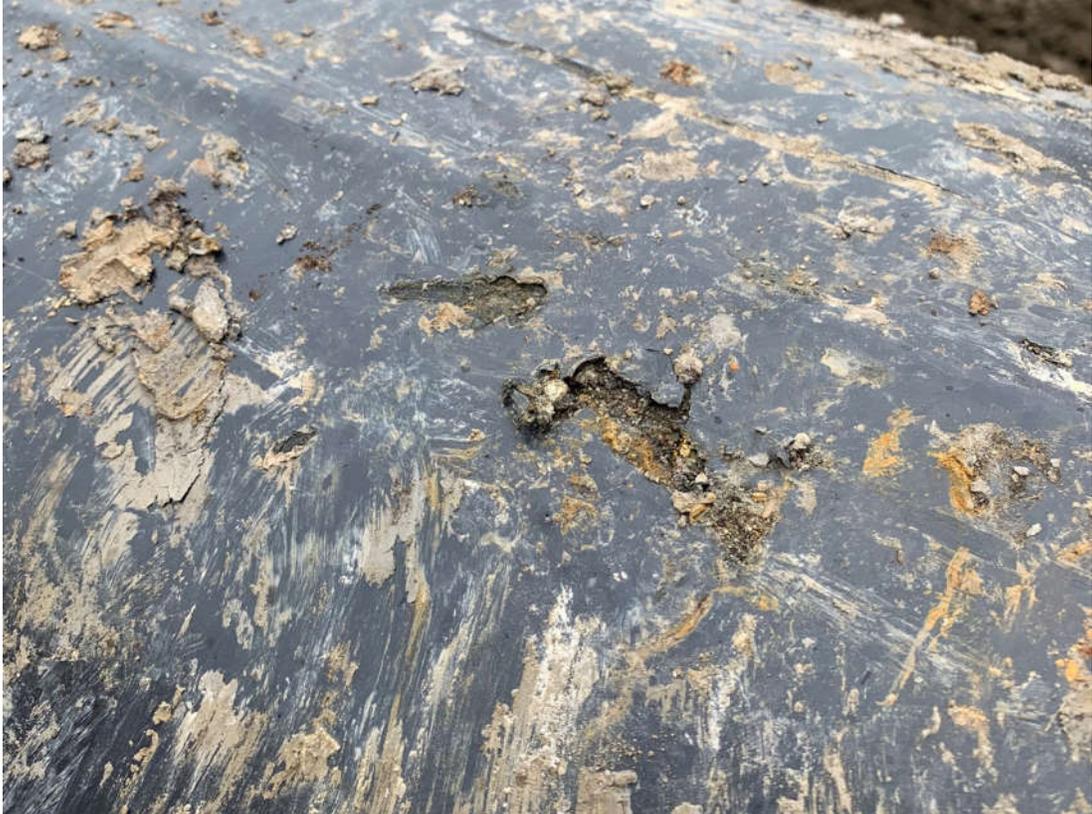
*Figure F: Additional Coating Damage at 12 O'clock Position*

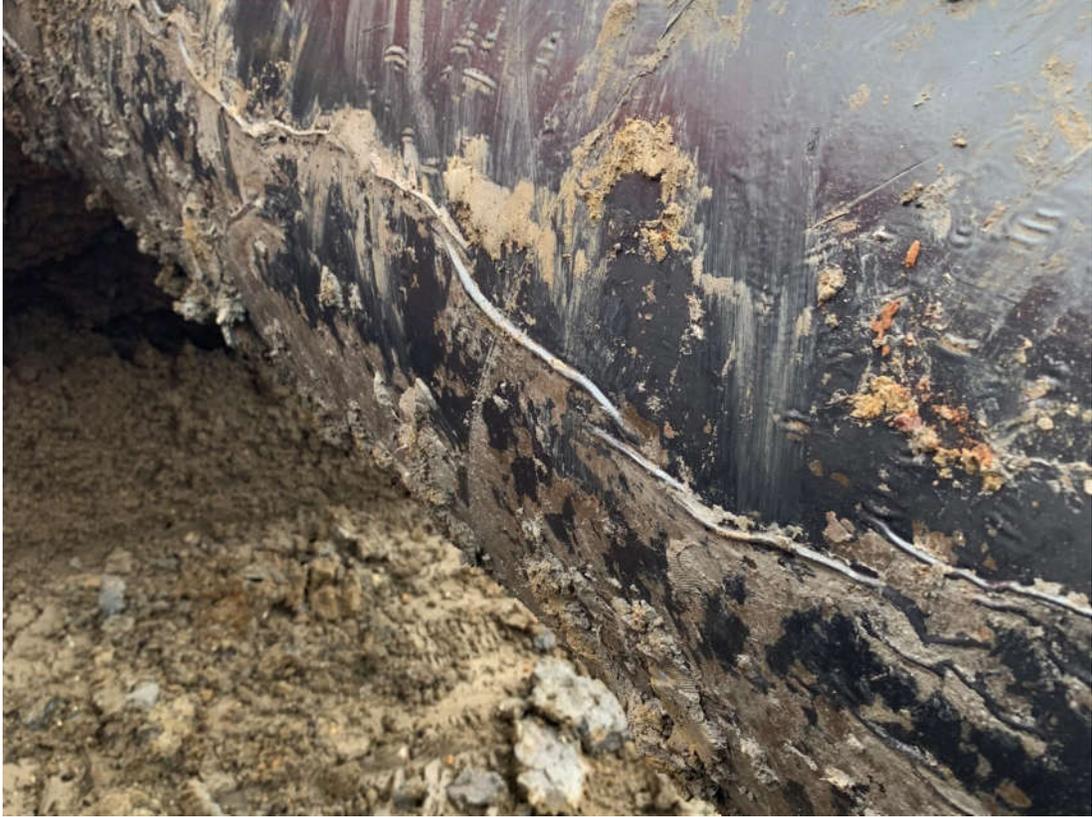
*Figure G: Coating 'Wrinkling' Disbondment Detail View*

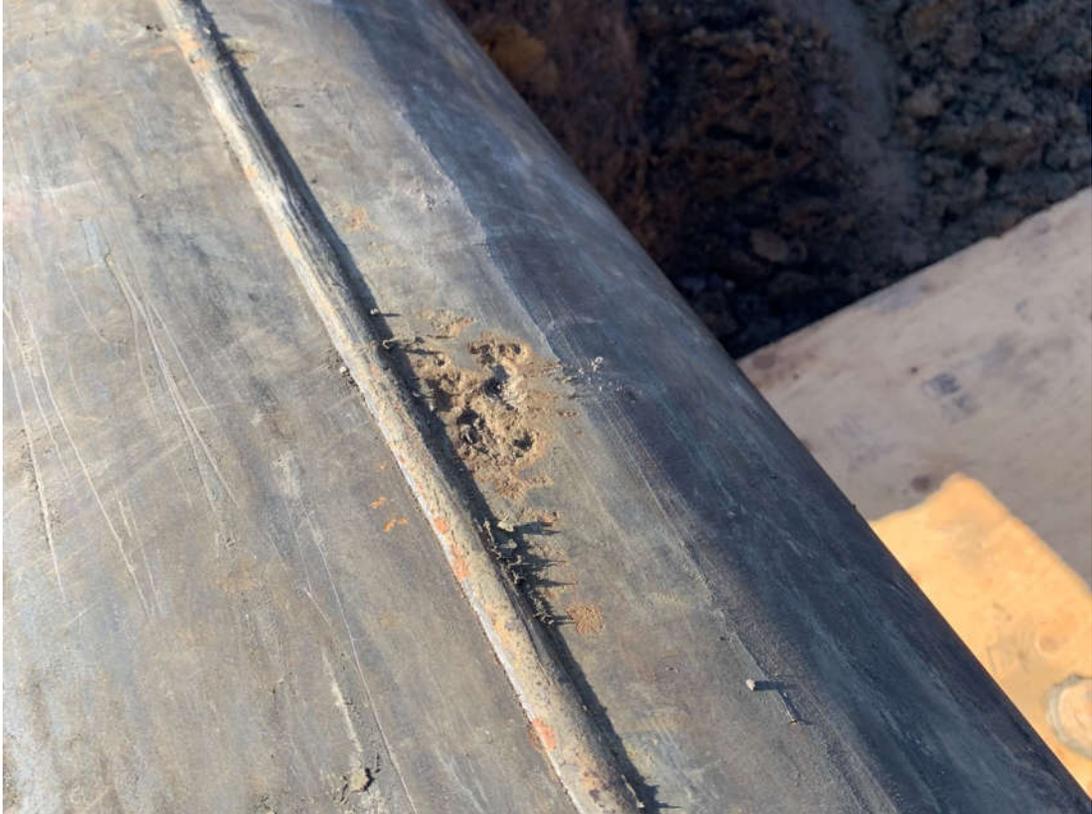
*Figure J: Pitting Corrosion Along Seam After Initial Sandblasting*

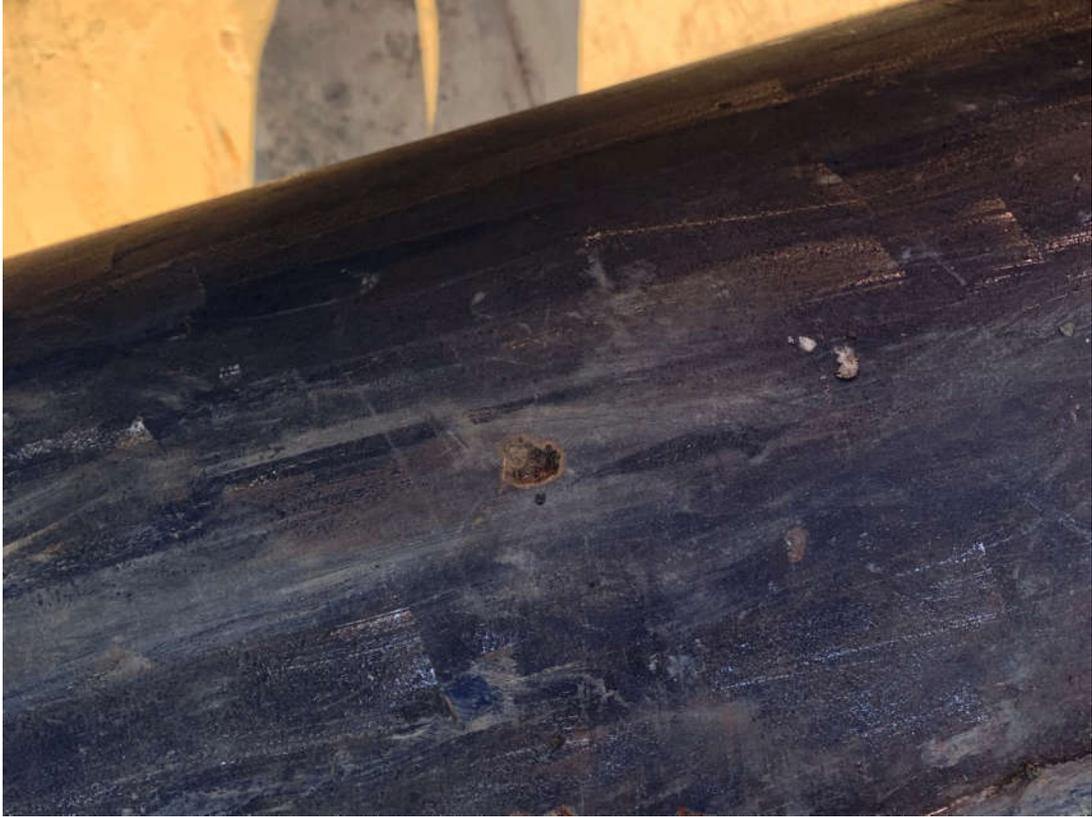
*Figure K: Pitting Corrosion Detail at 12 O'clock Position*

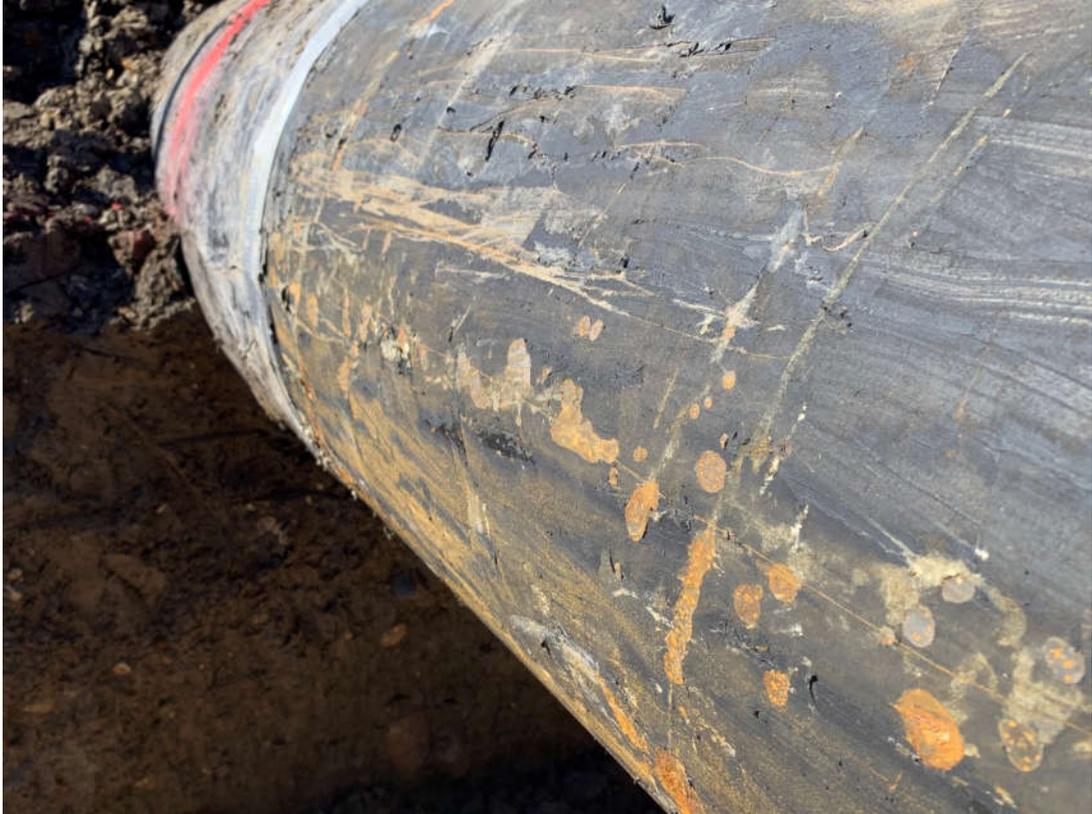
*Figure L: Shallow Pitting Corrosion Along 9 O'clock Position*

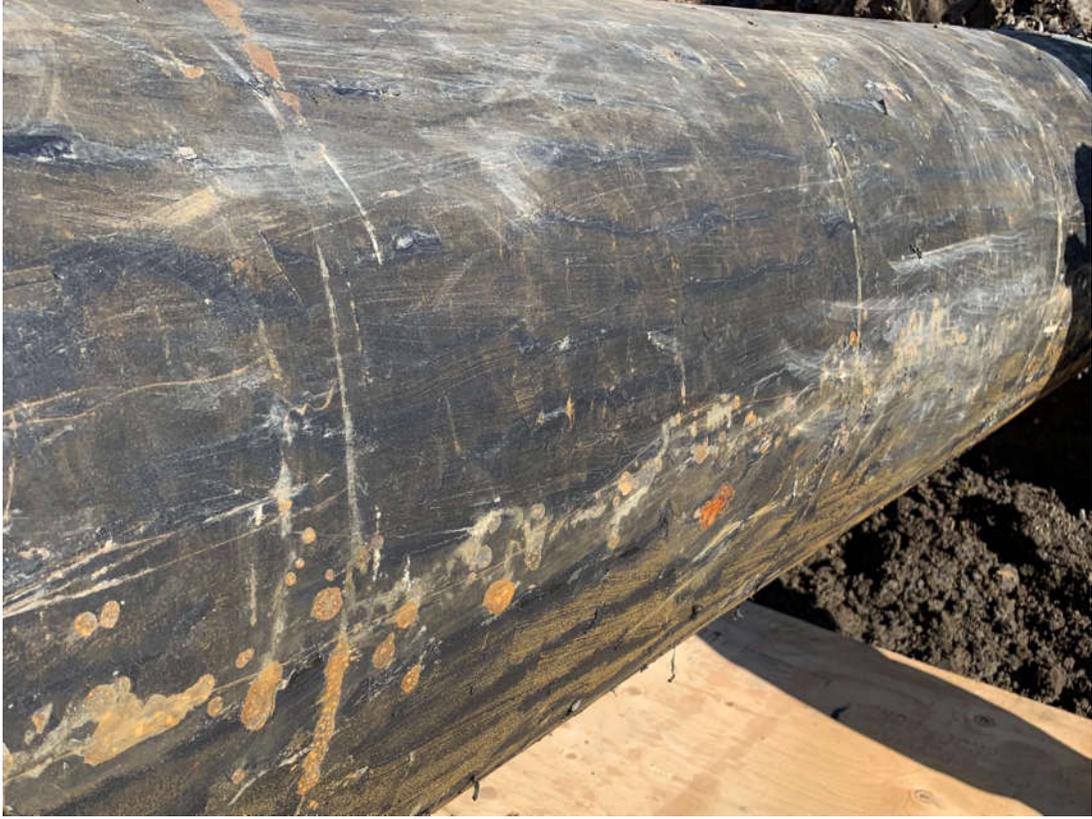
*Figure M: Shallow Pitting Corrosion Along 3 O'clock Position*

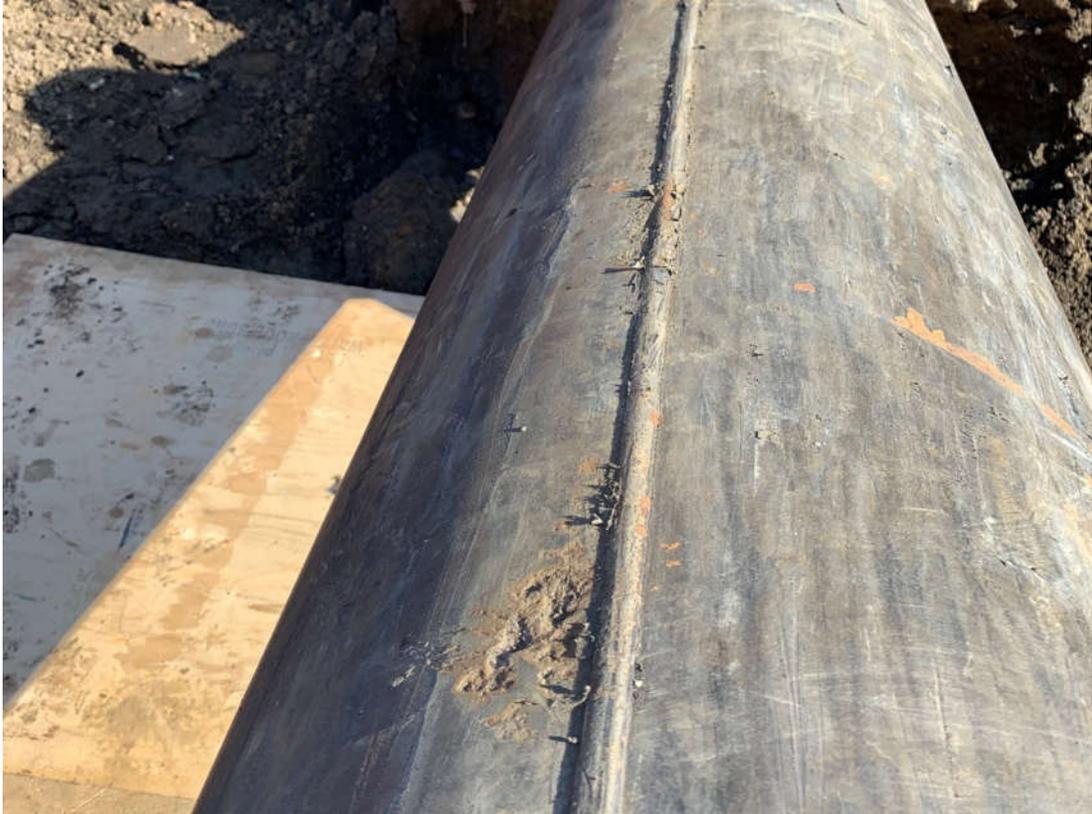
*Figure N: Additional Pitting Corrosion Along Seam After Initial Sandblasting*

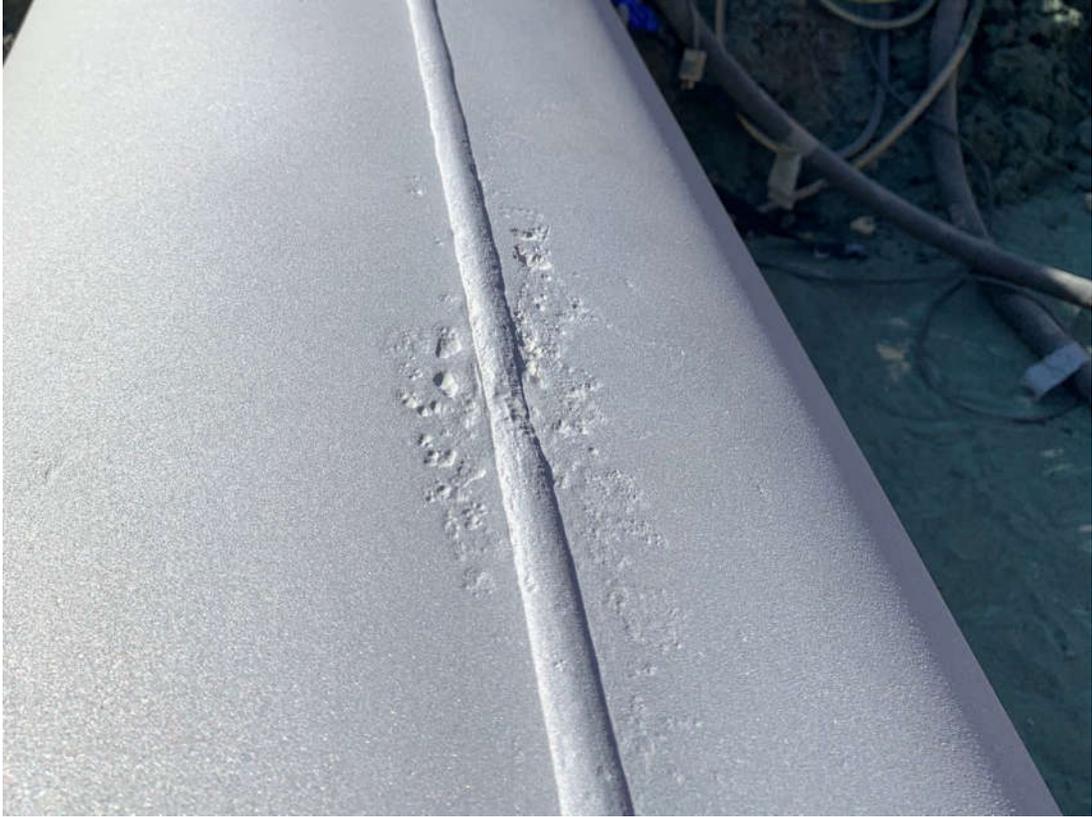
*Figure O: Pitting Corrosion Detail at Seam, Clean*

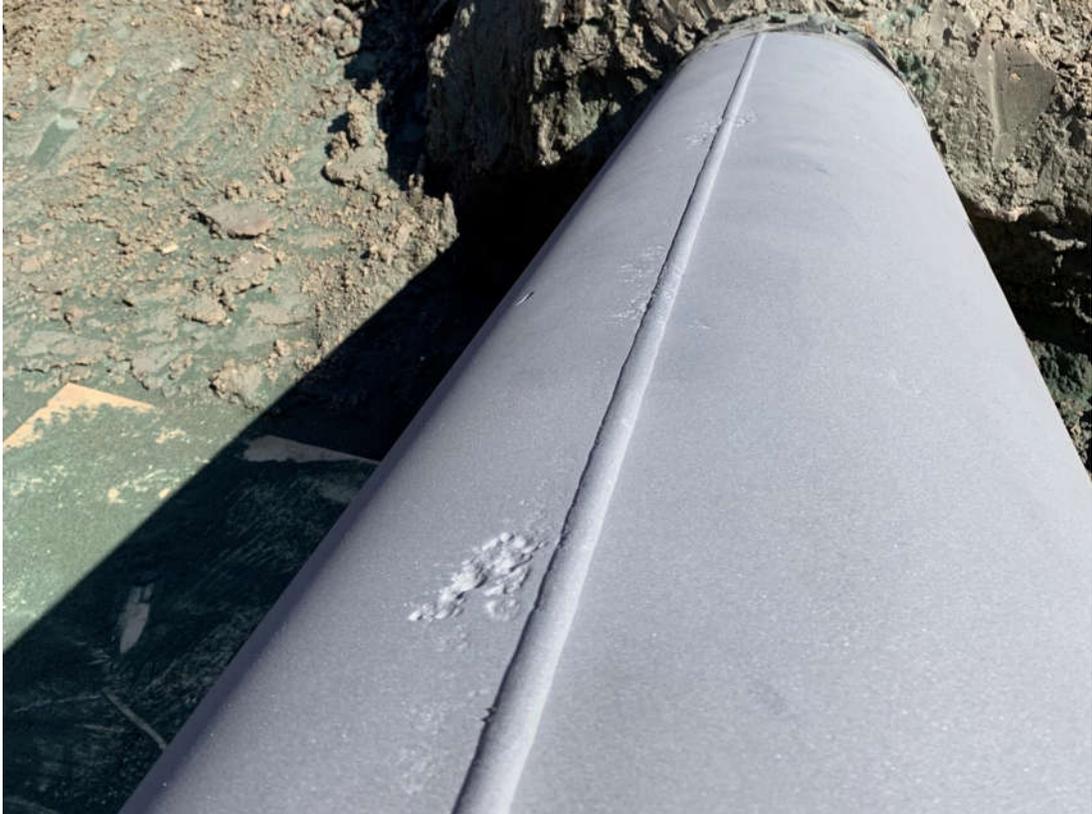
*Figure P: Additional Pitting Corrosion Detail at Seam, Clean*

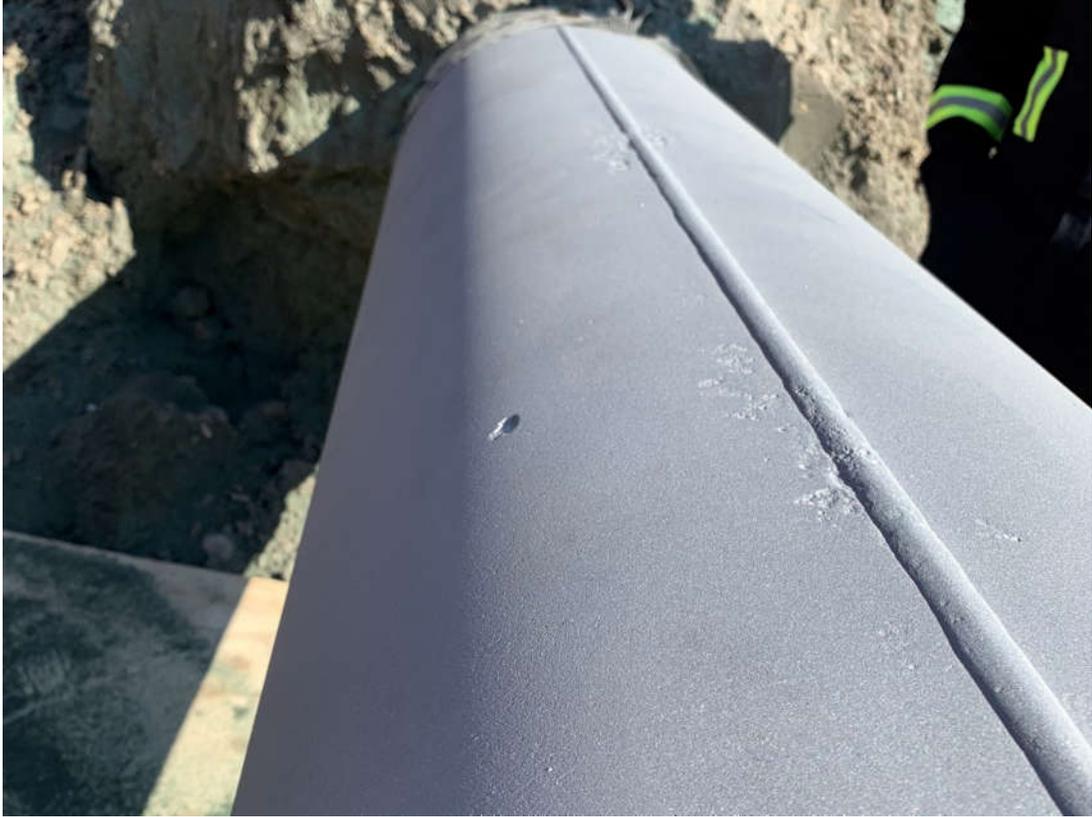
Figure Q: Deep Pitting Corrosion Detail at 11 O'clock Position
