Final Report for AUPRF Project

# **Assessing Peatland Restoration Success to Meet Alberta's Peatland Reclamation Criteria**

August 15 – December 15, 2015

NAIT Boreal Research Institute, Peace River, Alberta

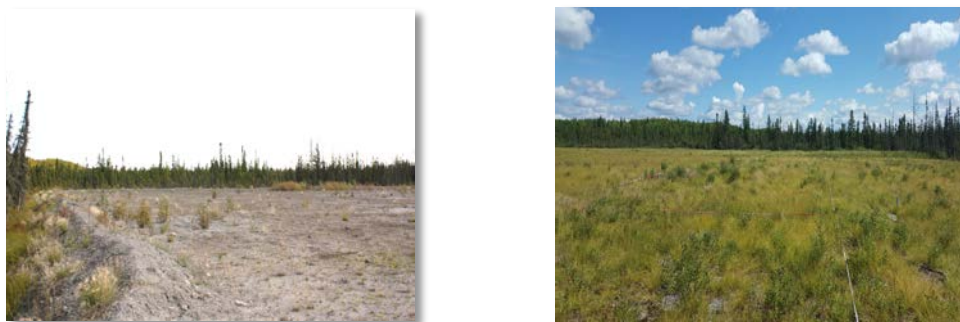
**Figure 1. Inversion Pad (IPAD) trial #1: Pre-restoration in 2011 (left) and three years (summer 2015) after donor transfer (right).**

The NAIT Inversion Pad trial #1 (IPAD) is located 50 km northeast of the Town of Peace River. Prior to disturbance, the site was a treed, poor fen. Shell Canada built the 1.27 ha site in 2006 with borrow clay material (Figure 1 left). Civil earth work of the reclamation project started in November 2011 with the removal of a clay pad using a combination of six different clay removal and peat inversion techniques, followed by moss donor transfer in the summer of 2012 (Figure 1 right). A detailed step by step site preparation and moss transfer method can be found in **Appendix II** of this report. Partnered with university researchers, NAIT Boreal Research Institute has been closely monitoring the vegetation establishment, hydrological connectivity, and overall restoration success on the site since 2012.

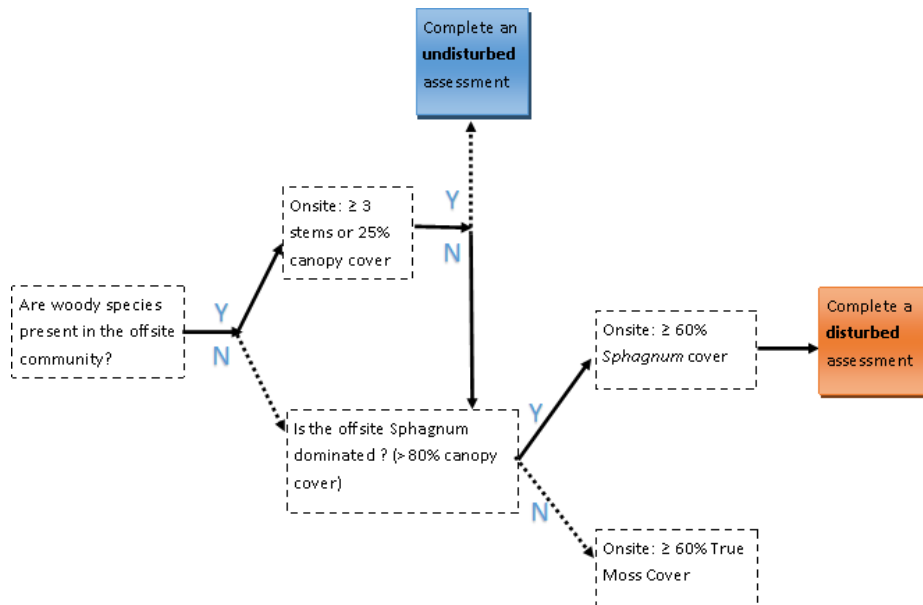
**Figure 2. Decision tree for an undisturbed assessment. We used the same process and determined that a disturbed assessment is needed. Solid arrows indicate the selection process. From the Criteria.**

The criteria provide a decision tree for choosing the correct assessment for each site (Figure 2), particularly for sites that were not padded but considered disturbed. In our case, the surrounding area does have woody species present and is dominated by *Sphagnum* spp. (over 80% canopy). There are more than 1 stem/grid woody plants (or 25% of canopy cover) onsite but *Sphagnum* spp. cover is significantly less than the 60% required to be considered undisturbed. Therefore, the disturbed assessment is the appropriate method to use.

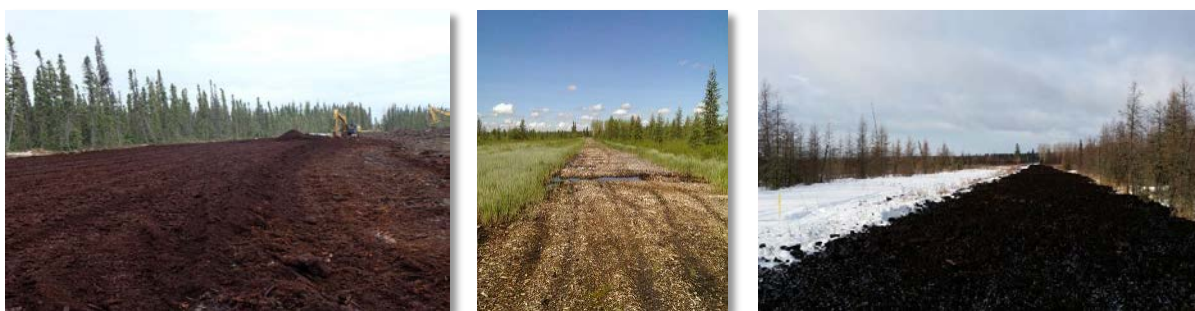
Figure 6. (Left) Inversion trial #2 as the pad is being removed and peat being inverted. (Middle) the chip winter road before reclamation; (Right) The chip winter road after the peat inversion.

The chip road civil earth work was completed over two days in February, 2015 (Figure 6 middle and right). The wood chips were stripped off the surface and inverted with the underlying peat (**Appendix IV**). The surface was contoured to be about 30 cm higher than the surrounding natural area as it was expected the road would settle with rain and the flow through hydrology perpendicular to the road. Drought conditions in 2015 led to the road not settling as much as anticipated, so a dozer was brought in August, 2015 to further compact the surface elevation to match the surrounding area.
