PARSC 017

Enbridge Line 3 Abandoned Pipeline
Segment Subsurface Field Study

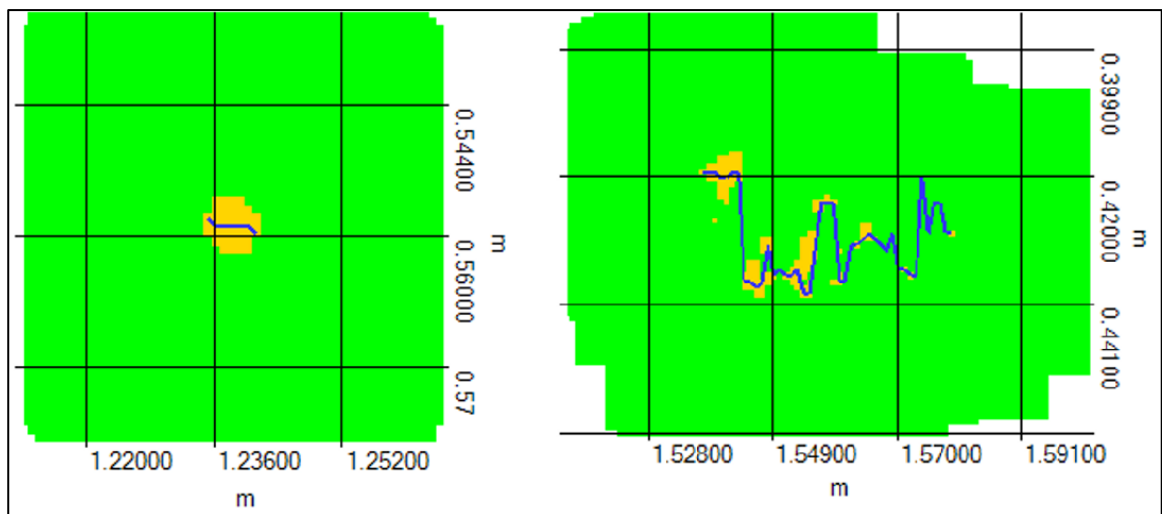
Figure 4-2: Laser scan of regular (left, DMA 65) and irregular (right, CLS 76) features.

To investigate this quantitatively, the area of each feature can be estimated as an ellipse, with major and minor axes corresponding to axial and circumferential length. Note that while this approximation is effective at estimating the corroded area of “regular” features, the area of “irregular” or clustered features may be overestimated using this technique as shown in Figure 4-2, and provides conservatism in the estimation.
