# PARSC 016

## Peace River Mainline Abandoned Pipeline Segment Field Study

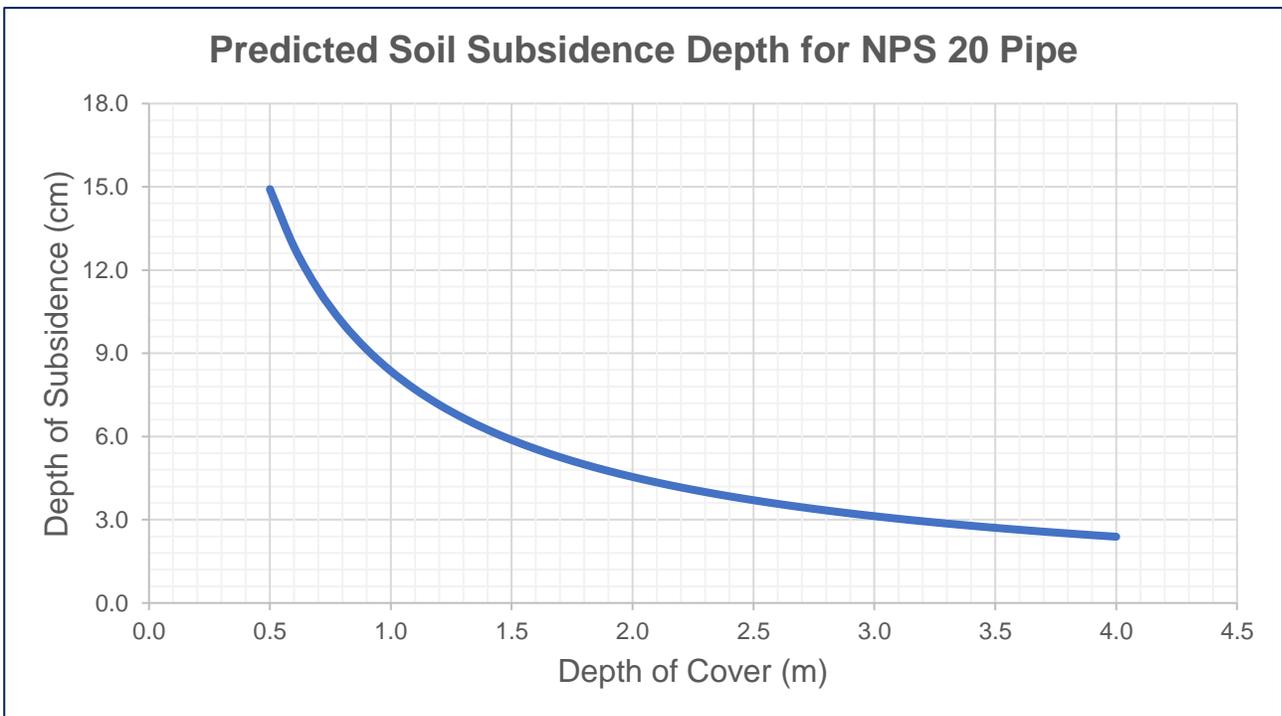
Figure 4-1: Predicted Soil Subsidence Depth for NPS 20 Pipe

For typical a typical depth of cover of 3 to 5 ft (0.9 to 1.5 m), the predicted subsidence depth for PRML would be approximately 9.0 to 6.0 cm. As the depth of cover increases, such as at Four Mile Creek crossing, the subsidence depth decreases significantly. Additionally, a 100% infill is conservative, as the pipe infill would likely be an incomplete infill via through-wall perforations.

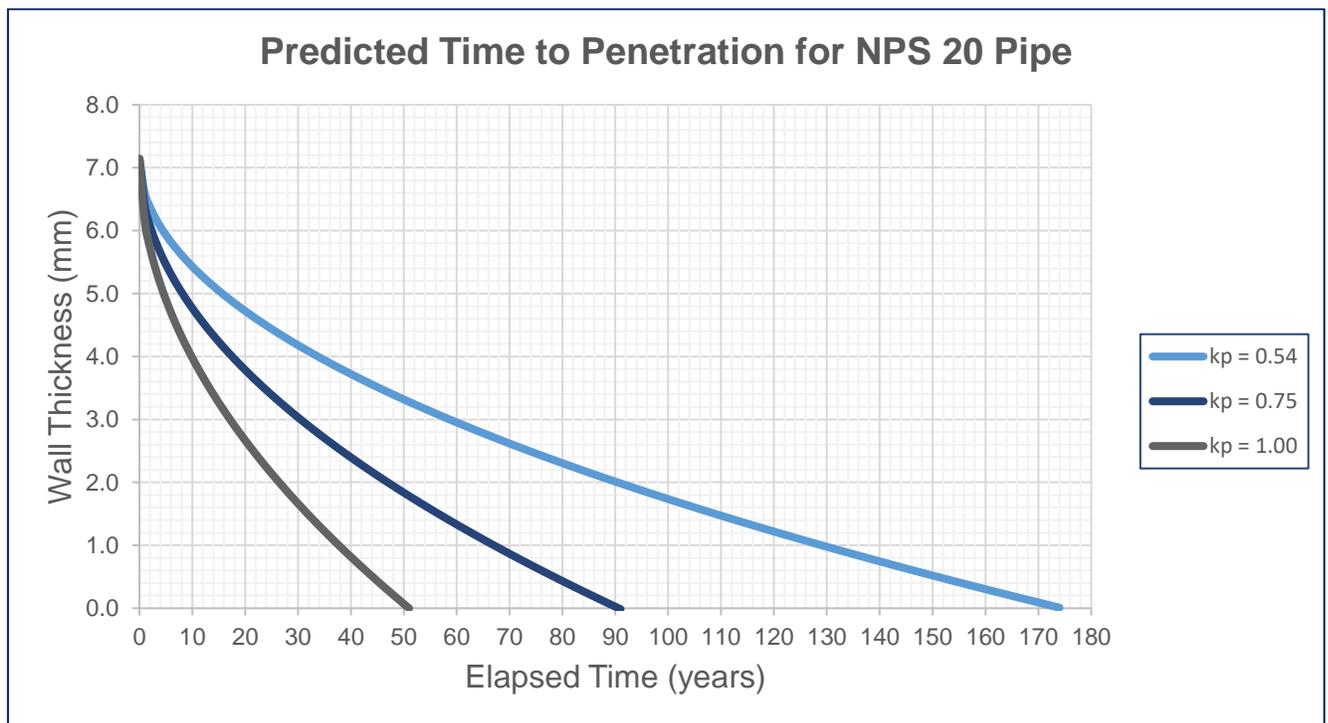
Figure 4-4: Predicted Time to Penetration for NPS 20 Pipe

The calculated  $k_p$  values for the abandoned PRML are significantly lower than the values given by the NBS. Assuming that the values are normally distributed (i.e., Gaussian distribution), a  $k_p$  value of 0.54 is a reasonable upper bound, capturing 95% of all values (i.e., two standard deviations). The predicted time to penetration for various  $k_p$  values is shown in Figure 4-4.

The NBS models from PARSC 001 indicate that through-wall penetration would occur in 51 years for the ‘fair’ to ‘very poor’ case ( $k_p = 1.00$ ) and 91 years for the ‘good’ case ( $k_p = 0.75$ ). However, the PRML data suggests that penetration would not occur until 175 years, with 95% confidence ( $k_p = 0.54$ ). Assuming that the PRML soils would be classified as ‘fair’ or ‘poor’, these results suggest that the PARSC 001 models for  $k_p$  are conservative by an approximate 2x factor. Due to the exponential relationship between  $k_p$  and  $T$ , this yields an end result which is approximately 4x more conservative than predicted. Note that these results are valid only for this PRML case study.

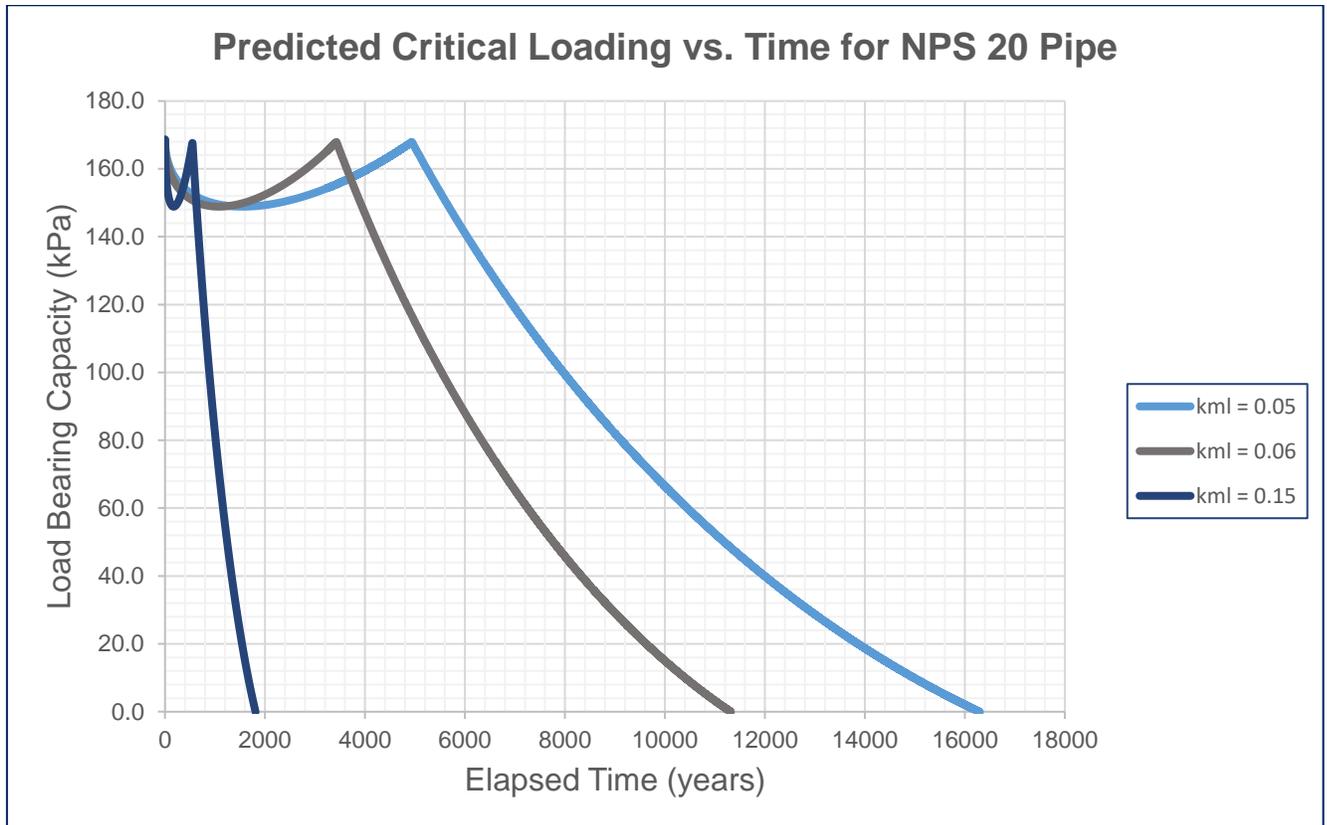
Figure 4-5: Predicted Critical Loading vs. Time for NPS 20 Pipe

The PARSC 001 models indicate a total loss of loading bearing capacity in approximately 1,800 years for the ‘poor’ case ( $k_{ml} = 0.15$ ), and approximately 16,300 years for the ‘good’ case ( $k_{ml} = 0.05$ ). The extrapolated PRML data suggests a timeline of approximately 11,300 years, with 95% confidence ( $k_{ml} = 0.06$ ). Note that the timeline should actually be  $[11,300 + t_{coat}]$  years, where  $t_{coat}$  is the time required for the PE coating to completely deteriorate. The timeline to failure for this model is significantly higher than the penetration models given in Section 4.3, by 1 to 2 orders of magnitude. Therefore, it is much likelier that failure would occur due to pitting penetration and pit coalescence, rather than general wall loss.

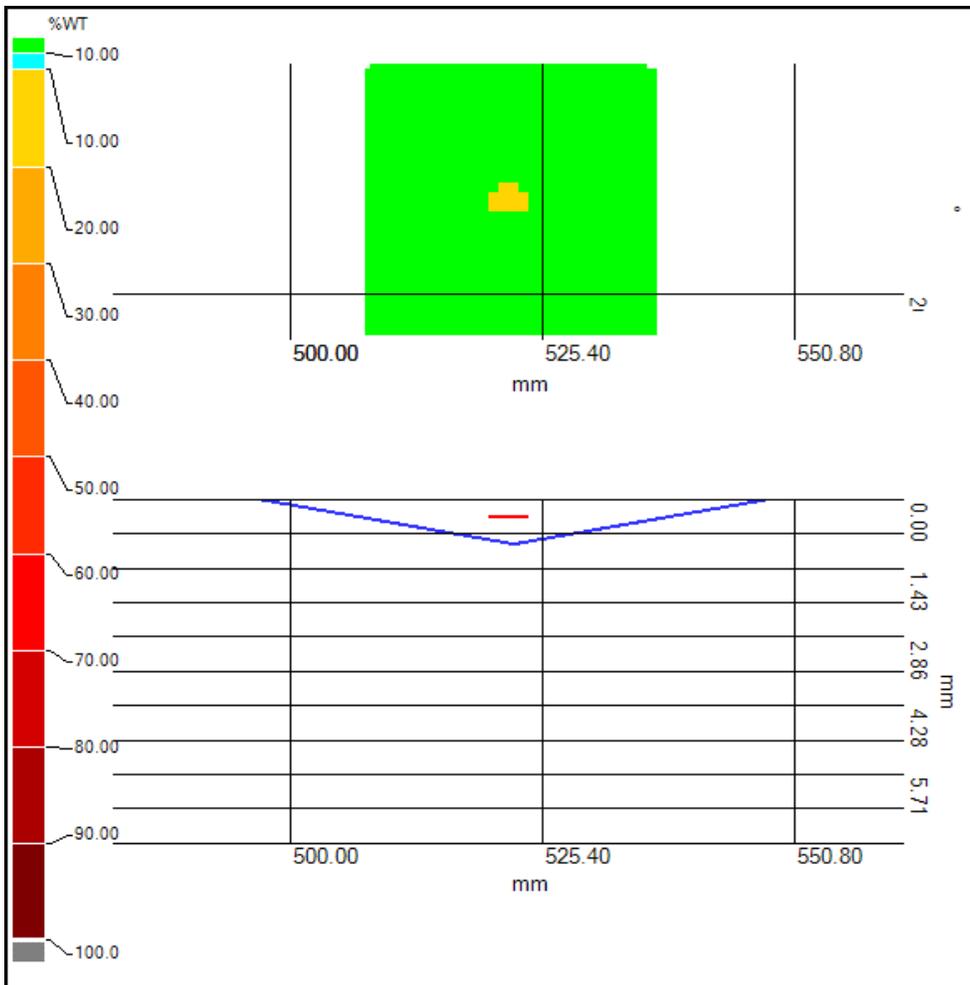
**Worst Case Profile values for Feature 1**

Axial start	520.00 mm
Axial end	524.00 mm
Axial length	4.00 mm
Circ. start	265.94 °
Circ. end	266.62 °
Circ. length	0.68 °
Max. depth	0.92 mm
Max. depth	87.11 %RWT
Axial pos.	522.50 mm
Circ. pos.	266.50 °
Vol. loss	8.14 mm <sup>3</sup>
Anomaly	Pinhole

Eff. area	12015.28 kPa
RPR (MAOP)	1.49
Modified B31G	12014.38 kPa
RPR (MAOP)	1.49
B31G	11084.28 kPa
RPR (MAOP)	1.37

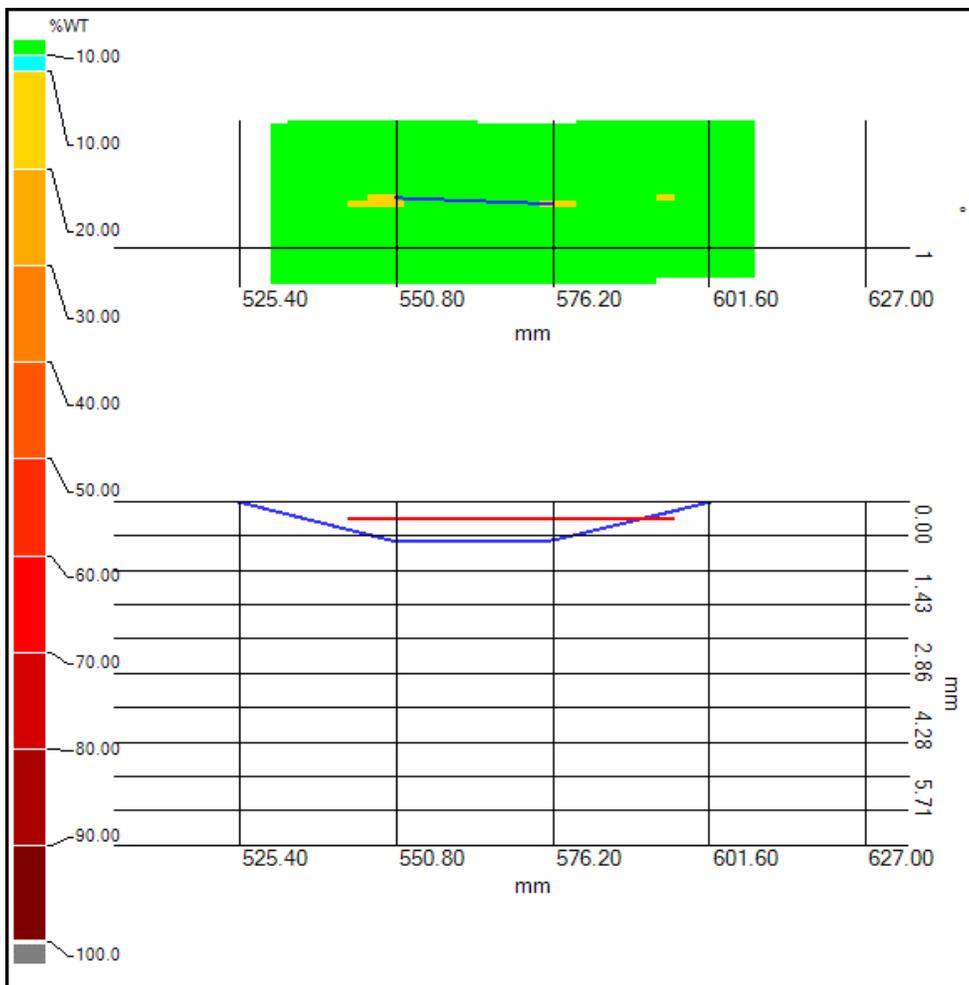
## Worst Case Profile values for Feature 2

Axial start	543.00 mm
Axial end	596.01 mm
Axial length	53.00 mm
Circ. start	15.11 °
Circ. end	15.56 °
Circ. length	0.45 °
Max. depth	0.82 mm
Max. depth	88.52 %RWT
Axial pos.	550.50 mm
Circ. pos.	15.23 °
Vol. loss	17.87 mm <sup>3</sup>
Anomaly	Pinhole

Eff. area	11821.33 kPa
RPR (MAOP)	1.47
Modified B31G	11787.90 kPa
RPR (MAOP)	1.46
B31G	10892.54 kPa
RPR (MAOP)	1.35

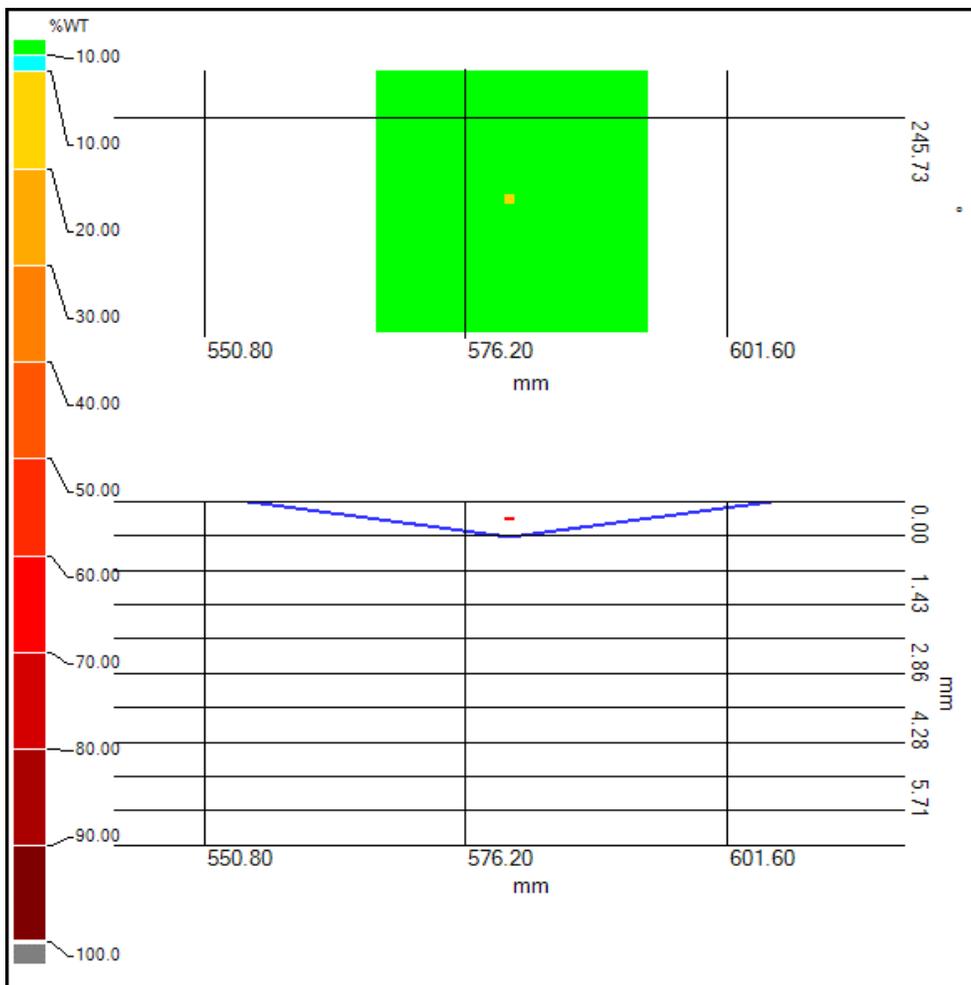
### Worst Case Profile values for Feature 3

Axial start	580.01 mm
Axial end	581.01 mm
Axial length	1.00 mm
Circ. start	247.44 °
Circ. end	247.67 °
Circ. length	0.23 °
Max. depth	0.73 mm
Max. depth	89.78 %RWT
Axial pos.	580.51 mm
Circ. pos.	247.56 °
Vol. loss	0.73 mm <sup>3</sup>
Anomaly	Pinhole

Eff. area	12016.37 kPa
RPR (MAOP)	1.49
Modified B31G	12016.32 kPa
RPR (MAOP)	1.49
B31G	11086.03 kPa
RPR (MAOP)	1.37

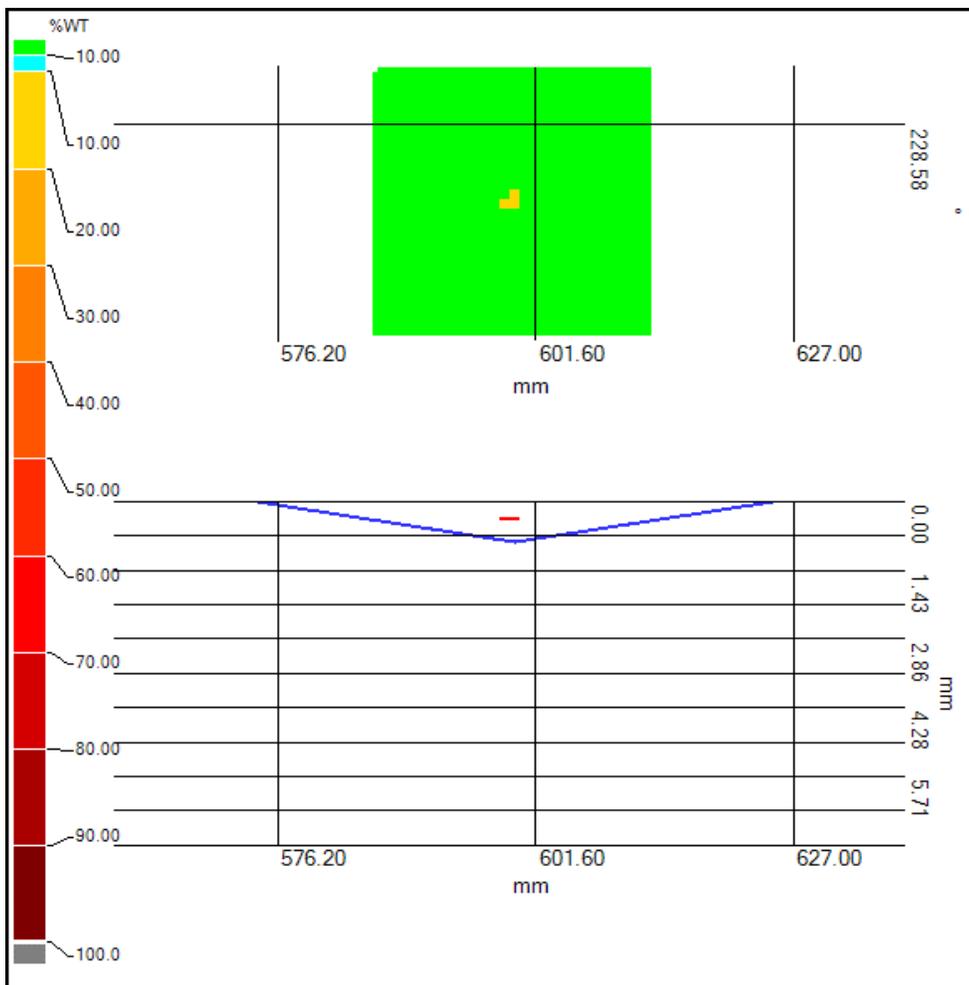
**Worst Case Profile values for Feature 4**

Axial start	598.01 mm
Axial end	600.01 mm
Axial length	2.00 mm
Circ. start	230.08 °
Circ. end	230.53 °
Circ. length	0.45 °
Max. depth	0.84 mm
Max. depth	88.24 %RWT
Axial pos.	599.51 mm
Circ. pos.	230.19 °
Vol. loss	2.41 mm <sup>3</sup>
Anomaly	Pinhole

Eff. area	12016.16 kPa
RPR (MAOP)	1.49
Modified B31G	12015.96 kPa
RPR (MAOP)	1.49
B31G	11085.70 kPa
RPR (MAOP)	1.37

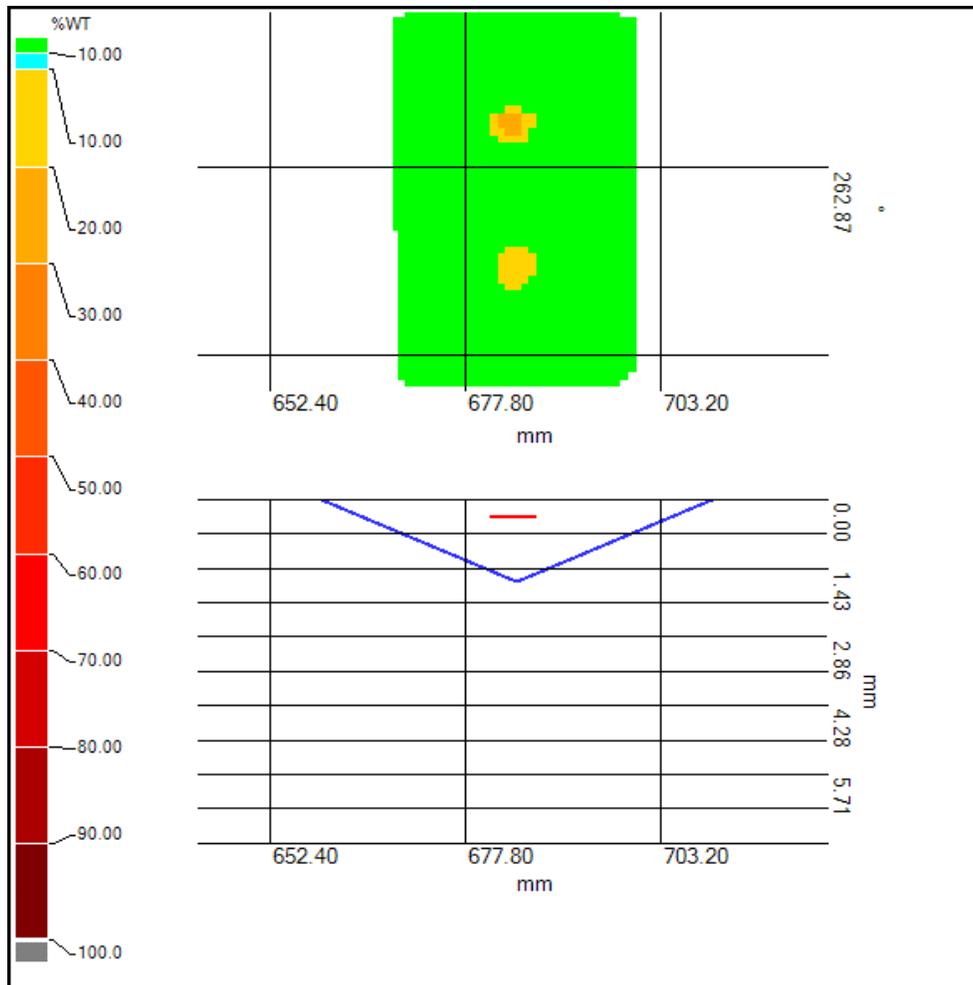
### Worst Case Profile values for Feature 5

Axial start	681.01 mm
Axial end	687.01 mm
Axial length	6.00 mm
Circ. start	260.98 °
Circ. end	266.62 °
Circ. length	5.64 °
Max. depth	1.70 mm
Max. depth	76.19 %RWT
Axial pos.	684.51 mm
Circ. pos.	261.54 °
Vol. loss	50.38 mm <sup>3</sup>
Anomaly	Pinhole

Eff. area	12011.37 kPa
RPR (MAOP)	1.49
Modified B31G	12006.94 kPa
RPR (MAOP)	1.49
B31G	11077.84 kPa
RPR (MAOP)	1.37

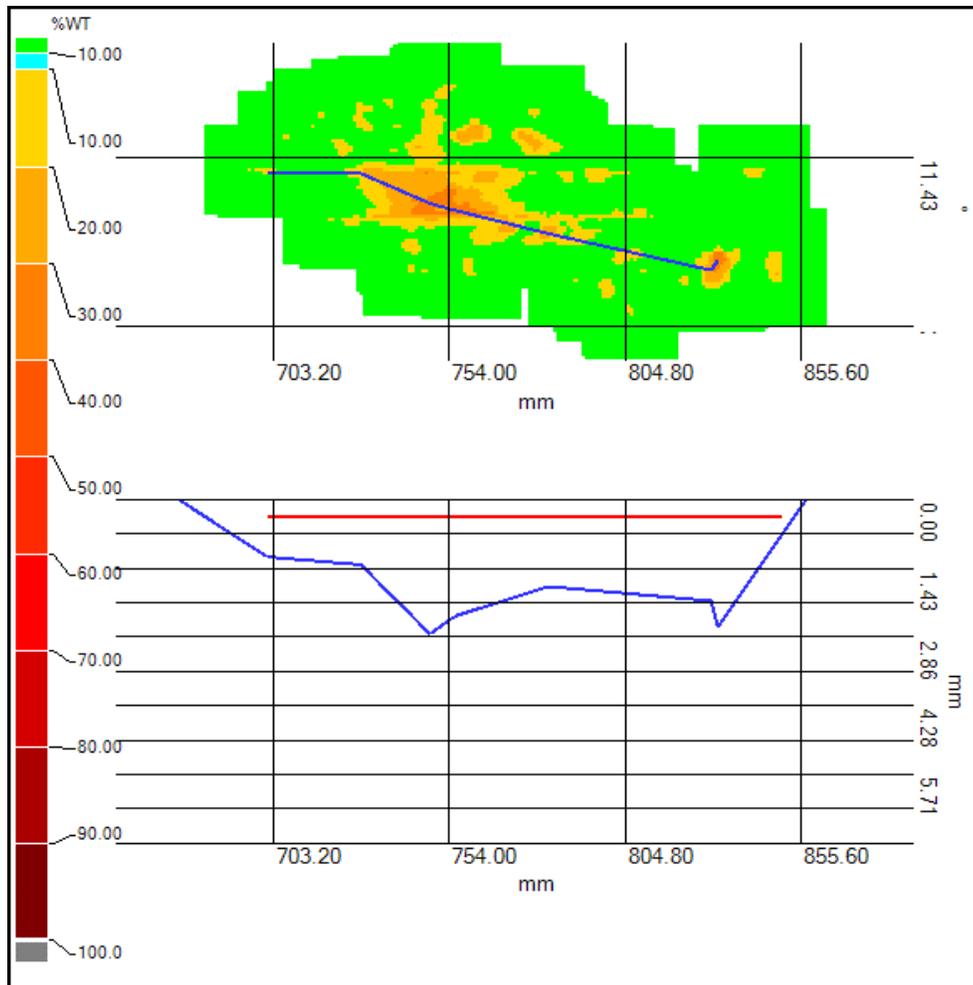
### Worst Case Profile values for Feature 6

Axial start	696.01 mm
Axial end	850.03 mm
Axial length	154.01 mm
Circ. start	6.54 °
Circ. end	22.11 °
Circ. length	15.56 °
Max. depth	2.79 mm
Max. depth	60.92 %RWT
Axial pos.	748.52 mm
Circ. pos.	14.55 °
Vol. loss	2259.54 mm <sup>3</sup>
Anomaly	General-Pinhole-Axial slotting Pitting

Eff. area	10133.98 kPa
RPR (MAOP)	1.26
Modified B31G	9428.11 kPa
RPR (MAOP)	1.17
B31G	9150.56 kPa
RPR (MAOP)	1.13

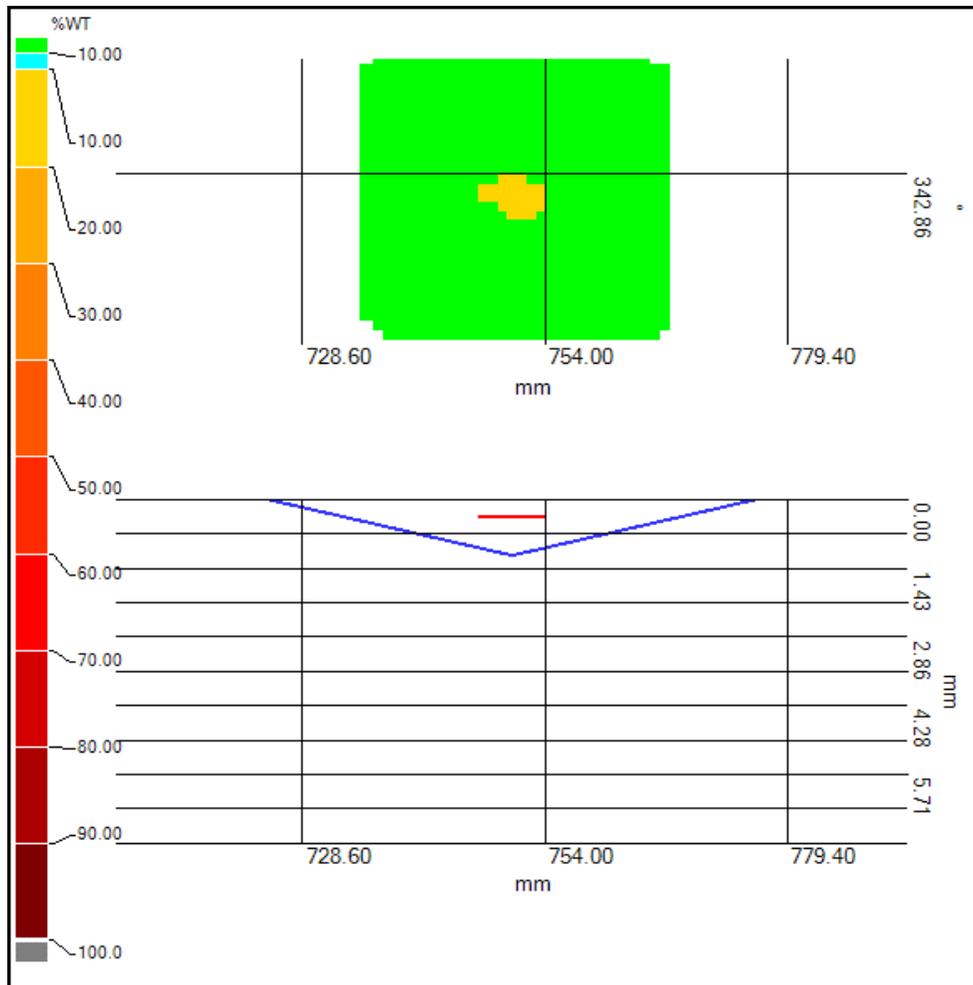
**Worst Case Profile values for Feature 7**

Axial start	747.02 mm
Axial end	754.02 mm
Axial length	7.00 mm
Circ. start	342.86 °
Circ. end	343.98 °
Circ. length	1.13 °
Max. depth	1.16 mm
Max. depth	83.75 %RWT
Axial pos.	750.52 mm
Circ. pos.	343.42 °
Vol. loss	23.21 mm <sup>3</sup>
Anomaly	Pinhole

Eff. area	12011.96 kPa
RPR (MAOP)	1.49
Modified B31G	12008.34 kPa
RPR (MAOP)	1.49
B31G	11078.92 kPa
RPR (MAOP)	1.37

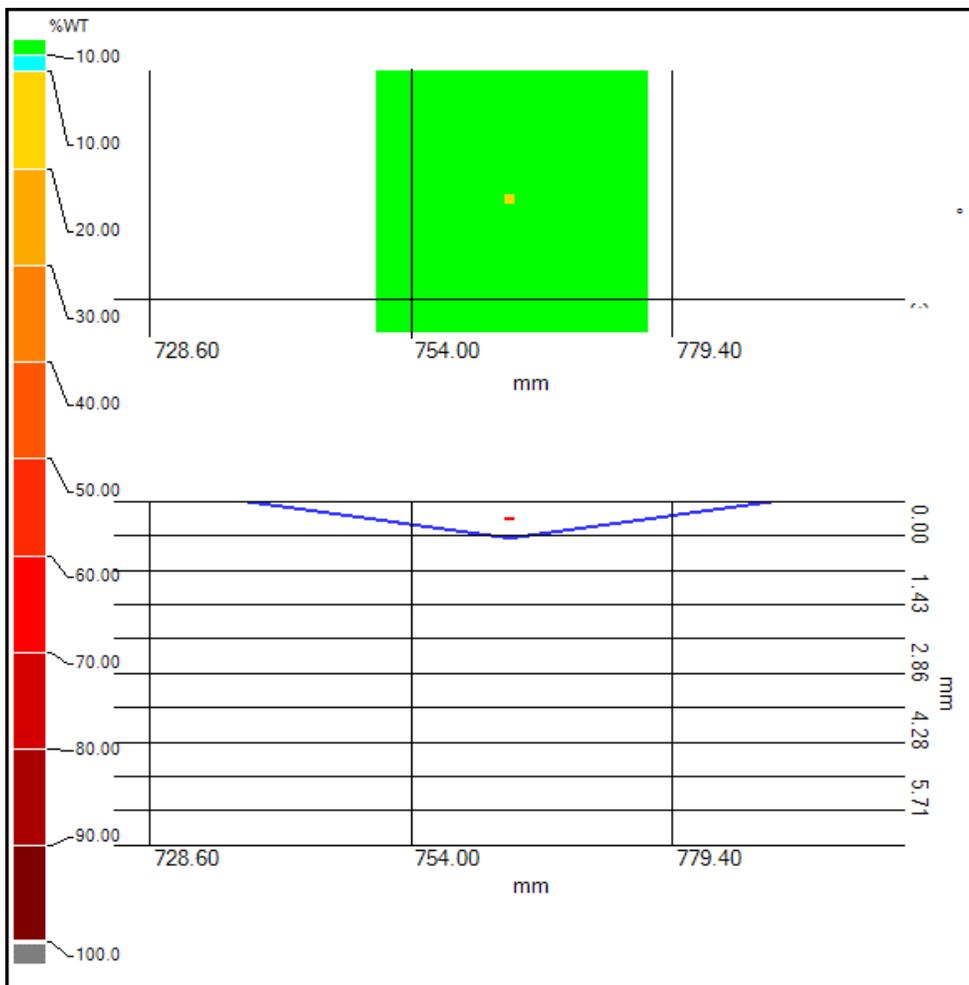
**Worst Case Profile values for Feature 8**

Axial start	763.02 mm
Axial end	764.02 mm
Axial length	1.00 mm
Circ. start	317.59 °
Circ. end	317.82 °
Circ. length	0.23 °
Max. depth	0.75 mm
Max. depth	89.50 %RWT
Axial pos.	763.52 mm
Circ. pos.	317.71 °
Vol. loss	0.76 mm <sup>3</sup>
Anomaly	Pinhole

Eff. area	12016.36 kPa
RPR (MAOP)	1.49
Modified B31G	12016.32 kPa
RPR (MAOP)	1.49
B31G	11086.03 kPa
RPR (MAOP)	1.37

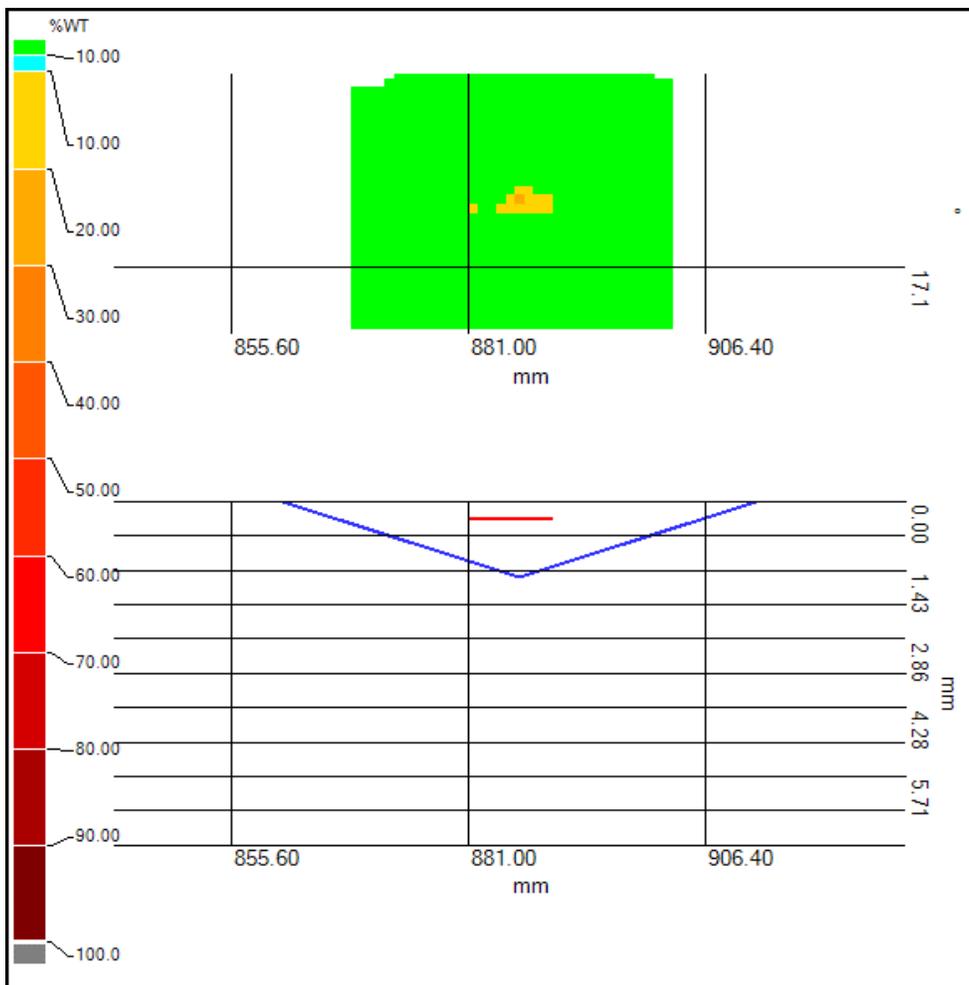
**Worst Case Profile values for Feature 9**

Axial start	881.03 mm
Axial end	890.03 mm
Axial length	9.00 mm
Circ. start	15.11 °
Circ. end	15.79 °
Circ. length	0.68 °
Max. depth	1.57 mm
Max. depth	78.01 %RWT
Axial pos.	886.53 mm
Circ. pos.	15.45 °
Vol. loss	14.99 mm <sup>3</sup>
Anomaly	Pinhole

Eff. area	12006.16 kPa
RPR (MAOP)	1.49
Modified B31G	11997.34 kPa
RPR (MAOP)	1.49
B31G	11069.39 kPa
RPR (MAOP)	1.37

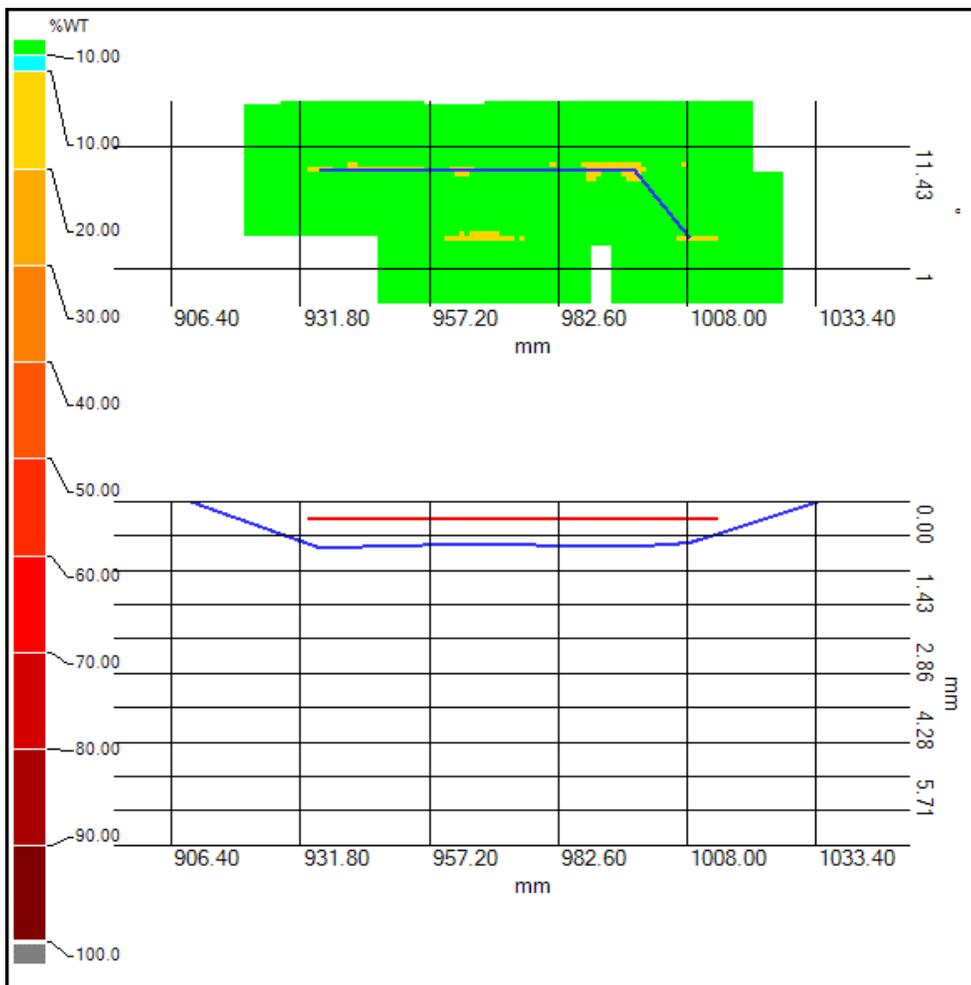
### Worst Case Profile values for Feature 10

Axial start	933.03 mm
Axial end	1014.04 mm
Axial length	81.01 mm
Circ. start	12.18 °
Circ. end	15.79 °
Circ. length	3.61 °
Max. depth	0.96 mm
Max. depth	86.55 %RWT
Axial pos.	935.53 mm
Circ. pos.	12.52 °
Vol. loss	75.71 mm <sup>3</sup>
Anomaly	Pinhole-Axial slotting

Eff. area	11520.14 kPa
RPR (MAOP)	1.43
Modified B31G	11549.86 kPa
RPR (MAOP)	1.43
B31G	10706.75 kPa
RPR (MAOP)	1.33

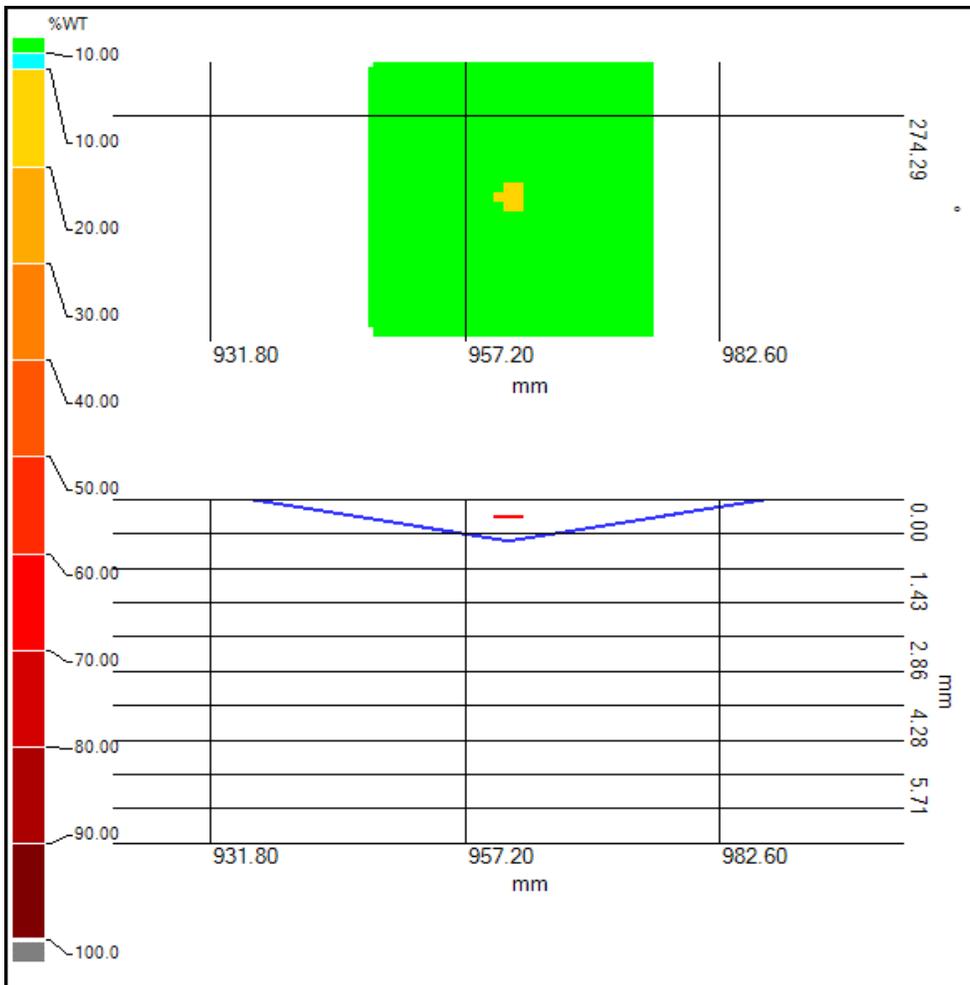
### Worst Case Profile values for Feature 11

Axial start	960.03 mm
Axial end	963.03 mm
Axial length	3.00 mm
Circ. start	275.86 °
Circ. end	276.54 °
Circ. length	0.68 °
Max. depth	0.86 mm
Max. depth	87.96 %RWT
Axial pos.	961.53 mm
Circ. pos.	276.20 °
Vol. loss	5.51 mm <sup>3</sup>
Anomaly	Pinhole

Eff. area	12015.83 kPa
RPR (MAOP)	1.49
Modified B31G	12015.36 kPa
RPR (MAOP)	1.49
B31G	11085.16 kPa
RPR (MAOP)	1.37

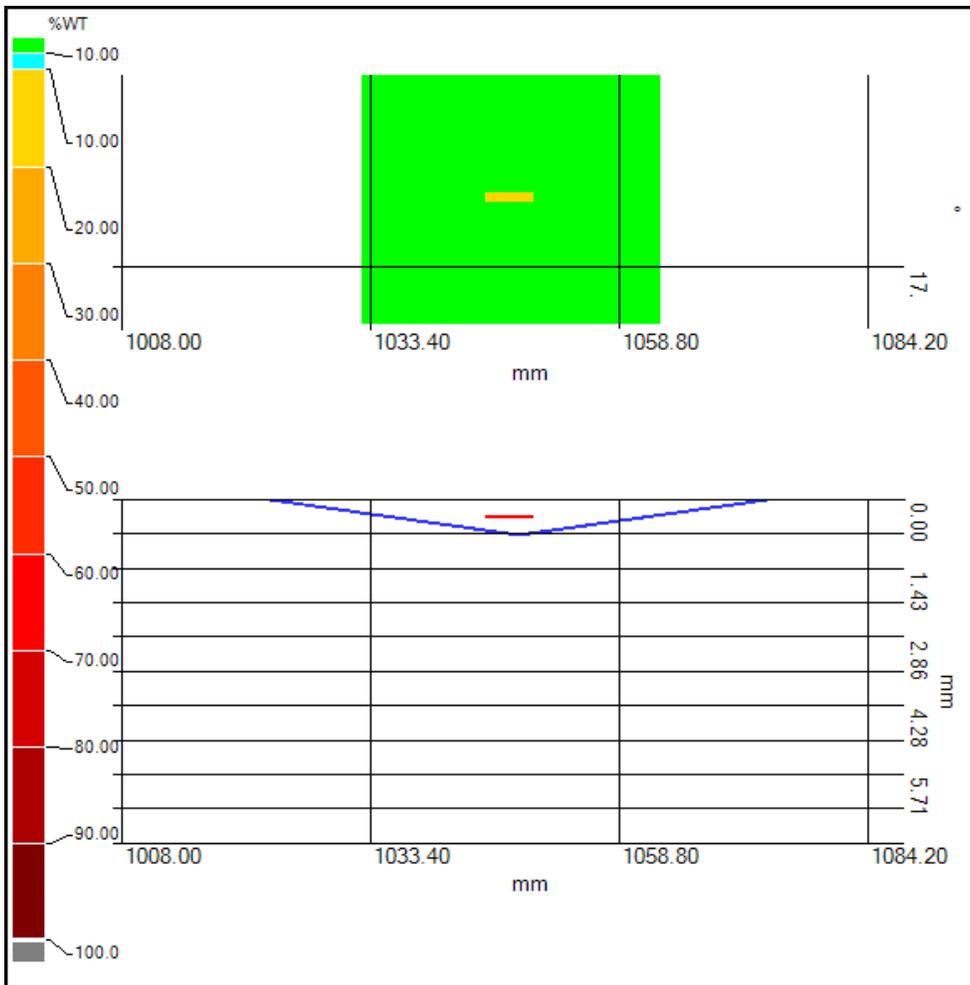
### Worst Case Profile values for Feature 12

Axial start	1045.04 mm
Axial end	1050.04 mm
Axial length	5.00 mm
Circ. start	15.34 °
Circ. end	15.56 °
Circ. length	0.23 °
Max. depth	0.73 mm
Max. depth	89.78 %RWT
Axial pos.	1048.54 mm
Circ. pos.	15.45 °
Vol. loss	3.64 mm <sup>3</sup>
Anomaly	Pinhole

Eff. area	12015.02 kPa
RPR (MAOP)	1.49
Modified B31G	12013.95 kPa
RPR (MAOP)	1.49
B31G	11083.89 kPa
RPR (MAOP)	1.37

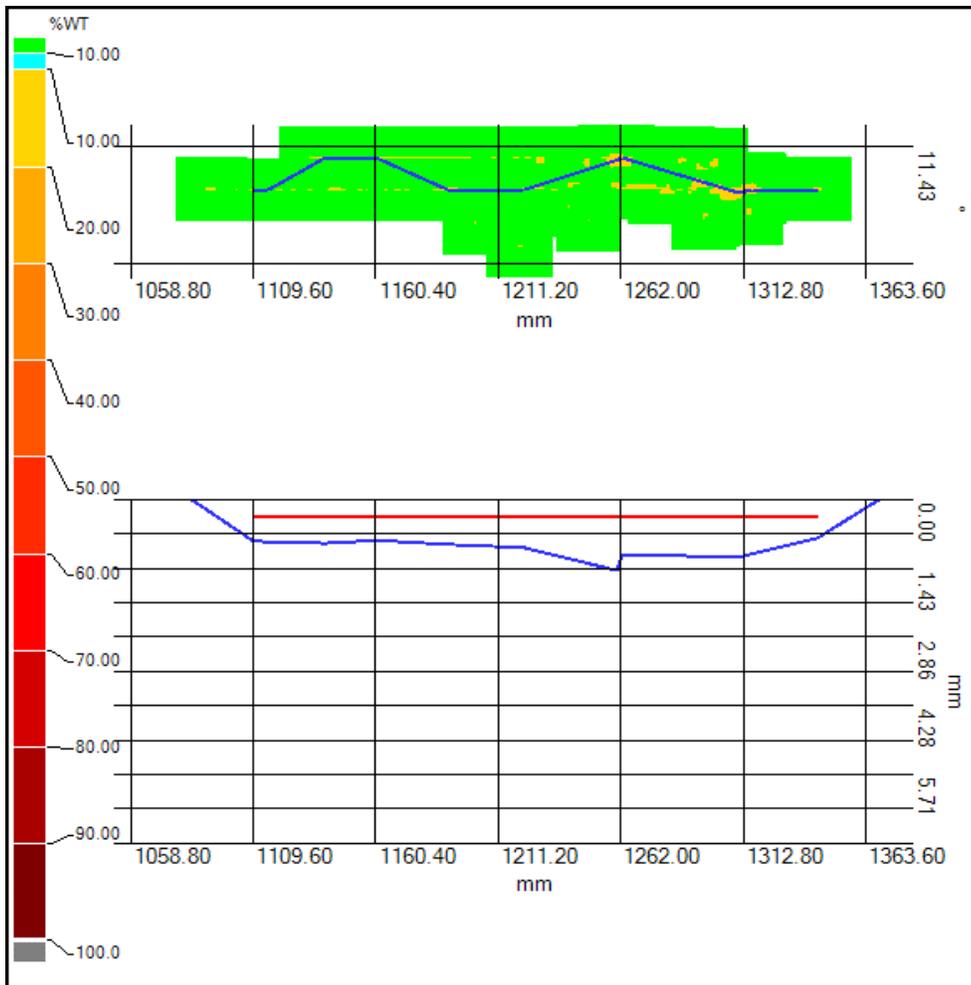
### Worst Case Profile values for Feature 13

Axial start	1090.04 mm
Axial end	1345.06 mm
Axial length	255.02 mm
Circ. start	12.18 °
Circ. end	21.20 °
Circ. length	9.02 °
Max. depth	1.47 mm
Max. depth	79.41 %RWT
Axial pos.	1260.56 mm
Circ. pos.	12.74 °
Vol. loss	386.72 mm <sup>3</sup>
Anomaly	Axial slotting-Pinhole

Eff. area	10783.81 kPa
RPR (MAOP)	1.34
Modified B31G	10458.70 kPa
RPR (MAOP)	1.30
B31G	9909.78 kPa
RPR (MAOP)	1.23

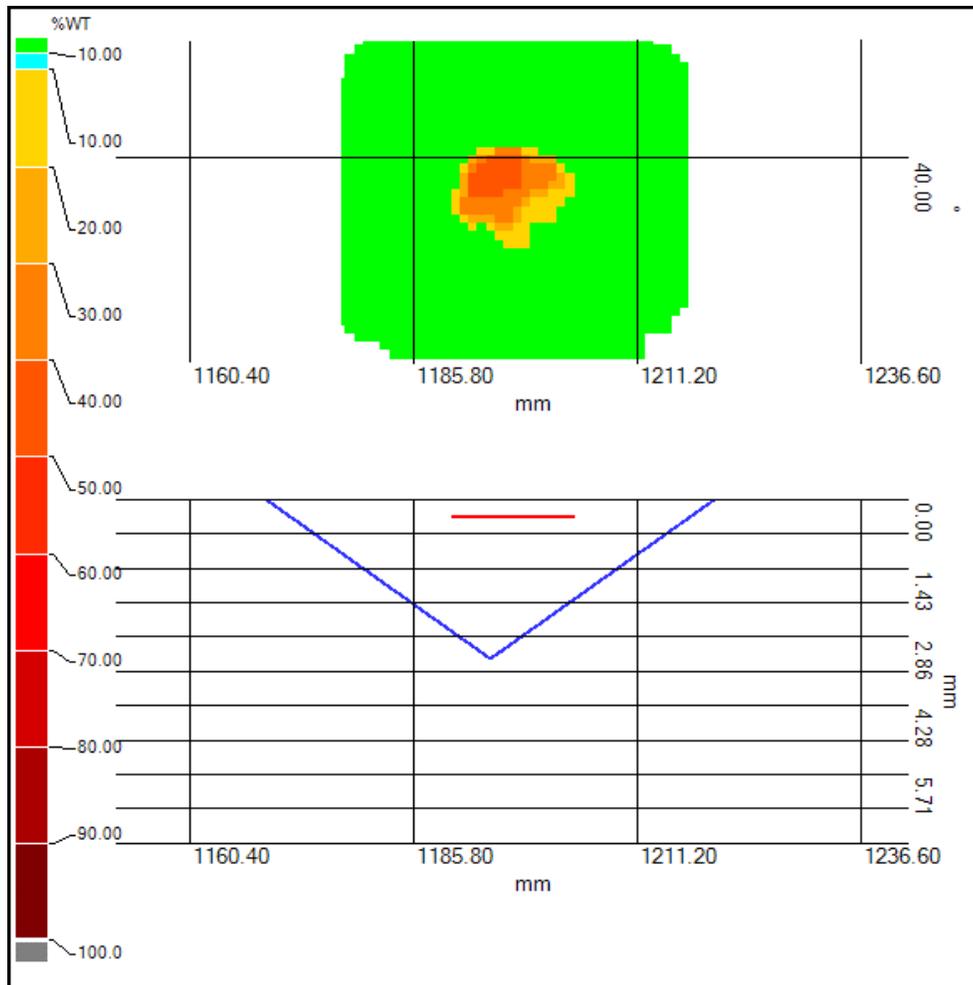
### Worst Case Profile values for Feature 14

Axial start	1190.05 mm
Axial end	1204.05 mm
Axial length	14.00 mm
Circ. start	39.70 °
Circ. end	42.41 °
Circ. length	2.71 °
Max. depth	3.31 mm
Max. depth	53.64 %RWT
Axial pos.	1194.55 mm
Circ. pos.	40.71 °
Vol. loss	239.99 mm <sup>3</sup>
Anomaly	Pitting

Eff. area	11956.81 kPa
RPR (MAOP)	1.48
Modified B31G	11888.70 kPa
RPR (MAOP)	1.47
B31G	10983.31 kPa
RPR (MAOP)	1.36

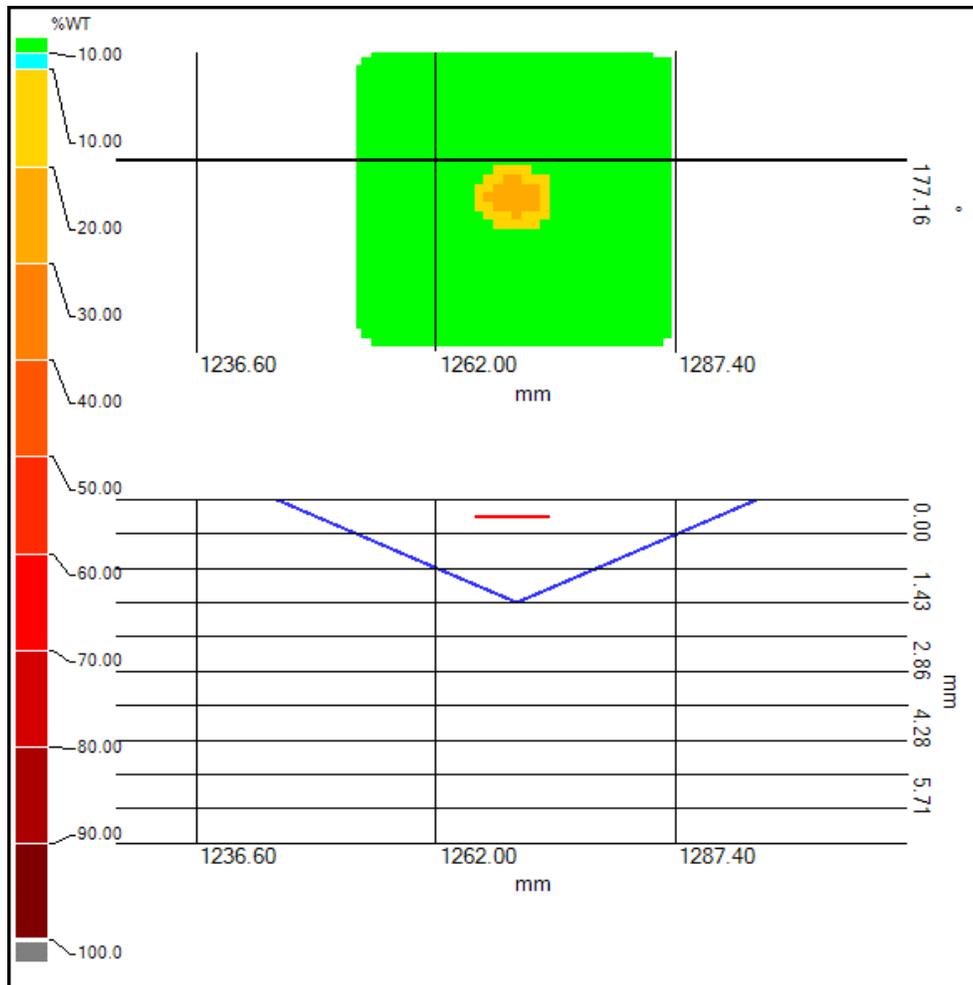
### Worst Case Profile values for Feature 15

Axial start	1266.06 mm
Axial end	1274.06 mm
Axial length	8.00 mm
Circ. start	177.29 °
Circ. end	178.87 °
Circ. length	1.58 °
Max. depth	2.14 mm
Max. depth	70.03 %RWT
Axial pos.	1270.56 mm
Circ. pos.	178.08 °
Vol. loss	61.82 mm <sup>3</sup>
Anomaly	Pinhole

Eff. area	12004.82 kPa
RPR (MAOP)	1.49
Modified B31G	11993.95 kPa
RPR (MAOP)	1.49
B31G	11066.85 kPa
RPR (MAOP)	1.37

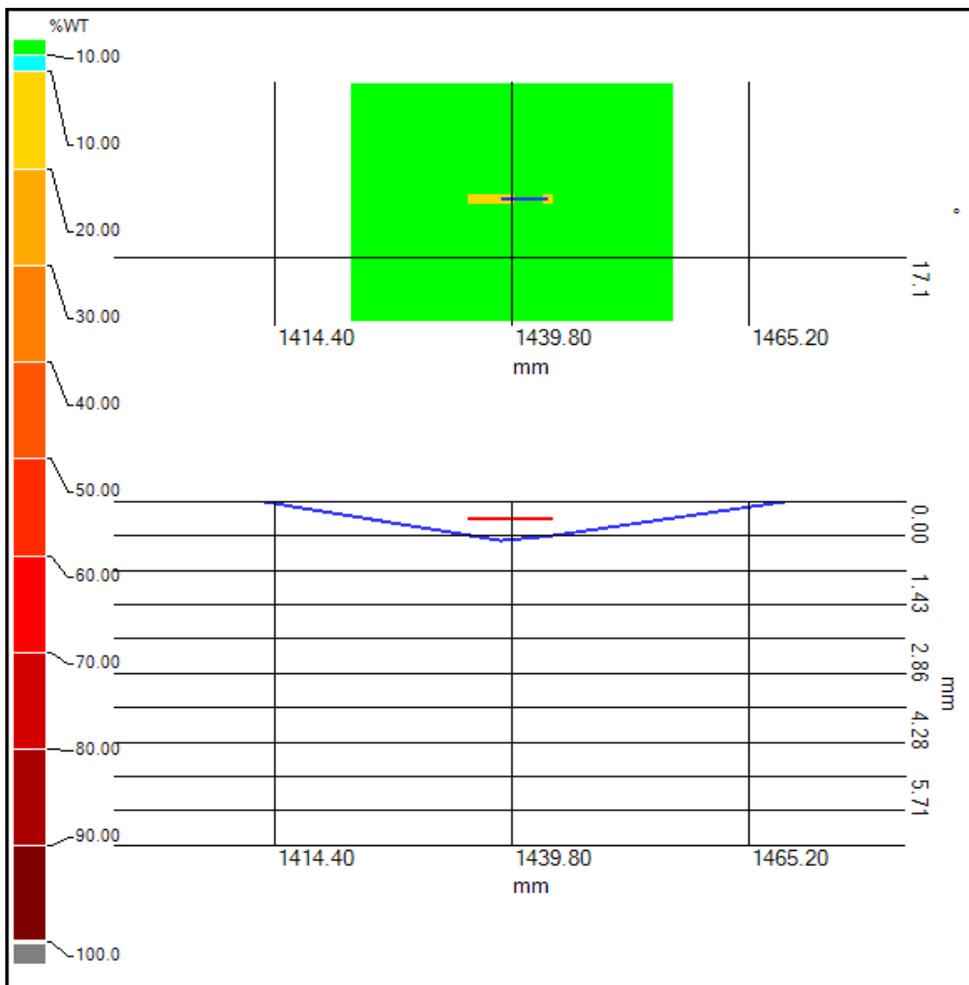
### Worst Case Profile values for Feature 16

Axial start	1435.07 mm
Axial end	1444.07 mm
Axial length	9.00 mm
Circ. start	15.56 °
Circ. end	15.79 °
Circ. length	0.23 °
Max. depth	0.81 mm
Max. depth	88.66 %RWT
Axial pos.	1438.57 mm
Circ. pos.	15.68 °
Vol. loss	4.56 mm <sup>3</sup>
Anomaly	Pinhole

Eff. area	12008.78 kPa
RPR (MAOP)	1.49
Modified B31G	12007.59 kPa
RPR (MAOP)	1.49
B31G	11078.18 kPa
RPR (MAOP)	1.37

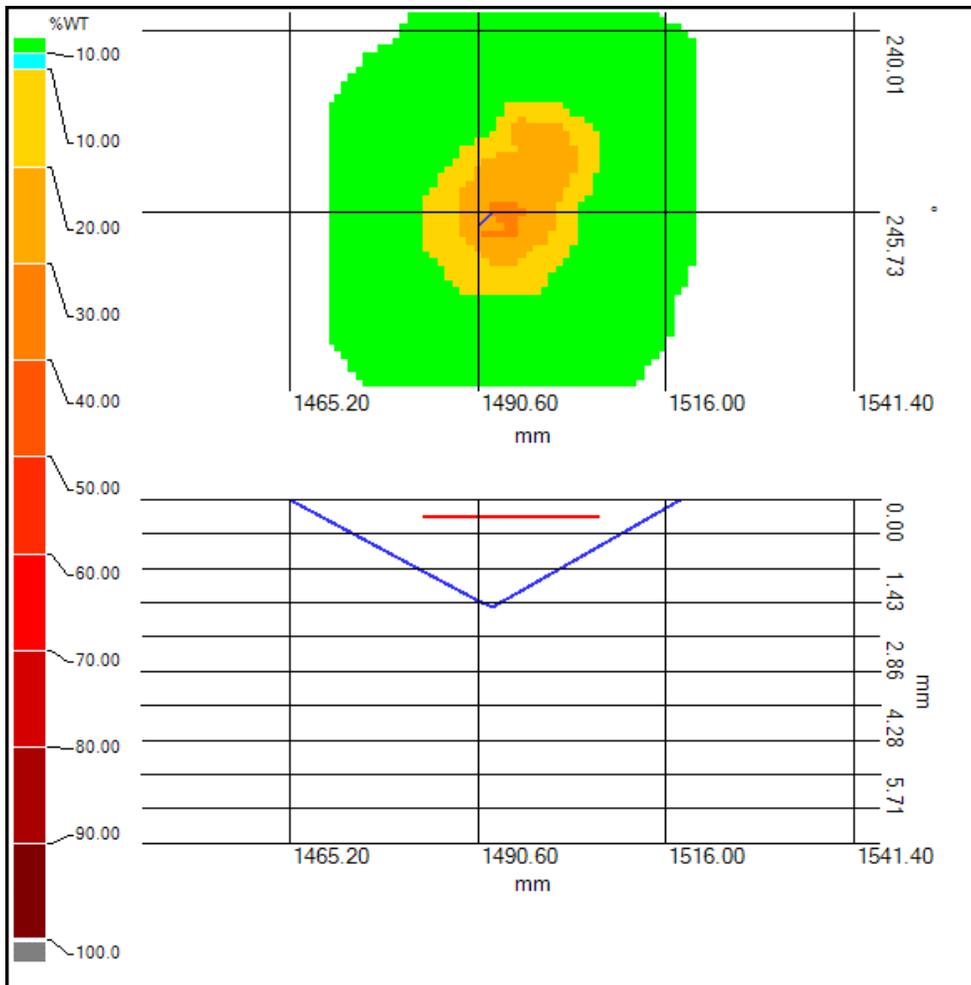
### Worst Case Profile values for Feature 17

Axial start	1483.07 mm
Axial end	1507.08 mm
Axial length	24.00 mm
Circ. start	242.26 °
Circ. end	248.35 °
Circ. length	6.09 °
Max. depth	2.23 mm
Max. depth	68.77 %RWT
Axial pos.	1492.57 mm
Circ. pos.	245.75 °
Vol. loss	660.62 mm <sup>3</sup>
Anomaly	Pitting

Eff. area	11906.78 kPa
RPR (MAOP)	1.48
Modified B31G	11817.89 kPa
RPR (MAOP)	1.47
B31G	10919.00 kPa
RPR (MAOP)	1.35

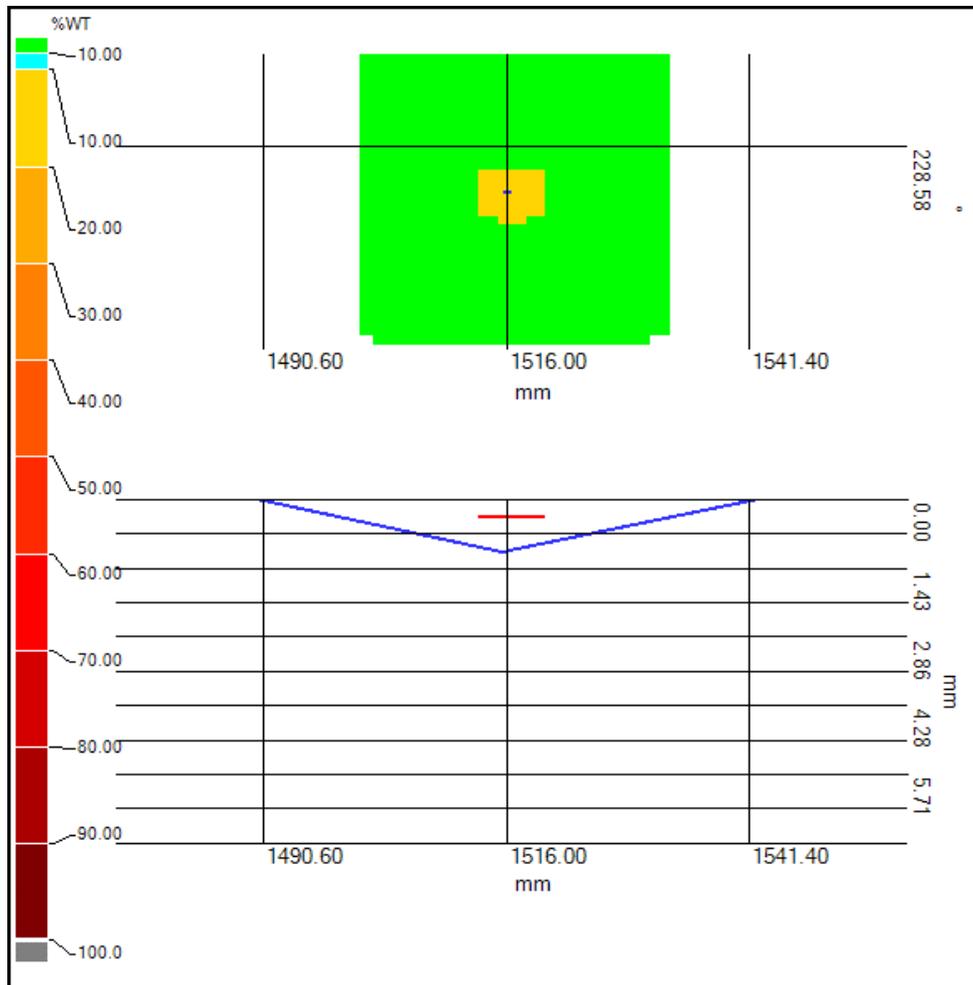
### Worst Case Profile values for Feature 18

Axial start	1513.08 mm
Axial end	1520.08 mm
Axial length	7.00 mm
Circ. start	229.17 °
Circ. end	230.53 °
Circ. length	1.35 °
Max. depth	1.09 mm
Max. depth	84.73 %RWT
Axial pos.	1515.58 mm
Circ. pos.	229.74 °
Vol. loss	33.37 mm <sup>3</sup>
Anomaly	Pinhole

Eff. area	12011.73 kPa
RPR (MAOP)	1.49
Modified B31G	12008.90 kPa
RPR (MAOP)	1.49
B31G	11079.41 kPa
RPR (MAOP)	1.37
