# PARSC 016

## Peace River Mainline Abandoned Pipeline Segment Field Study

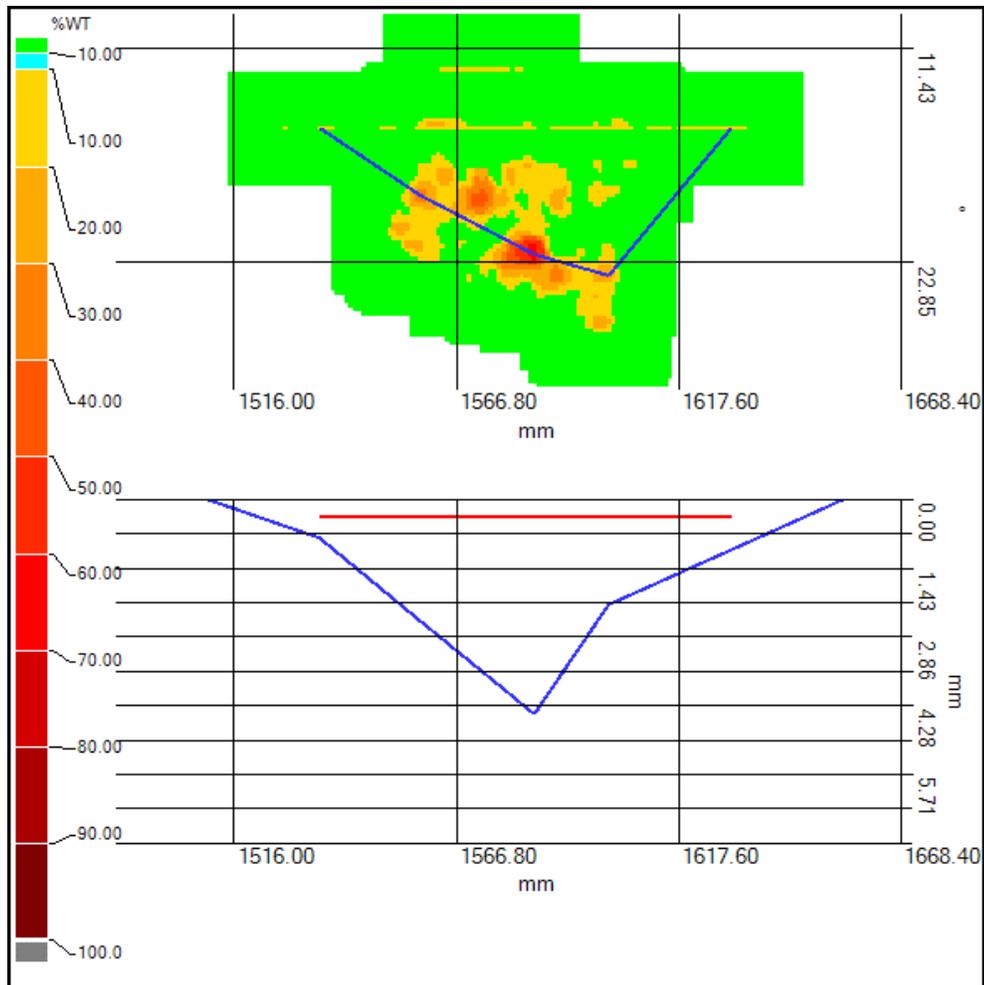
### Worst Case Profile values for Feature 19

Axial start	1527.08 mm
Axial end	1633.09 mm
Axial length	106.01 mm
Circ. start	12.41 °
Circ. end	26.62 °
Circ. length	14.21 °
Max. depth	4.46 mm
Max. depth	37.54 %RWT
Axial pos.	1584.58 mm
Circ. pos.	22.44 °
Vol. loss	1584.62 mm <sup>3</sup>
Anomaly	General-Pinhole-Axial slotting

Eff. area	10073.45 kPa
RPR (MAOP)	1.25
Modified B31G	8184.18 kPa
RPR (MAOP)	1.02
B31G	8330.45 kPa
RPR (MAOP)	1.03

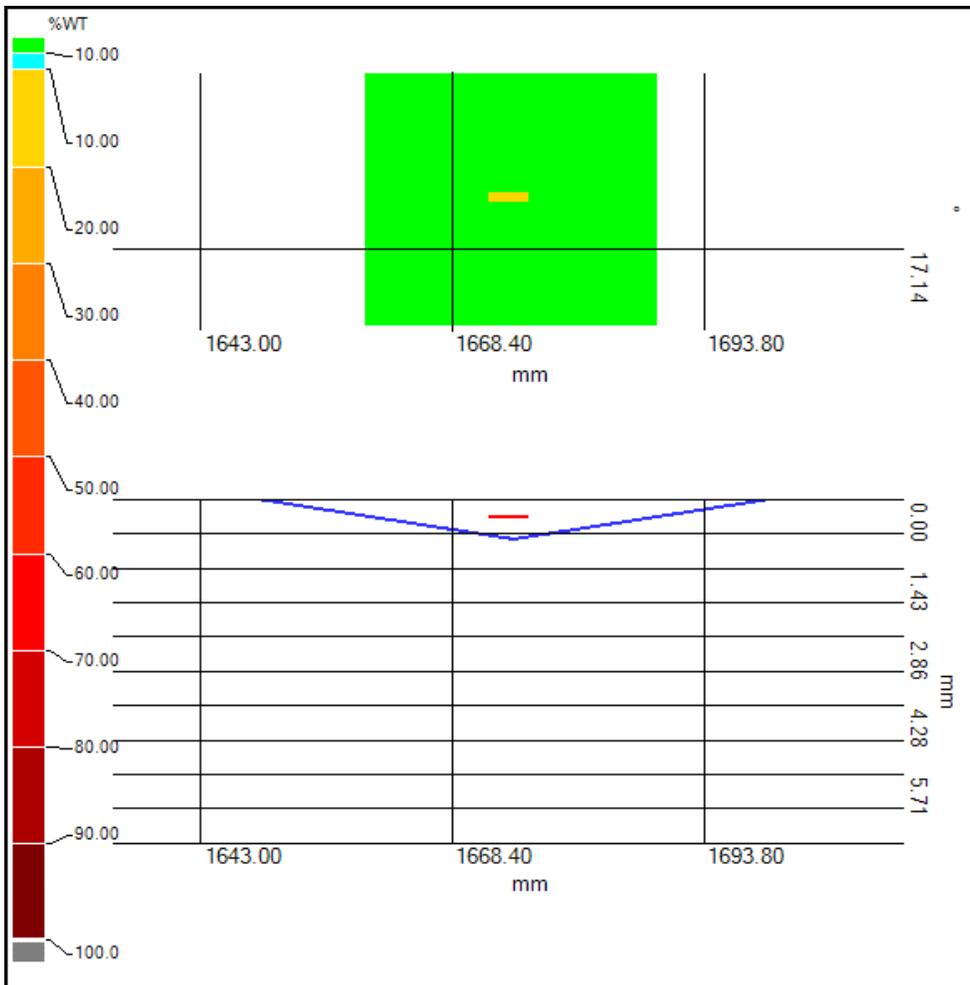
### Worst Case Profile values for Feature 20

Axial start	1672.09 mm
Axial end	1676.09 mm
Axial length	4.00 mm
Circ. start	15.79 °
Circ. end	16.02 °
Circ. length	0.23 °
Max. depth	0.82 mm
Max. depth	88.52 %RWT
Axial pos.	1674.59 mm
Circ. pos.	15.90 °
Vol. loss	3.11 mm <sup>3</sup>
Anomaly	Pinhole

Eff. area	12015.42 kPa
RPR (MAOP)	1.49
Modified B31G	12014.64 kPa
RPR (MAOP)	1.49
B31G	11084.51 kPa
RPR (MAOP)	1.37

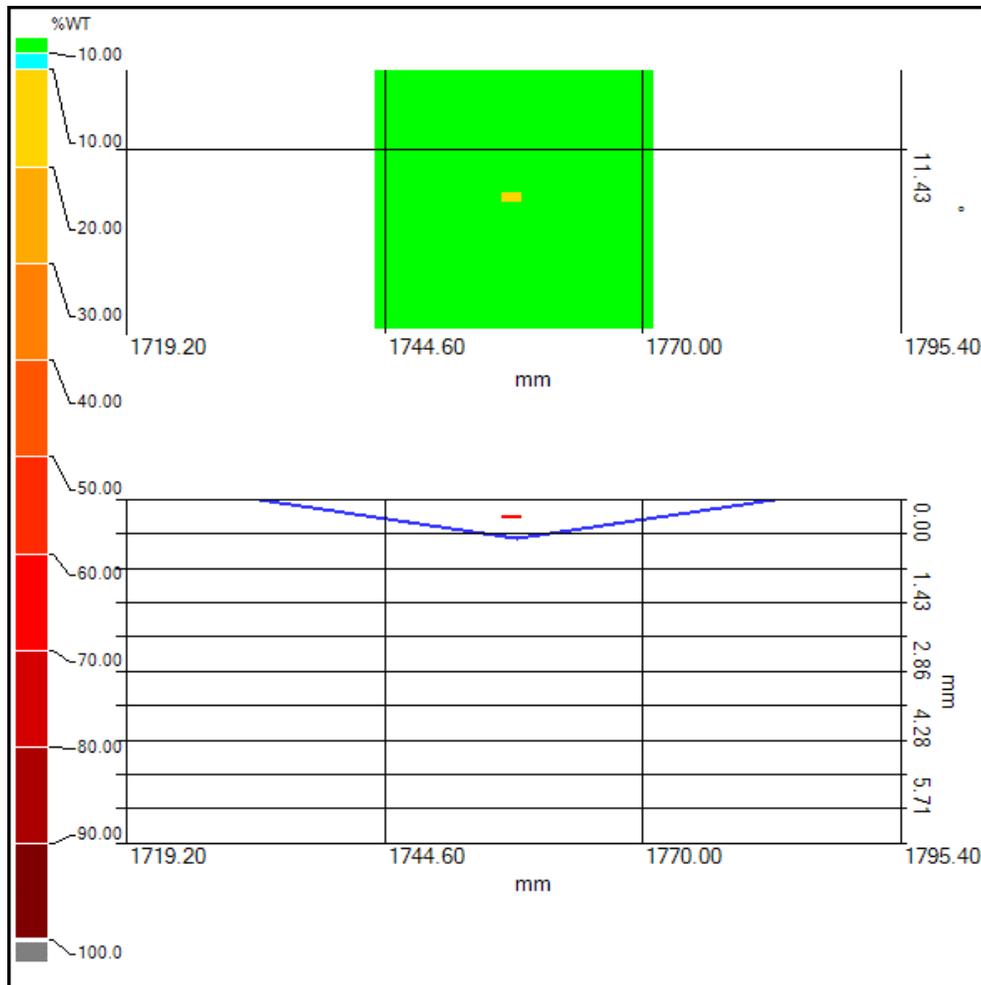
**Worst Case Profile values for Feature 21**

Axial start	1756.09 mm
Axial end	1758.09 mm
Axial length	2.00 mm
Circ. start	12.41 °
Circ. end	12.63 °
Circ. length	0.23 °
Max. depth	0.80 mm
Max. depth	88.80 %RWT
Axial pos.	1757.59 mm
Circ. pos.	12.52 °
Vol. loss	1.60 mm <sup>3</sup>
Anomaly	Pinhole

Eff. area	12016.17 kPa
RPR (MAOP)	1.49
Modified B31G	12015.98 kPa
RPR (MAOP)	1.49
B31G	11085.72 kPa
RPR (MAOP)	1.37

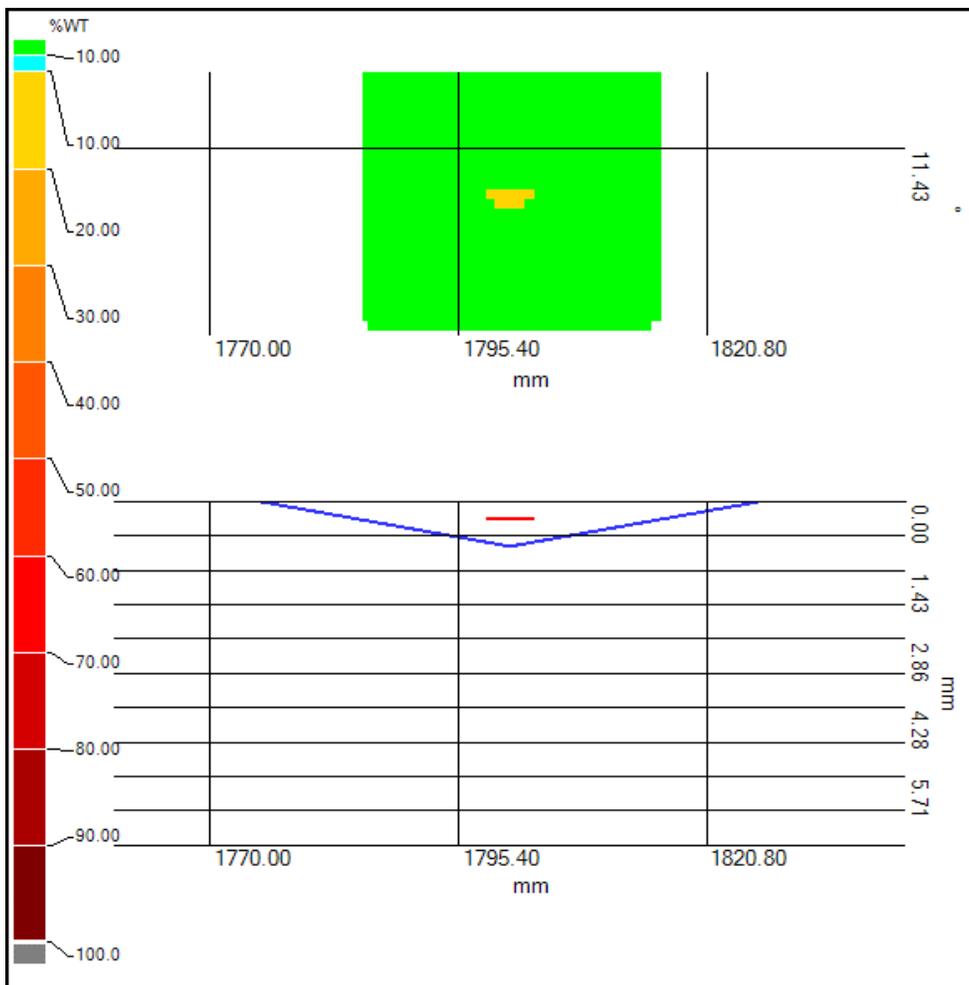
### Worst Case Profile values for Feature 22

Axial start	1798.10 mm
Axial end	1803.10 mm
Axial length	5.00 mm
Circ. start	12.41 °
Circ. end	12.86 °
Circ. length	0.45 °
Max. depth	0.93 mm
Max. depth	86.97 %RWT
Axial pos.	1800.60 mm
Circ. pos.	12.52 °
Vol. loss	6.66 mm <sup>3</sup>
Anomaly	Pinhole

Eff. area	12014.62 kPa
RPR (MAOP)	1.49
Modified B31G	12013.21 kPa
RPR (MAOP)	1.49
B31G	11083.24 kPa
RPR (MAOP)	1.37

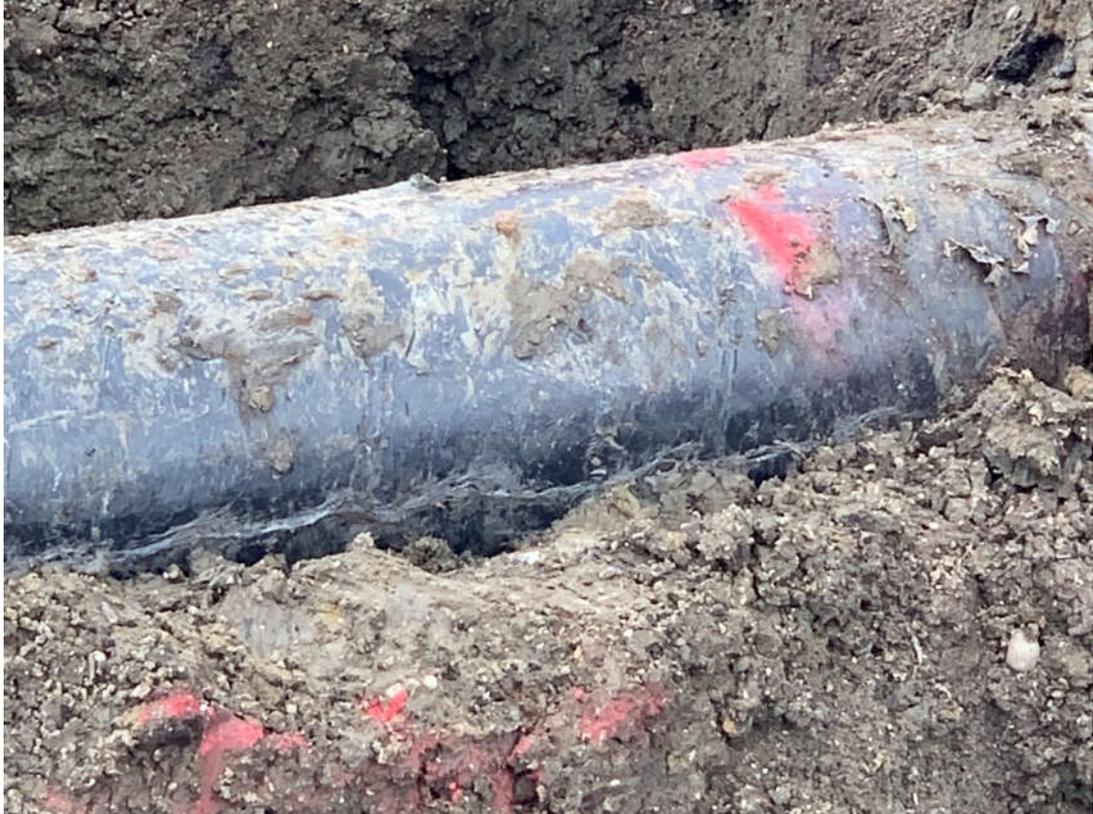
*Figure B: Example of Coating 'Wrinkling' Disbondment – Partial Excavation*

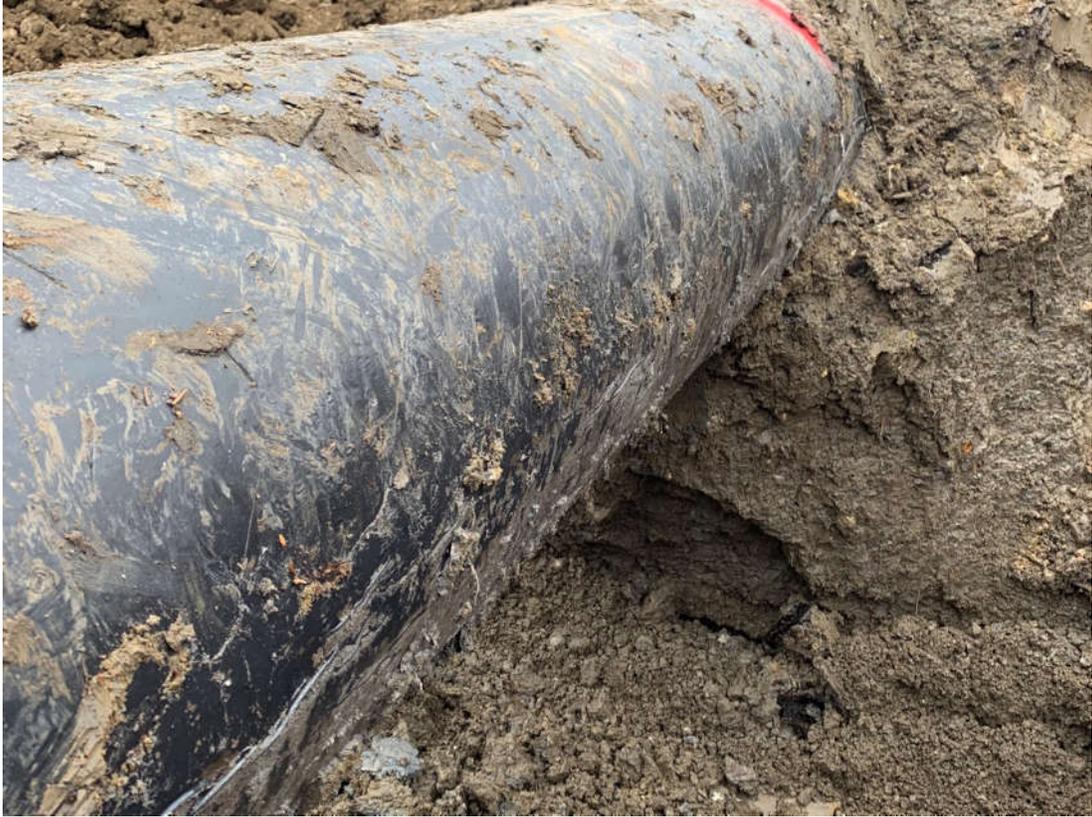
*Figure C: Example of Coating 'Wrinkling' Disbondment – Full Excavation*

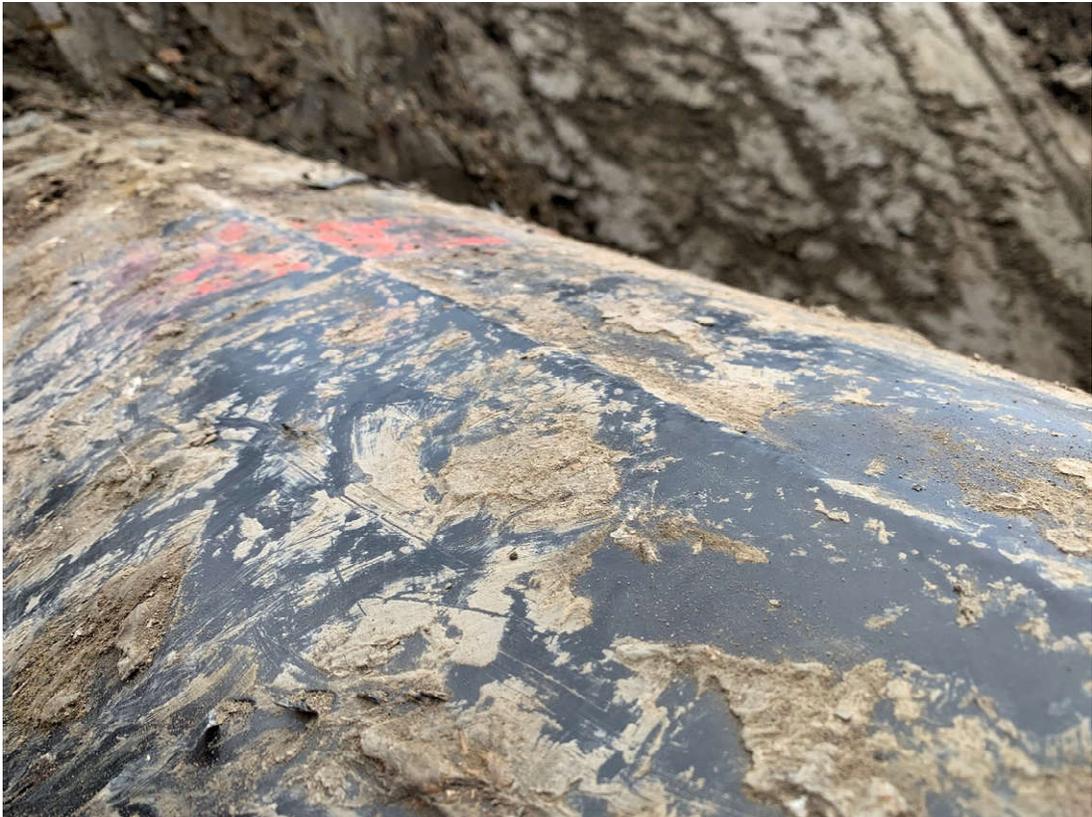
*Figure H: Coating 'Tenting' at 12 O'clock Position*

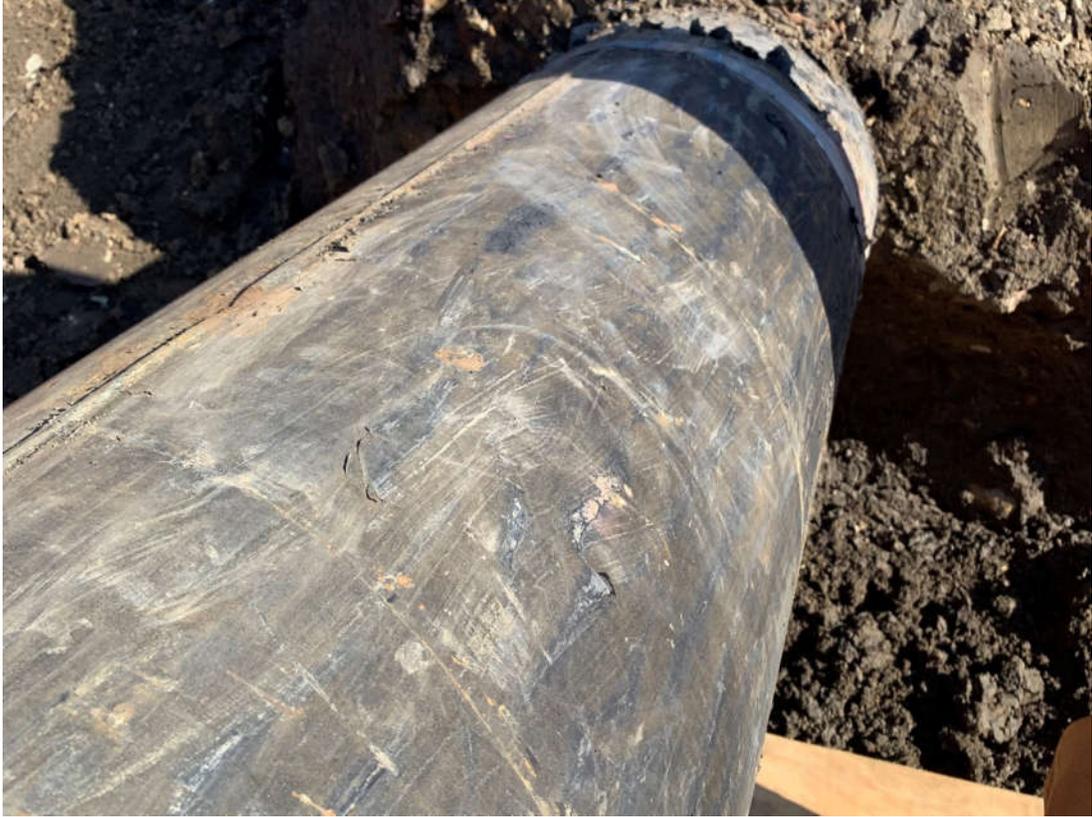
*Figure I: Pipe Surface After Initial Sandblasting*

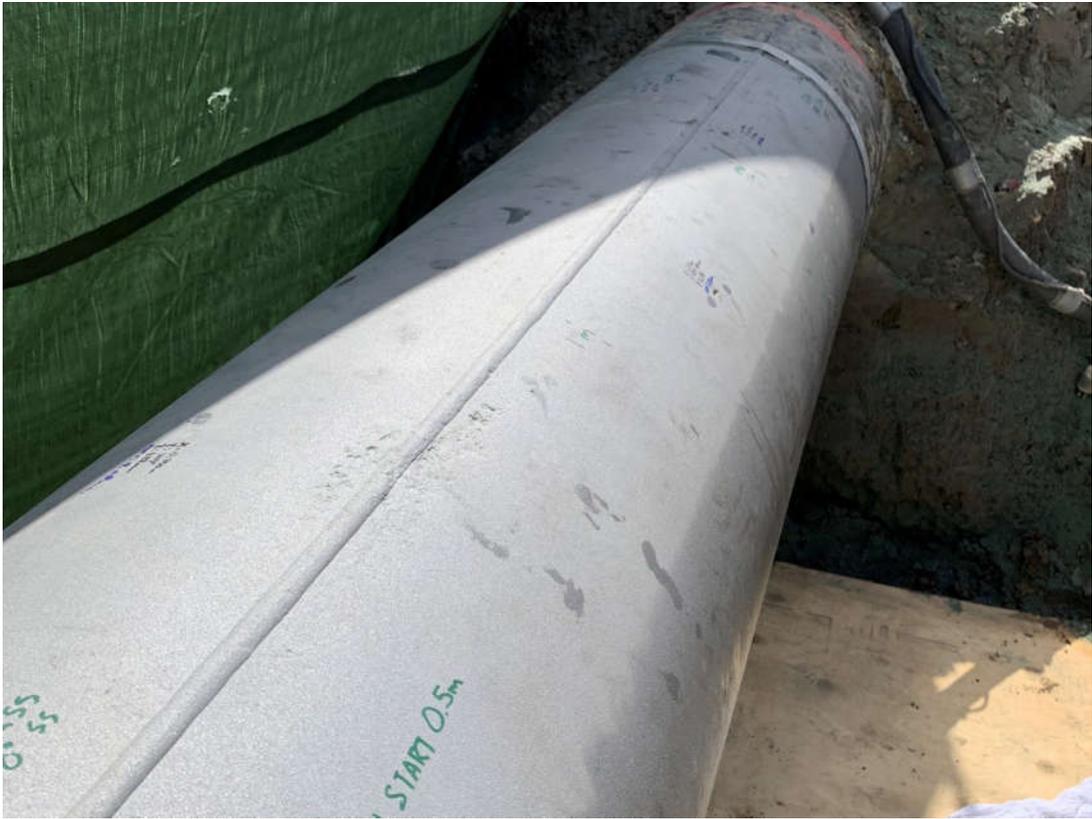
Figure U: Condensation Lines Forming on Pipe Exterior, 10 O'clock Position

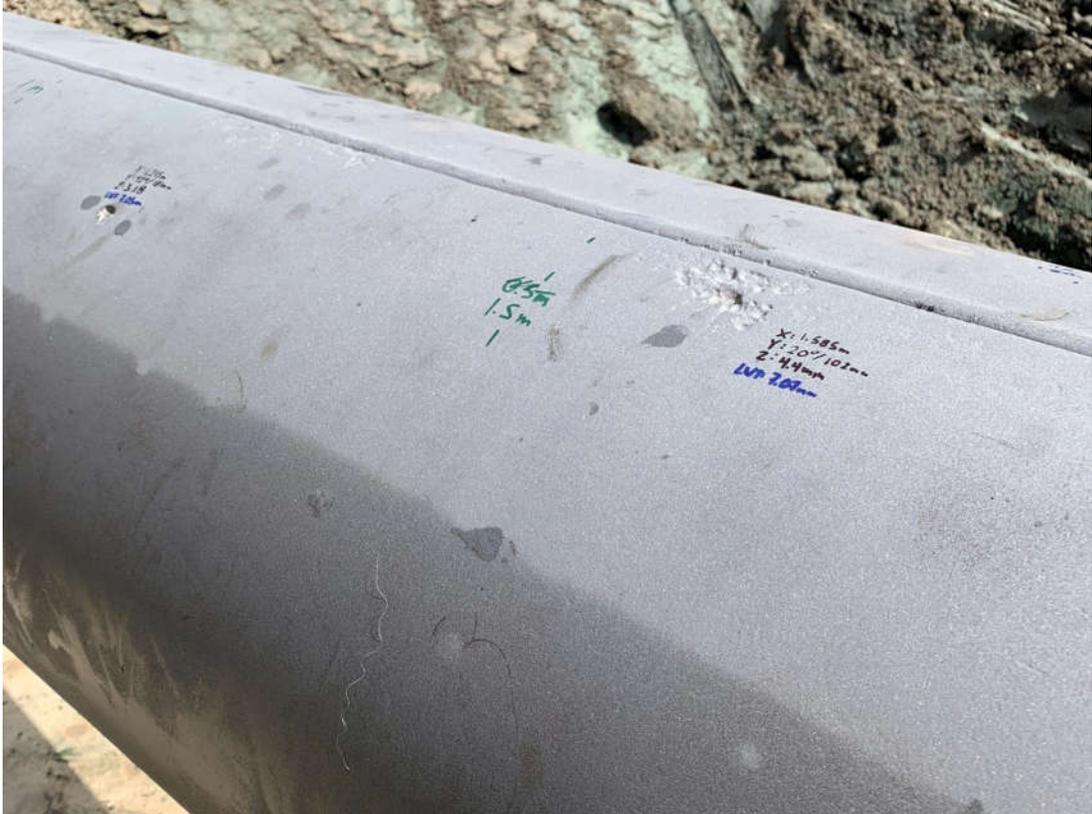
Figure V: Condensation Lines Forming on Pipe Exterior, 2 O'clock Position

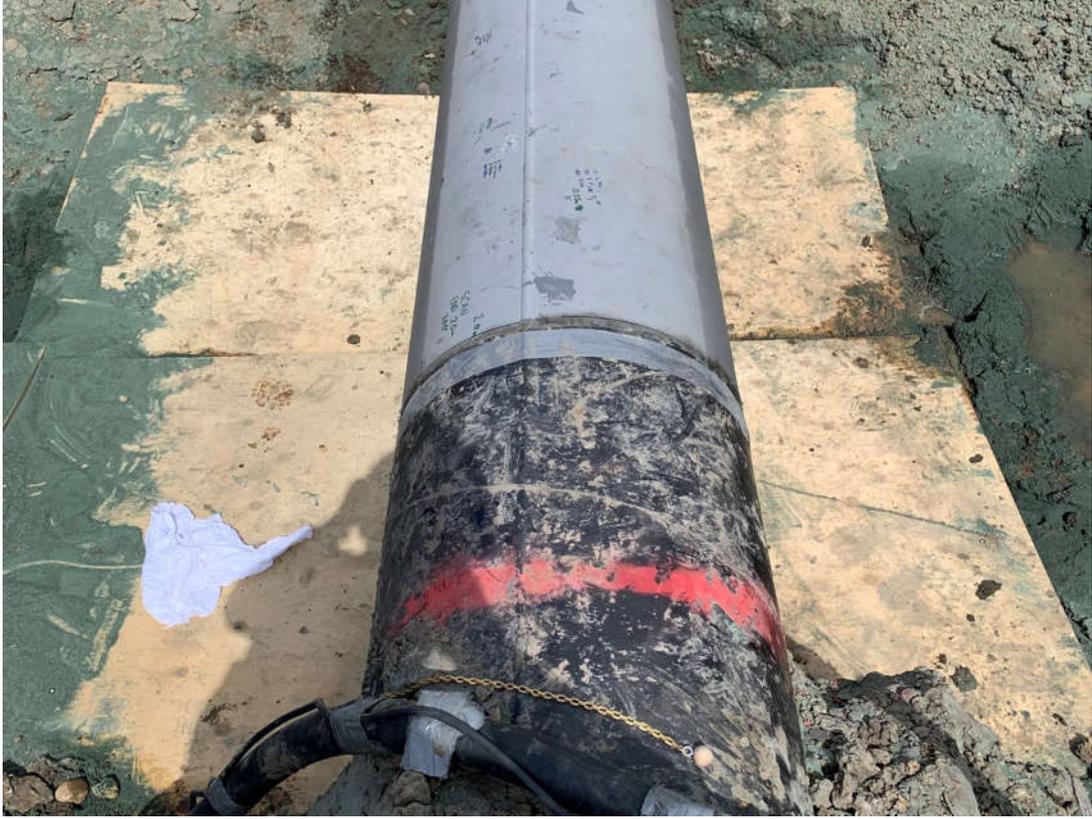
Figure W: Condensation Lines Forming on Pipe Exterior, Top View

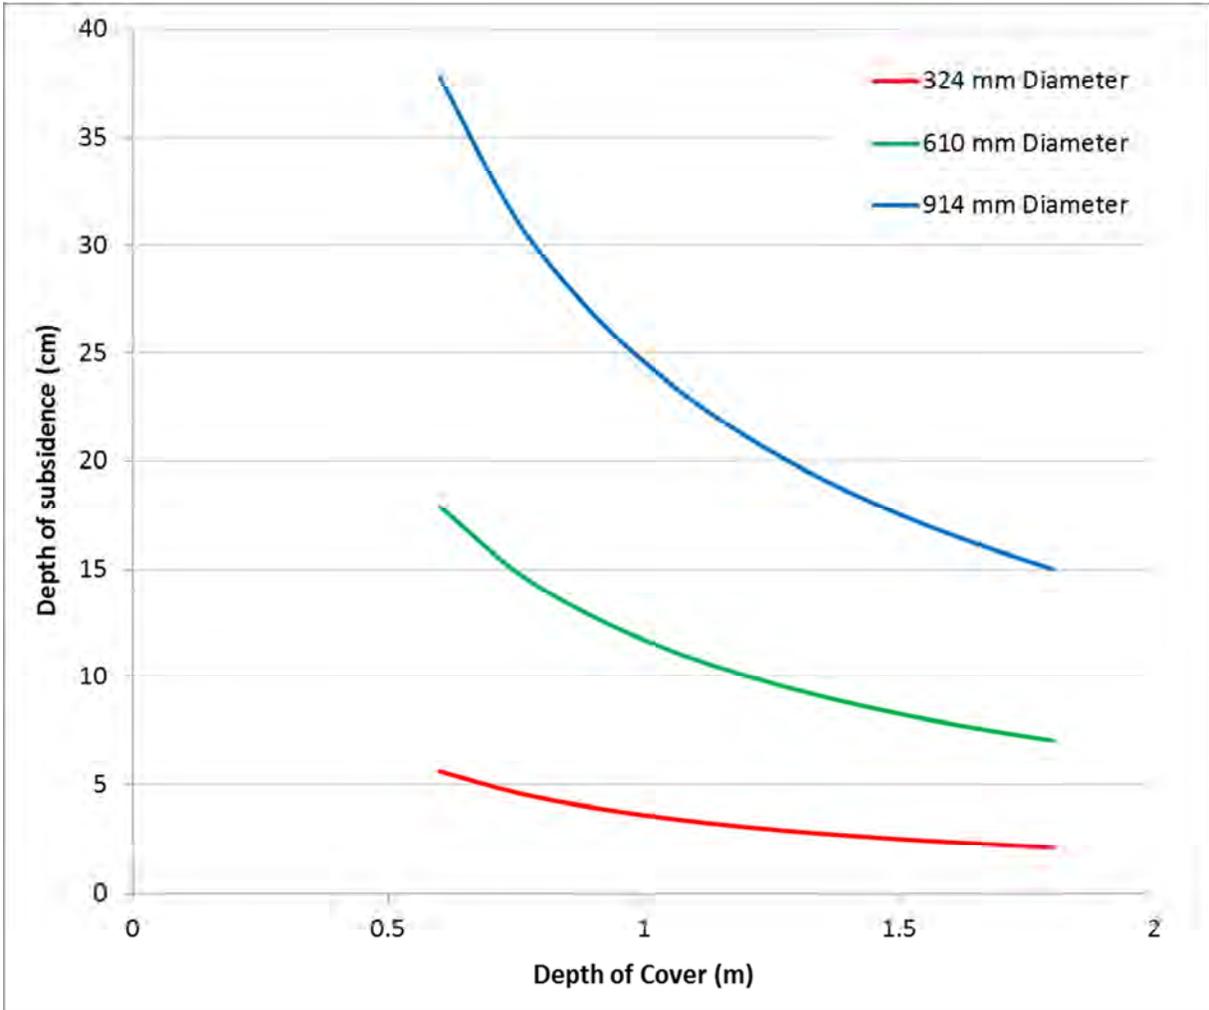
Figure 34 is a simple plot of predict subsidence depth as a function of depth of cover and pipeline diameter. The data is based on Equation 23. For these previous two examples, provided in Section 6.0, the soil collapse model predicts depths of approximately 10 cm for the “average” case and 40 cm for the “extreme” case.

Figure 34. Plot of predicted soil subsidence depth as a function of depth of cover and pipeline diameter.

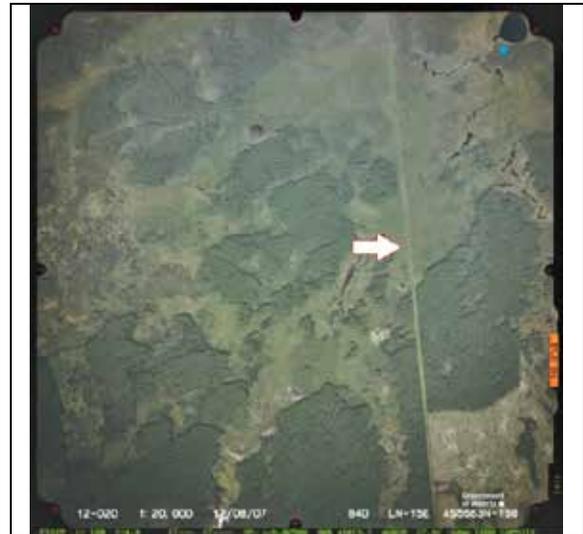
Plate C-4. White arrow shows the approximate screw anchor weight location on Segment 2 at SW 17-90-1 W6M, decades following pipeline abandonment; hydrology is similar in this location (August 2012). Blue star provides landscape reference point.

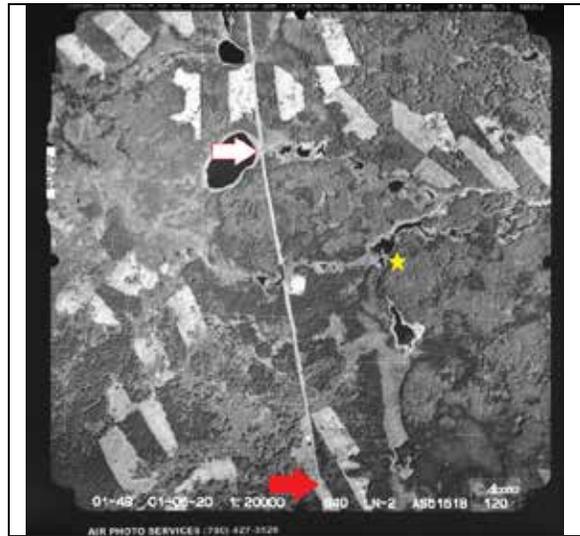
*Plate C-6. A white arrow shows the approximate screw anchor weight location on Segment 3 at NE 29-89-1 W6M, and red arrow shows the approximate beginning/end point at NW 16-89-1 W6M; hydrology is similar before and after pipeline abandonment; forest is cleared in the approximate area of beginning/end point in 2001 (June 2001). Yellow star provides landscape reference point.*

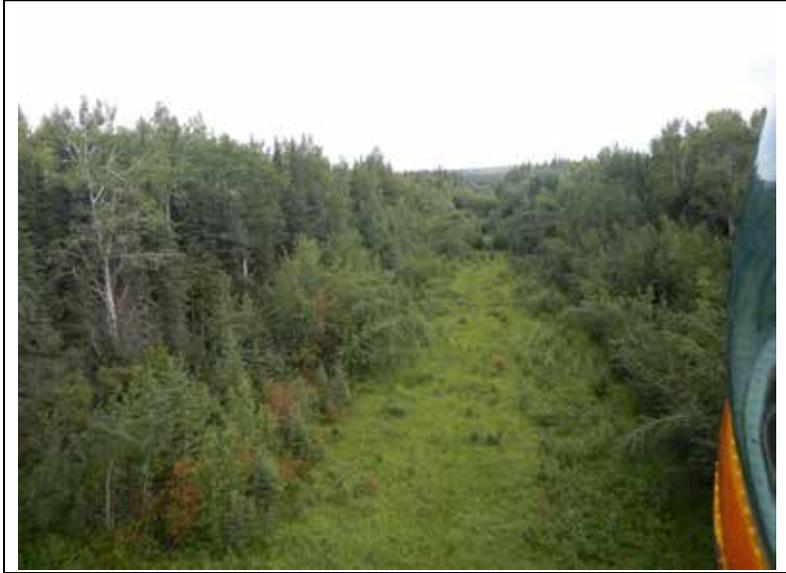
*Plate D-1. View south along the abandoned pipeline Segment 1 showing the well-vegetated right-of-way (ROW) near the end point of the segment at SE 18-91-1 W6M (Unique ID 1-1).*

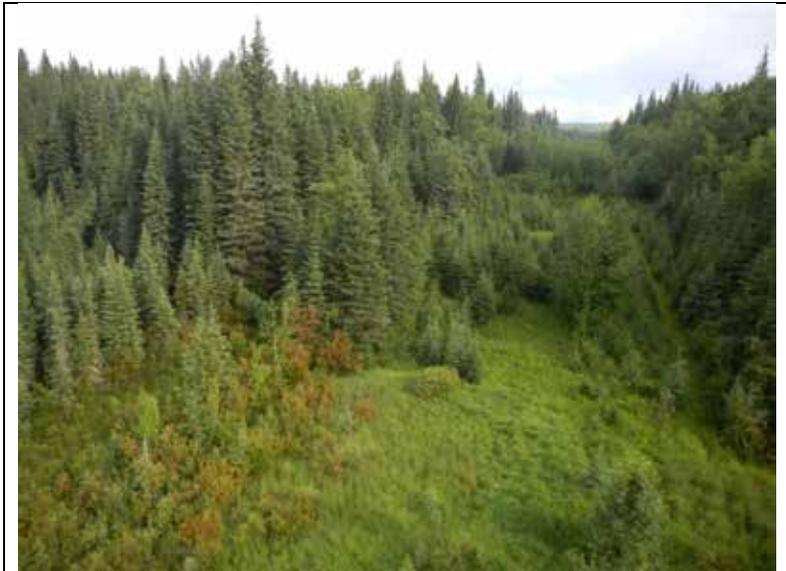
*Plate D-2. View south along the abandoned pipeline Segment 1 showing the well-vegetated ROW near the start point of the segment at SE 19-91-1 W6M (Unique ID 1-1).*

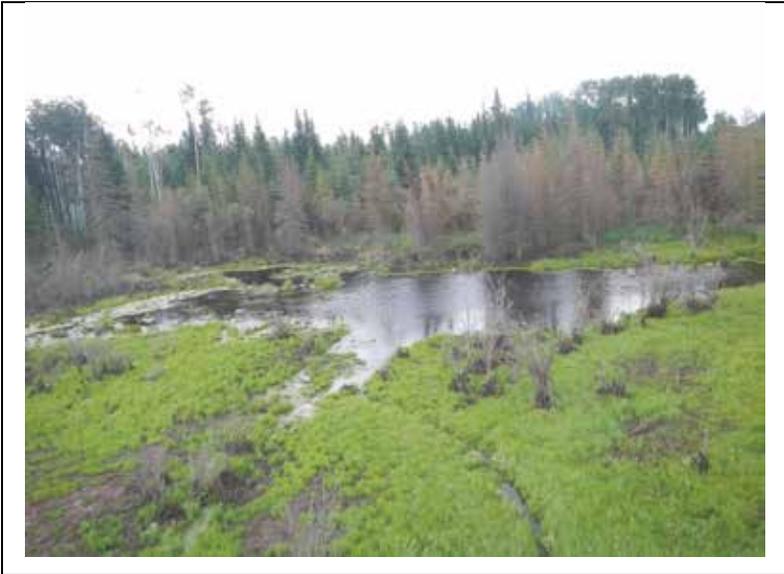
*Plate D-5. View west across the abandoned pipeline Segment 2 showing beaver impoundment at SE 6-91-1 W6M, near the start point (Unique ID 2-1).*

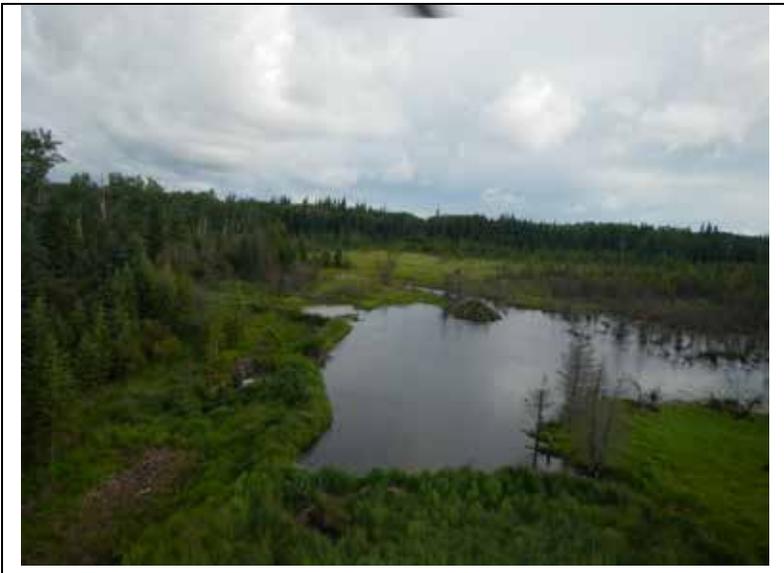
*Plate D-6. View south along the abandoned pipeline Segment 2 showing beaver activity and an area with a screw anchor; no issues with pipe buoyancy at SE 6-91-1 W6M (Unique ID 2-2).*

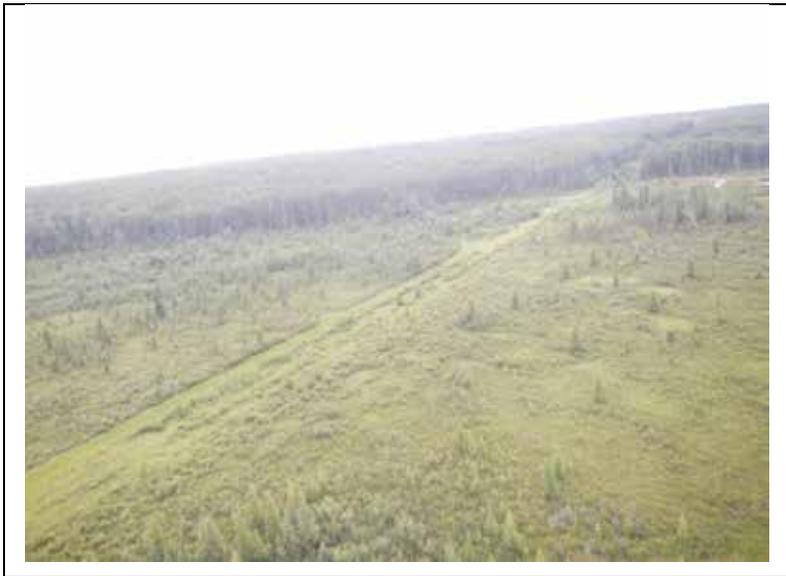
*Plate D-7. View south along the abandoned pipeline Segment 2 showing an area with a screw anchor and no issues with pipe buoyancy at SW 17-90-1 W6M (Unique ID 2-3).*

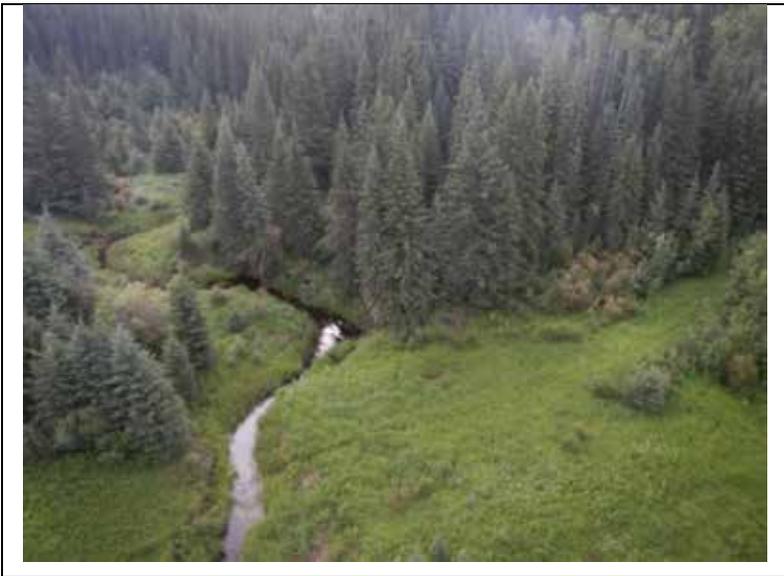
*Plate D-8. View west at the valve site showing healthy, woody vegetation growing on the abandoned pipeline Segment 2 ROW at NW 8-90-1 W6M (Unique ID 2-4).*

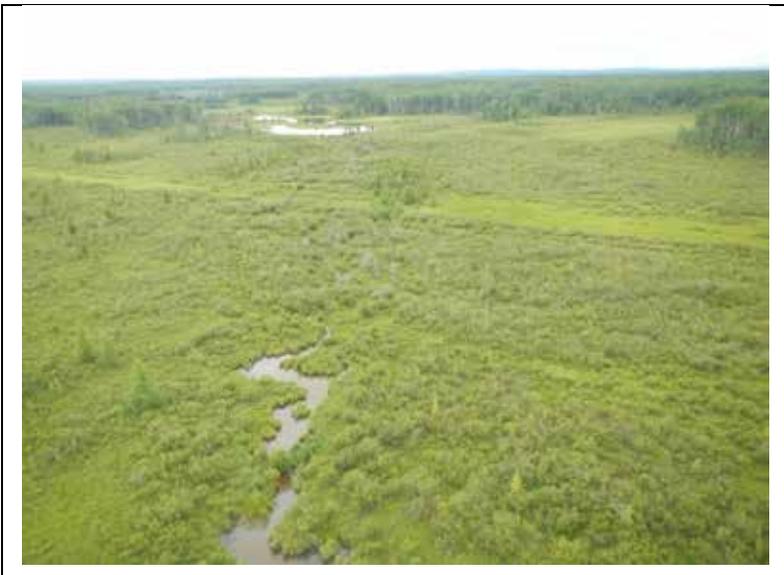
*Plate D-9. View west across the abandoned pipeline Segment 2 showing a watercourse crossing at NE 31-90-1 W6M (Unique ID 2-5).*

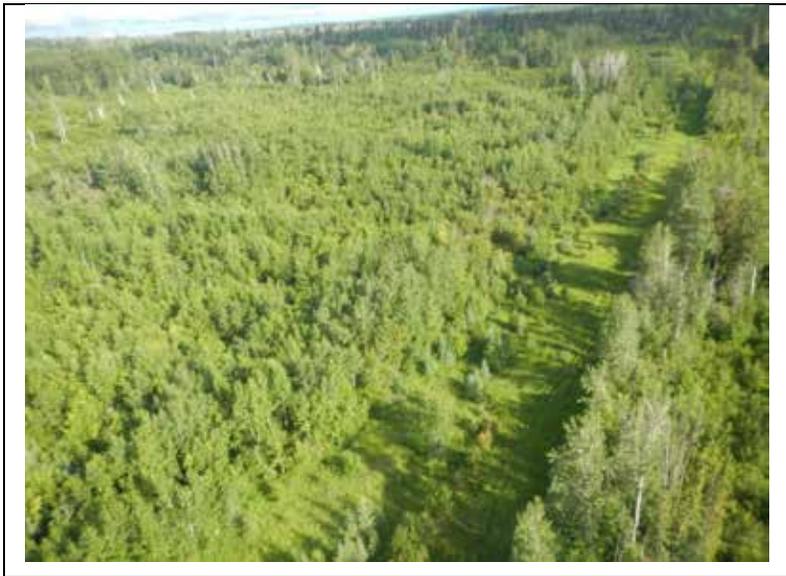
*Plate D-10. View east across the abandoned pipeline Segment 2 showing a watercourse crossing at SW 17-90-1 W6M (Unique ID 2-6).*

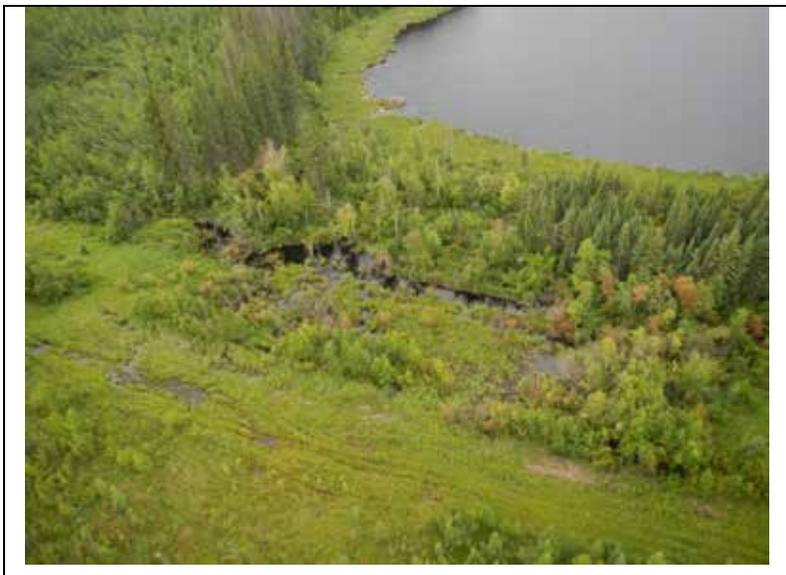
*Plate D-11. View north along the abandoned pipeline Segment 3 showing the well-vegetated ROW near the end point of the segment at NW 16-89-1 W6M (Unique ID 3-1).*

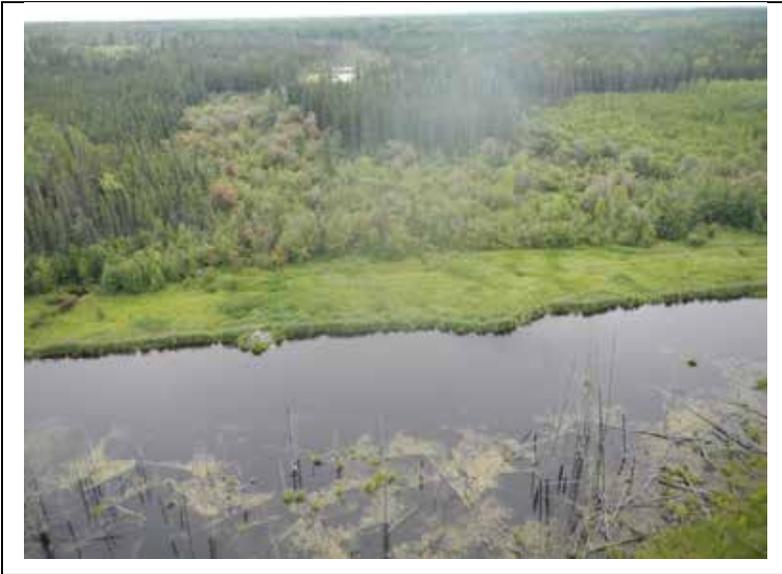
*Plate D-12. View west across the abandoned pipeline Segment 3 showing a beaver impoundment at NE 29-89-1 W6M (Unique ID 3-1).*

Segment 3 start and end point (Unique ID 3-1)	NE 32-89-1 W6M (431725E 6292057N) NW 16-89-1 W6M (432404E 6287437N)	<ul style="list-style-type: none"> <li>Collect soil samples for the area immediately surrounding the pipeline and submit for microbial culture to gain an understanding of whether the metabolic by-products of the bacterial population could contribute to corrosion of the pipe as discussed in Microbially Influenced Corrosion of Pipelines in the Oil and Gas Industry (Alabbas and Mishra, 2013).</li> <li>Collect pipe coating samples and submit for characterization (for example, coal tar enamel, polyvinyl chloride, or asphalt enamel) screening (for example, plasticizers).</li> <li>Assess the condition of the pipeline by measuring the wall thickness and soil resistivity.</li> <li>Open the abandoned pipeline and collect samples to determine the composition, the concentration, and the volume of any residue left remaining in the pipe (as informed by Alberta Innovates – Technology Futures' Cleaning of Pipelines for Abandonment [2015]). Determining the volume of residue will confirm if there is enough material to cause contamination outside of the pipe, or if the residue is voluminous enough to be mobile and cause contamination in other areas along the pipe.</li> </ul>

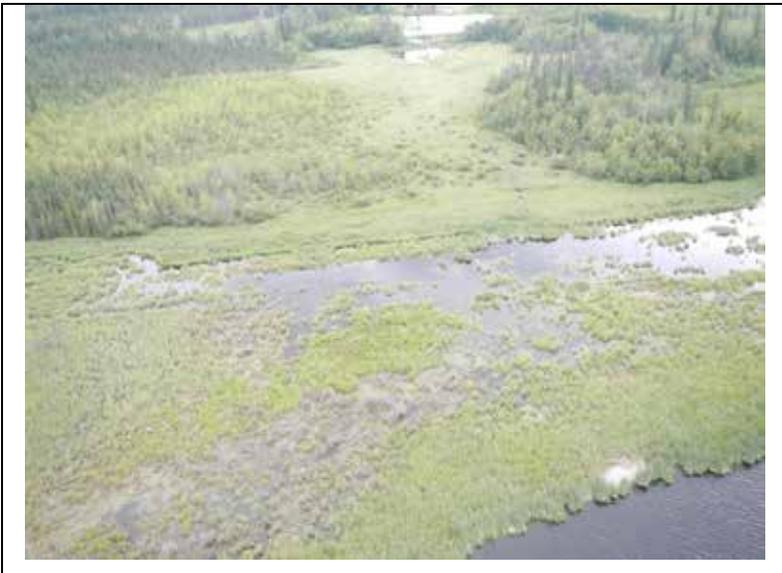
*Plate D-13. View east across the abandoned pipeline Segment 3 showing a beaver-altered wetland with healthy, emergent vegetation at SE 29-89-1 W6M (Unique ID 3-1).*

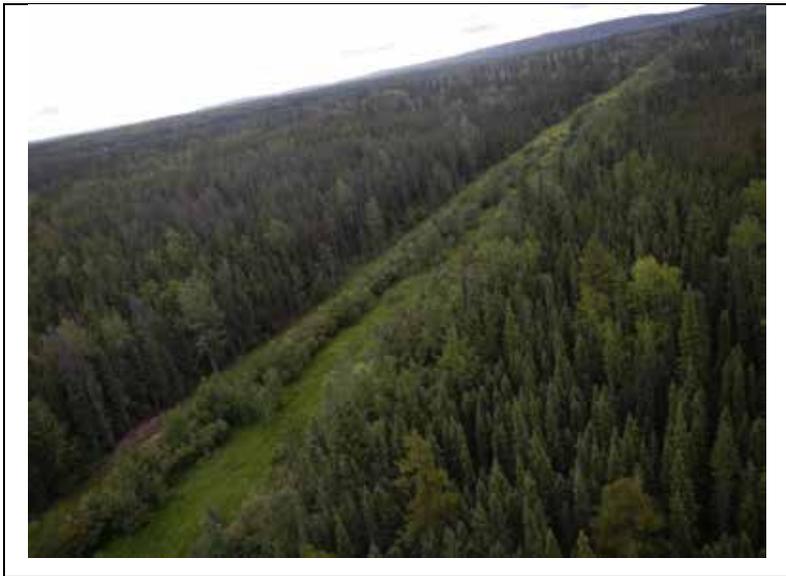
*Plate D-14. View east across the abandoned pipeline Segment 3 showing beaver dams and an area with a screw anchor; no issues with pipe buoyancy at NE 29-89-1 W6M (Unique ID 3-2).*

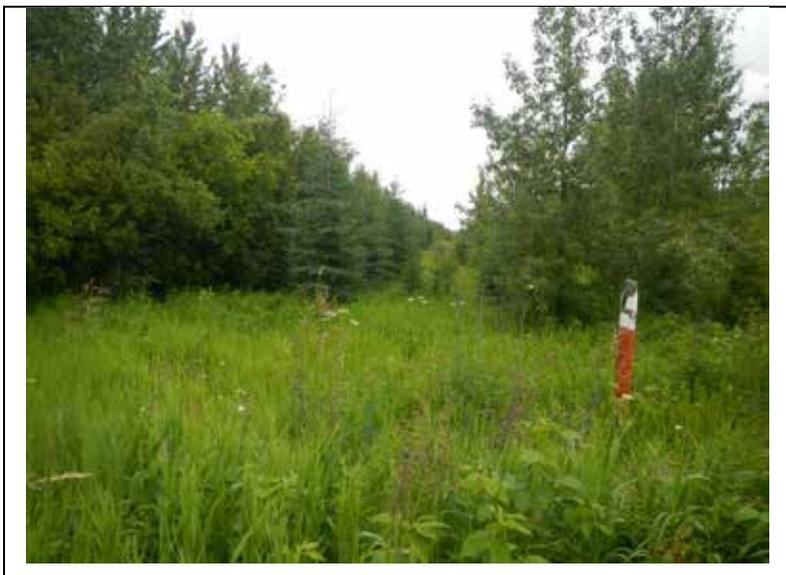
*Plate D-15. View west across the abandoned pipeline Segment 3 showing Peace River Mainline, the abandoned pipeline segment rights-of-way, and the approximate screw anchor location to the south at SW 21-89-1 W6M (Unique ID 3-3).*
